Geotechnical Study of Raspadalica Cliff Rockfall, Croatia

Udovič, Dalibor; Kordić, Branko; Arbanas, Željko

Source / Izvornik: **Applied Sciences, 2022, 12**

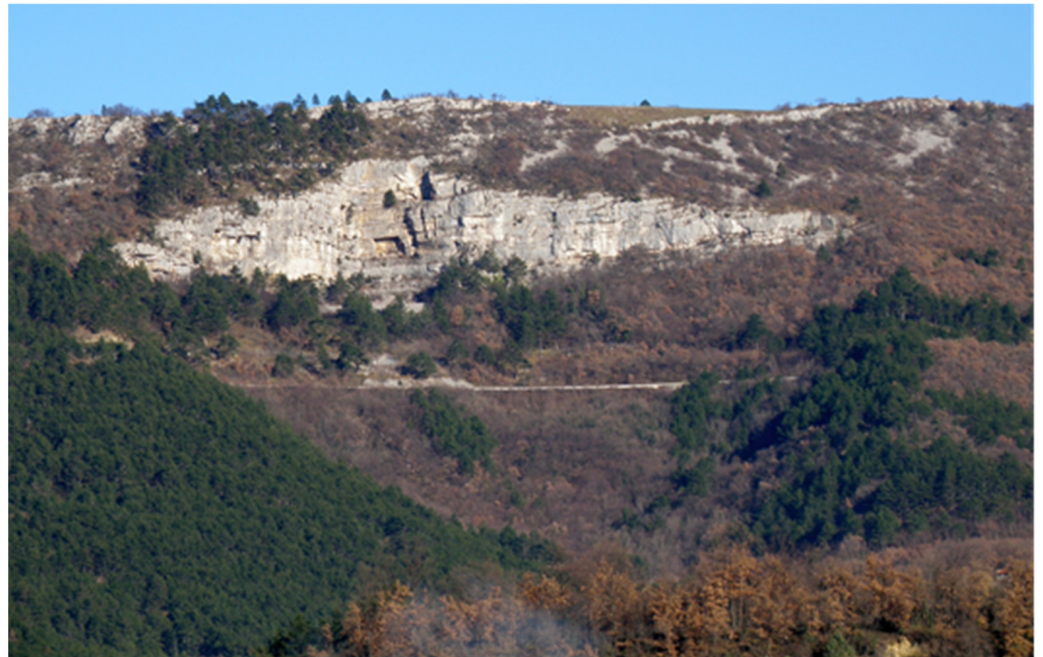
Figure 1. A view of the Raspadalica Cliff, Istria Peninsula, Croatia. The rockfalls threatening the railway line on the slope are clearly visible.

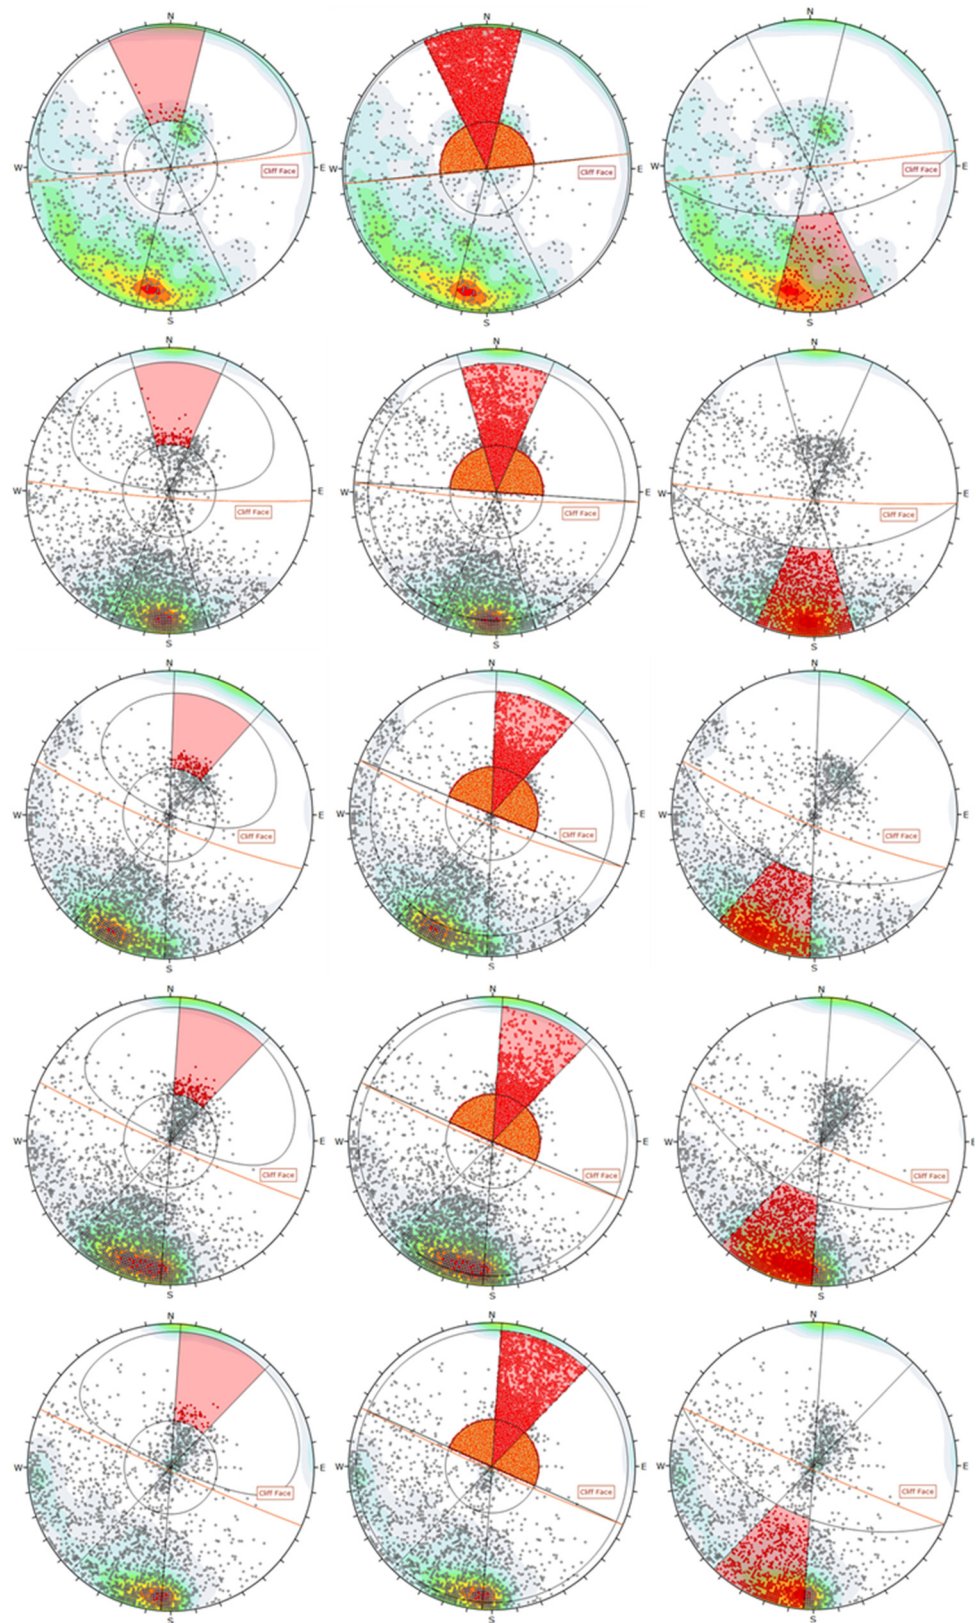
Figure 10. Kinematic analyses of the Raspadalica Cliff by cliff zones according to planar sliding, direct toppling and flexural toppling, conducted using Rocscience *Dips* software [91]. The results are presented in rows for each zone (e.g., Zone Z1 is in the first row). The results of planar sliding are in the first column, direct toppling in the second column, and flexural toppling in the third column.

According to the results of the kinematic analyses conducted for each zone of the cliff (Zones Z1 to Z5) presented in Figure 10 and Table 5, the probability of planar sliding and direct toppling in all five zones is relatively low, while the probability of flexural toppling has a relatively high failure (>40%). Analyzing the possibility of flexural toppling at the Raspadalica Cliff, it was determined that the rock mass conditions those have significant impact on occurrence of flexural toppling are not present at the Raspadalica Cliff. The process of flexural toppling is usually formed in slopes built of continuous columns of rock separated by well-developed, steeply dipping discontinuities breaking in flexure as they bend forward. Block–flexure toppling is characterized by pseudo-continuous flexure along long columns that are divided by numerous cross joints, which are not present at Raspadalica Cliff, and there is no evidence of any block–flexural toppling failure at the Raspadalica Cliff in the past. It is very clear that in a case of flexural toppling, rockfall occurrences should be evident at the top of the cliff and not in the middle part of the rock face, as it is at the Raspadalica Cliff. Analyzing toppling stability of single blocks at the top of the cliff as well as the stability of fictive single columns to the bottom of the cliff, taking into account unfavorable dimensions and maximal determined dip of the base, neglecting the impact of friction at the side walls of a block, centers of gravity of all blocks, and fictive lie inside their bases, confirming the stability regarding toppling. Additionally, based on determined bedding and joint set dips and dip direction, no change was found in the sense of increasing the dips of the layers in the upper part of the cliff that would point to development of flexural toppling mechanisms in the cliff rock mass.

Finally, it was concluded that flexural toppling, despite the relatively high percent of possible flexural failure (>40%), is just a result of kinematic conditions for flexural toppling built into *Rocscience Dips software* [91] but has no real basis in in situ phenomena and can be neglected in further stability analyses.
