# Geotechnical Study of Raspadalica Cliff Rockfall, Croatia

**Udovič, Dalibor; Kordić, Branko; Arbanas, Željko**

Source / Izvornik: **Applied Sciences, 2022, 12**

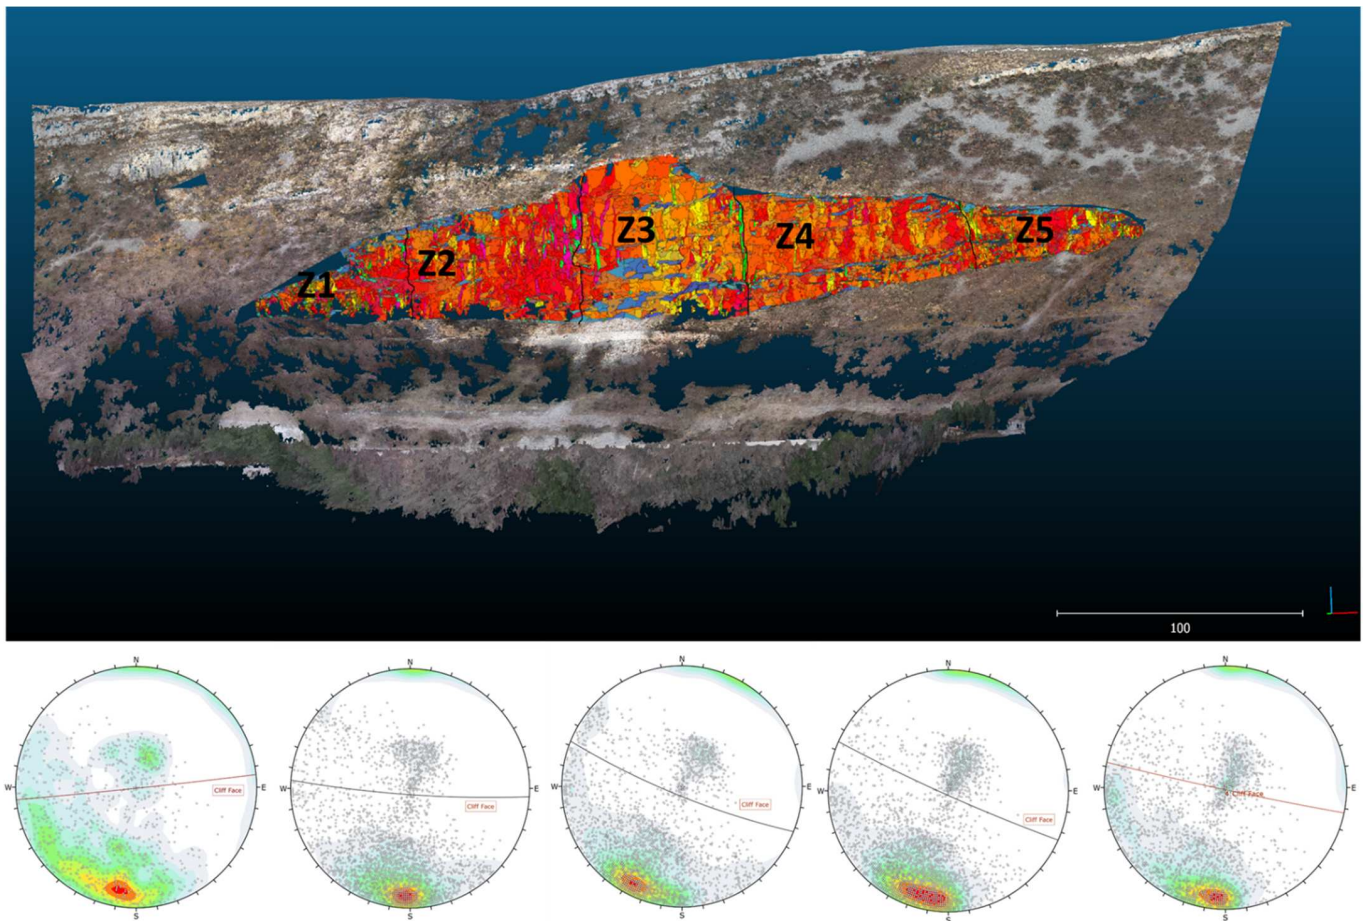
**Figure 9.** Three-dimensional HR Point Cloud of the Raspadalica Cliff with extracted facets using the *Cloud Compare Facet* plugin [43,61] (Fast Marching procedure). Orange and red to cyan facets represent Joint Set 1, parallel with the cliff face; green to yellow facets represent Joint Set 2, almost orthogonal to Joint Set 1; and blue facets represent Joint Set 3 (bedding).
