Geotechnical Study of Raspadalica Cliff Rockfall, Croatia

Source / Izvornik: **Applied Sciences, 2022, 12**

Abstract: The Raspadalica Cliff is an almost vertical 100 m high limestone cliff with a railway line at its foot and is known for numerous rockfall occurrences in the past. This article presents the results of the geotechnical study of the cliff based on a traditional geological and geotechnical field survey and remote sensing analysis. Both the traditional geological and geotechnical field survey and remote sensing surveys and analyses enabled the establishment of the structural model of the Raspadalica Cliff and the determination of the discontinuity sets and discontinuity features, such as orientation, spacing, persistence, roughness, discontinuity wall strength, aperture, degree of weathering of discontinuity wall, seepage conditions, and the presence and hardness of discontinuity filling. Kinematic analyses were performed on five cliff zones with slightly different structural features, indicating a relatively low probability of typical failures in the cliff rock mass that precede the rockfall occurrences. Although rockfall phenomena from the cliff face are relatively f

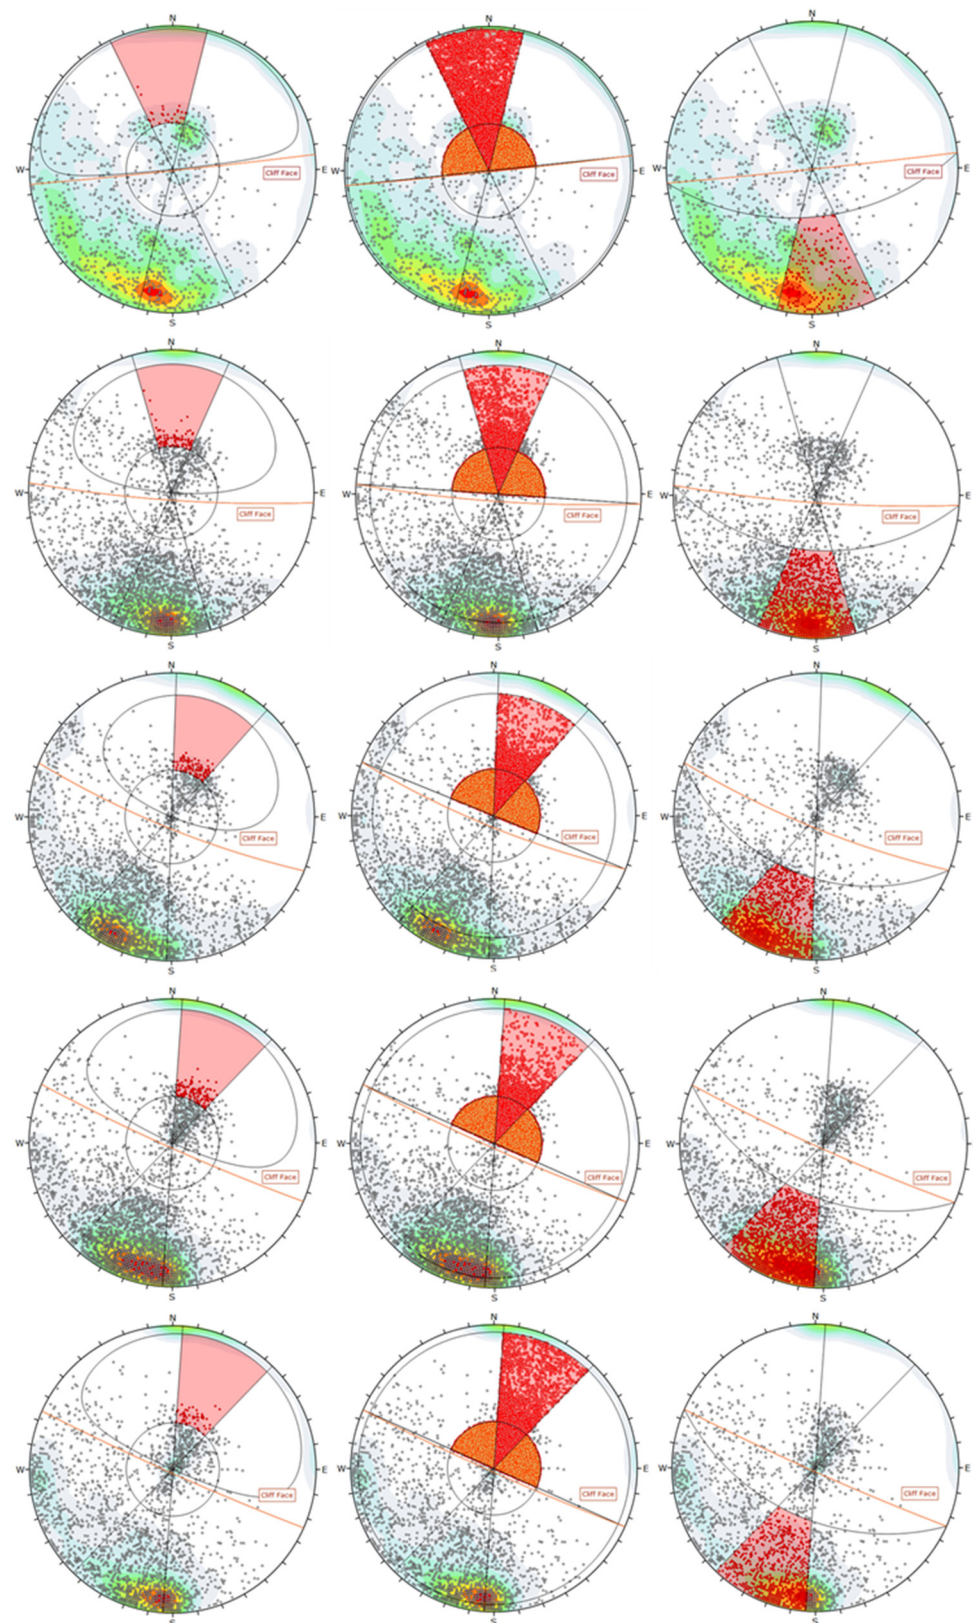
Figure 10. Kinematic analyses of the Raspadalica Cliff by cliff zones according to planar sliding, direct toppling and flexural toppling, conducted using Rocscience *Dips* software [91]. The results are presented in rows for each zone (e.g., Zone Z1 is in the first row). The results of planar sliding are in the first column, direct toppling in the second column, and flexural toppling in the third column.

According to the results of the kinematic analyses conducted for each zone of the cliff (Zones Z1 to Z5) presented in Figure 10 and Table 5, the probability of planar sliding and direct toppling in all five zones is relatively low, while the probability of flexural toppling has a relatively high failure (>40%). Analyzing the possibility of flexural toppling at the Raspadalica Cliff, it was determined that the rock mass conditions those have significant impact on occurrence of flexural toppling are not present at the Raspadalica Cliff. The process of flexural toppling is usually formed in slopes built of continuous columns of rock separated by well-developed, steeply dipping discontinuities breaking in flexure as they bend forward. Block–flexure toppling is characterized by pseudo-continuous flexure along long columns that are divided by numerous cross joints, which are not present at Raspadalica Cliff, and there is no evidence of any block–flexural toppling failure at the Raspadalica Cliff in the past. It is very clear that in a case of flexural toppling, rockfall occurrences should be evident at the top of the cliff and not in the middle part of the rock face, as it is at the Raspadalica Cliff. Analyzing toppling stability of single blocks at the top of the cliff as well as the stability of fictive single columns to the bottom of the cliff, taking into account unfavorable dimensions and maximal determined dip of the base, neglecting the impact of friction at the side walls of a block, centers of gravity of all blocks, and fictive lie inside their bases, confirming the stability regarding toppling. Additionally, based on determined bedding and joint set dips and dip direction, no change was found in the sense of increasing the dips of the layers in the upper part of the cliff that would point to development of flexural toppling mechanisms in the cliff rock mass.

Finally, it was concluded that flexural toppling, despite the relatively high percent of possible flexural failure (>40%), is just a result of kinematic conditions for flexural toppling built into *Rocscience Dips software* [91] but has no real basis in in situ phenomena and can be neglected in further stability analyses.

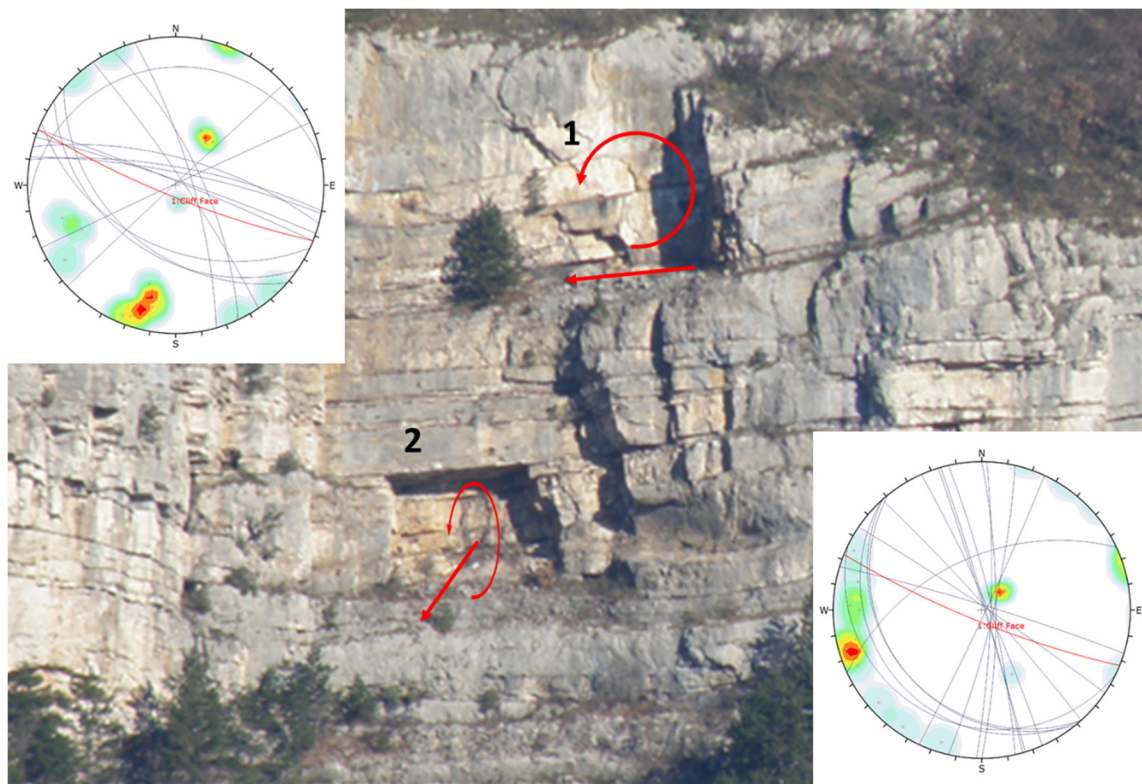
Figure 12 presents part of Zone 3 in the middle part of the cliff. Instability 1 in the upper part of the cliff face was caused by the joint influence of sliding and toppling mechanisms and both movements (displacement and rotation) were parallel to the cliff face. The stability analyses showed that the factor of safety (FoS) for each particular mechanism is satisfactory, and only a combination of mechanisms caused rock block detachment. Instability 2 in the lower part of the cliff face was caused by the joint influence of sliding and toppling mechanisms, and both movements (displacement and toppling (rotation)) were almost orthogonal to the cliff face. The bedding plane is too slightly inclined to cause the sliding of the rock block, while the bed above the fallen block prevented toppling (rotation), but the simultaneous action of the two mechanisms allowed rockfall to be triggered in conditions where additional forces were caused by rainfall infiltration and rise of horizontal forces caused by hydrostatic pressure.

Figure 12. A view of the central part of the Raspadalica Cliff (Zone 3) with two signs of previous rockfall instability (1, 2). Stereographic presentations of discontinuities are present in the figure (1 left up, 2 right down) and appropriate kinematic analysis do not indicate planar or toppling instabilities.

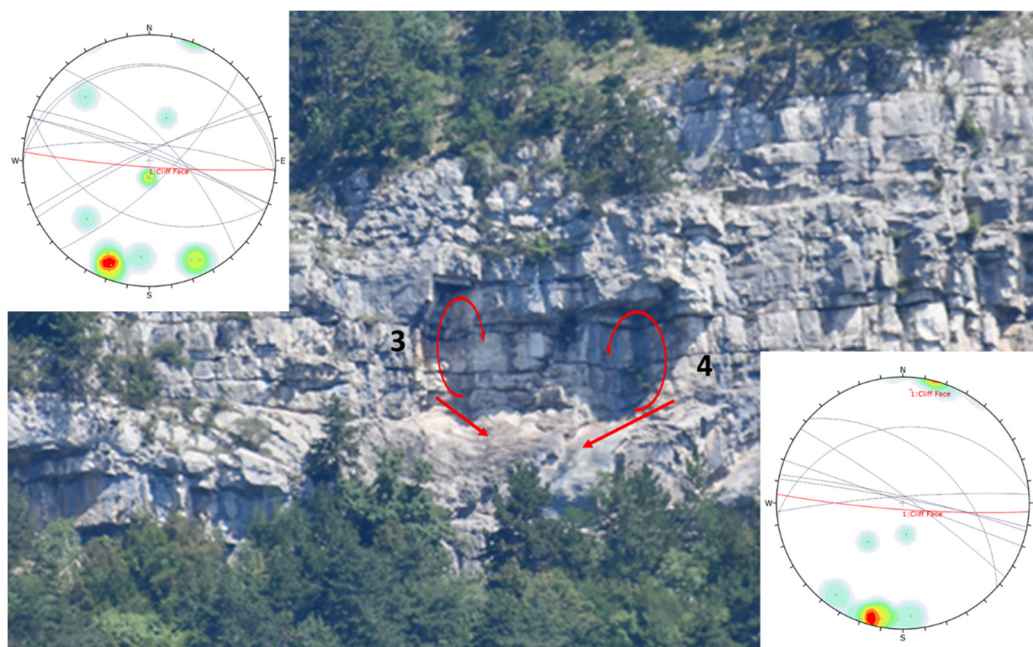
Figure 13 presents part of Zone 2 in the western part of the cliff. Instabilities 2 and 3 in the central part of the cliff face were caused by the joint influence of sliding and toppling mechanisms, and the direction of the instabilities was perpendicular to each other. The stability analyses showed that the factor of safety (FoS) for each particular mechanism was satisfactory, and only a combination of mechanisms caused the rock block detachments. The bedding planes are too slightly inclined to cause rock block sliding, while the bed above the fallen blocks prevented rotation, but the simultaneous action of two mechanisms allowed rockfall to be triggered in conditions where additional forces were caused by rainfall infiltration and rise of horizontal forces caused by hydrostatic pressure. It is not known whether these events occurred simultaneously or whether they were two separate processes.

Figure 13. A view of the western part of the Raspadalica Cliff (Zone 2) with two signs of previous rockfall instability (3, 4). Stereographic presentations of discontinuities are present in the figure (3 left up, 4 right down,) and appropriate kinematic analyses do not indicate planar or toppling instabilities.
