# Ties in unreinforced masonry structures: Case study in Krk

Conference presentation / Izlaganje na skupu

## TIES IN UNREINFORCED MASONRY STRUCTURES: CASE STUDY IN KRK

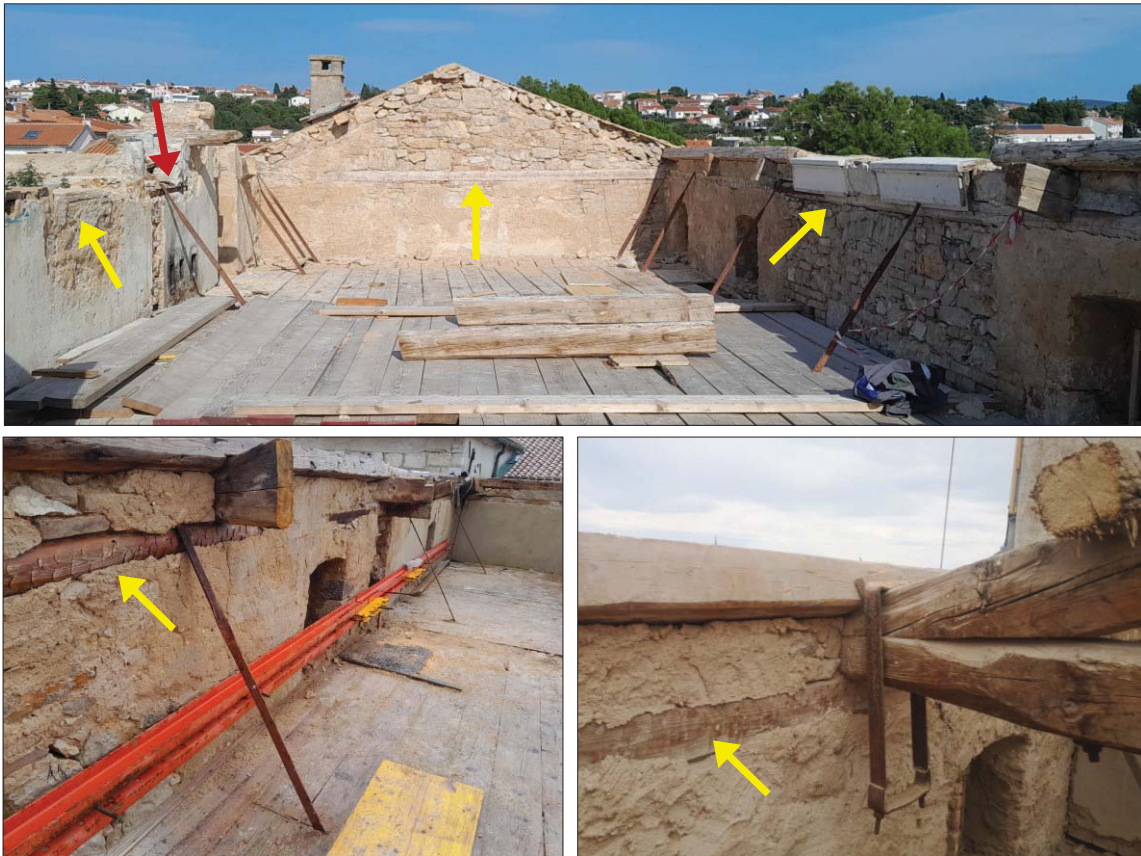
Figure 4. Timber ring beams at the roof level.

Authors of this paper have not so far detected timber ring beams embedded into masonry in the Kvarner Littoral, so the discovery of the timber beams in Krk was the motive for presenting this unique case study. These beams have minimum dimensions 13 x 19 cm, and are made continuous like a ring around the perimeter walls (Fig. 3): at the joint of two beam ends wrought iron ties have been used. At the positions of the opening for chimney in the cross-section of the wall, timber beams have been omitted (since there isn’t enough width, but also due to heating) and instead replaced with iron ties (denoted with a red arrow in Fig. 4). The ring beams have also been provided in the inner walls.

Diagonal iron ties are used to connect the attic walls and the floor beams, placed at every fourth or fifth floor beam (Fig. 4, Fig. 8). These ties have a “hockey stick” shape so that they can be attached to the floor beam by two nails, while the upper part of the tie is twisted by 90° and then bent into an L shape, so that it encompasses the timber ring beam (Fig. 8). The ties have a uniform rectangular cross-section measuring 45 mm in width, while the thickness varied from 8,5 to 12,5 mm, depending on the element.

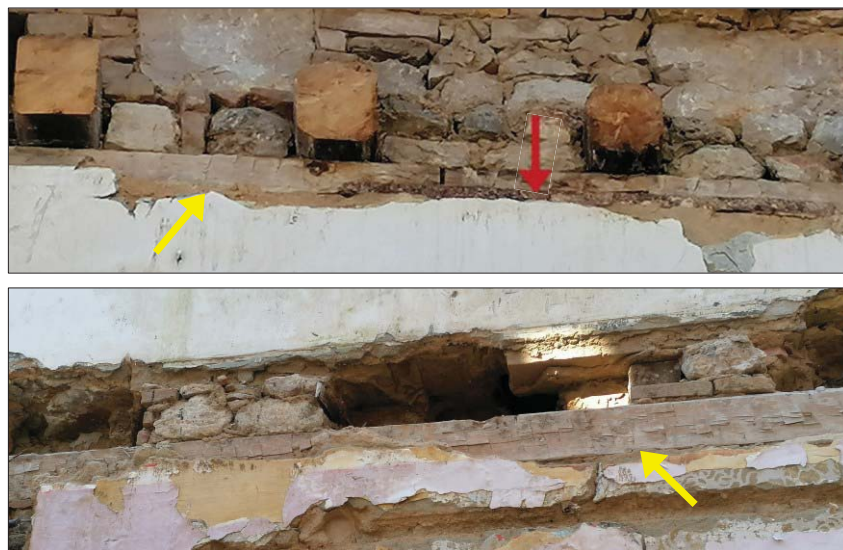
Figure 5. Timber ring beams at the floor levels.

The timber ring beams are provided at the floor levels and at the roof level (at the top of the attic walls). Note the connection of two beam ends using an iron tie (in order to ensure continuity), indicated with a red arrow in Fig. 5. No ring beams have been detected above the ground floor. This can be explained by the possibility that the ground floor had been probably built in an earlier period.

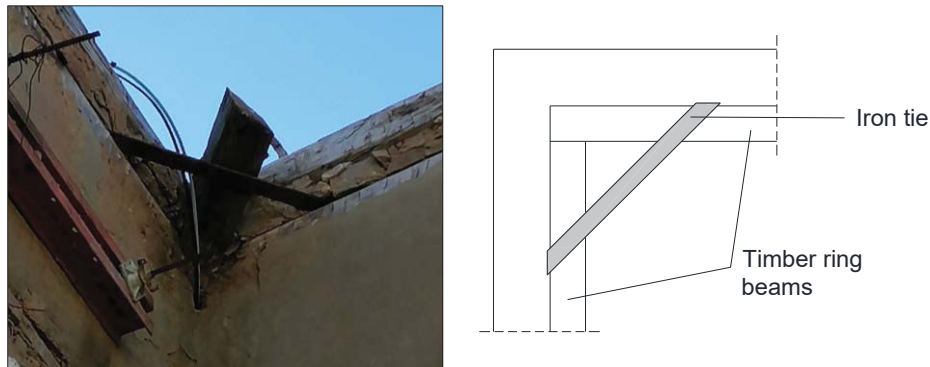
Figure 6. Connection of timber ring beams at a corner via iron ties.

The ring beams at one corner of the attic walls have been additionally connected by a cross iron tie at the top to prevent their separation (Fig. 6).

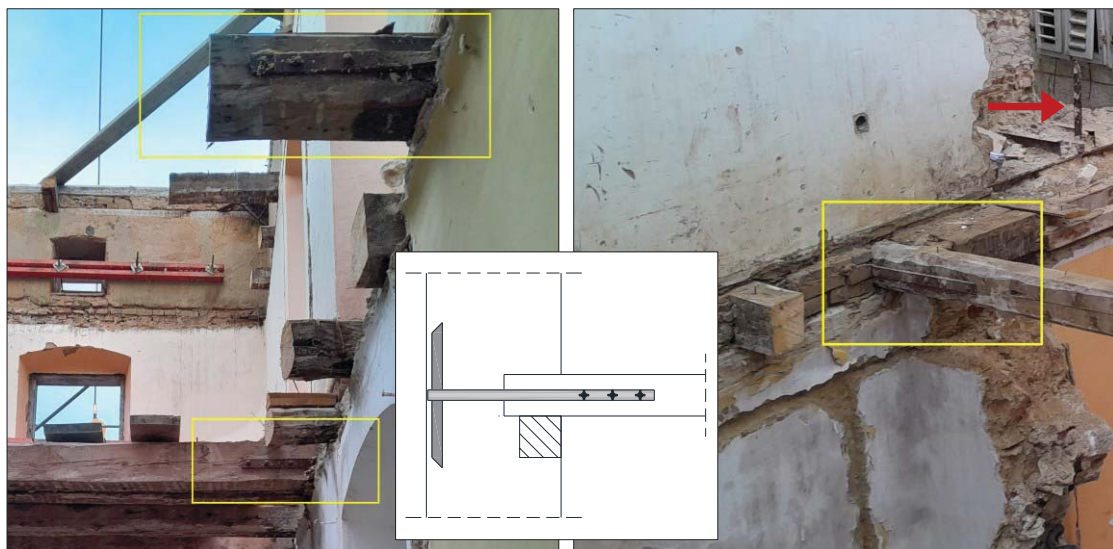
Figure 7. Horizontal wall-to-floor ties.

Wall-to-floor connections play a crucial role in the global stability of masonry buildings under seismic actions [13]. In this case study, connections between the timber floor beams and the masonry walls are placed at every fourth beam in the floor (Fig. 7). Wrought iron ties are anchored to the external walls by means of anchor iron bars (red arrow on Fig. 7). Three nails are used to connect the iron flat and the timber beam.

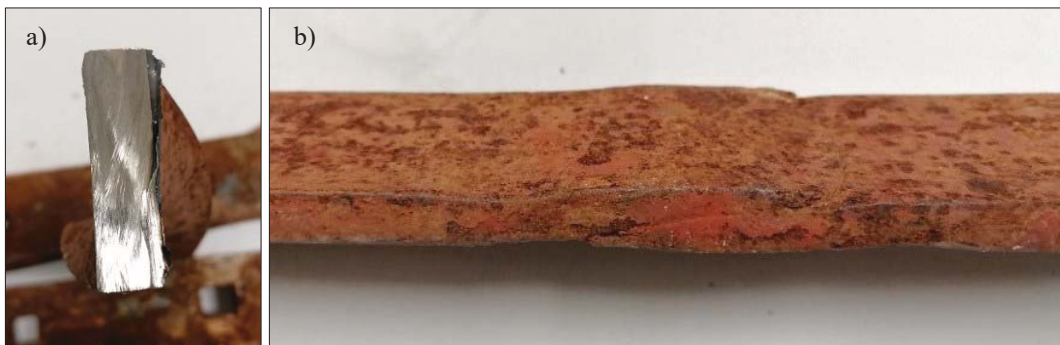
Table 1 shows the mean values of the measured weight percentage  $w$  of individual elements and their standard deviation  $SD$  obtained using glow-discharge spectrometer (GDS)[14]. The cross-section was prepared by polishing. According to the very low carbon content, a soft but very ductile material can be expected, what will be confirmed by tensile testing.

Figure 9. a) Cross section of a diagonal tie; b) Detail of forged connection confirming it is wrought iron.

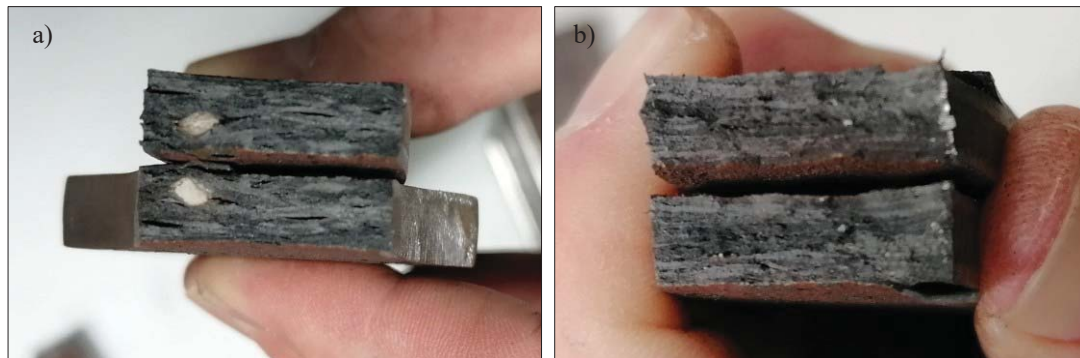
Fig. 14 presents the fracture surfaces of two specimens, where the foliar fractures may be noted. Specimen 2 had a smaller tensile strength and significantly smaller deformation  $A_t$ , what can be attributed to the defect in the cross section visible as a white spot in Fig. 14a.

Figure 14. Fracture surfaces: a) Specimen 2; b) Specimen 3.
