Geotechnical Study of Raspadalica Cliff Rockfall, Croatia

Dalibor Udovič¹, Branko Kordić² and Željko Arbanas^{3,*}

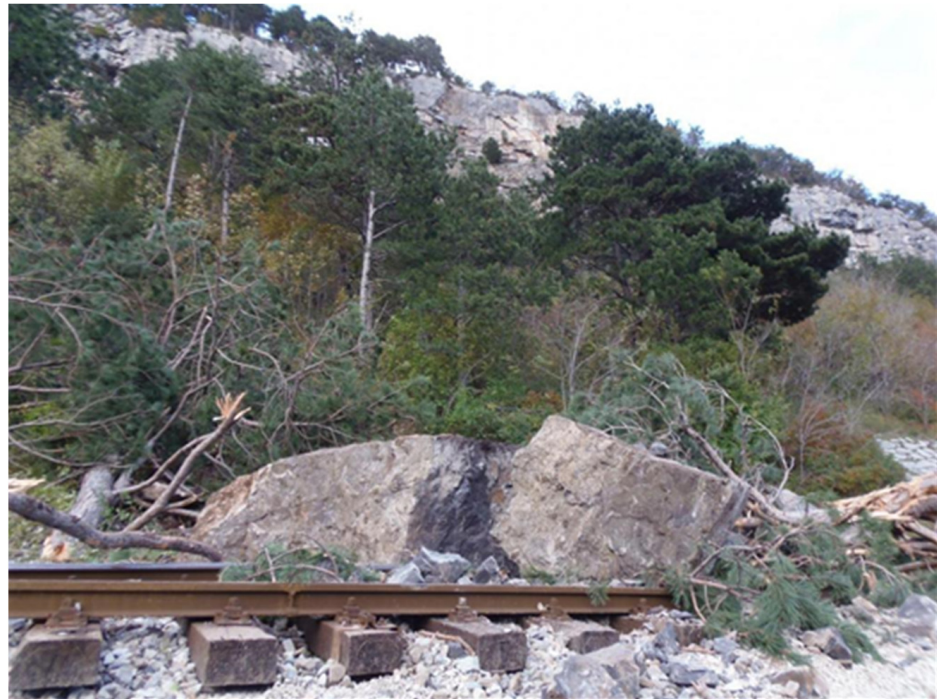
The last major rockfall occurred on 16 December 2013 (Figure 5), which caused an interruption to railway traffic lasting several months. Following this, the construction of rockfall protection measures was conducted based on field investigations [12] and rockfall

Figure 5. Photo of the rockfall originating from the Raspadalica Cliff on 16 December 2013.
