Ties in unreinforced masonry structures: Case study in Krk

Conference presentation / Izlaganje na skupu

TIES IN UNREINFORCED MASONRY STRUCTURES: CASE STUDY IN KRK

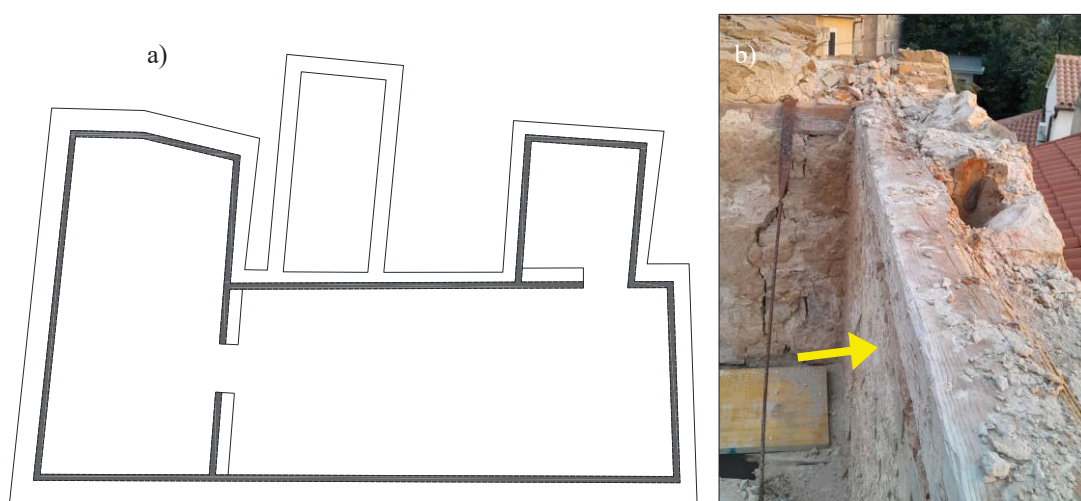
Figure 3. Timber ring beams at the roof level: a) Ground plan; b) Detail.

Authors of this paper have not so far detected timber ring beams embedded into masonry in the Kvarner Littoral, so the discovery of the timber beams in Krk was the motive for presenting this unique case study. These beams have minimum dimensions 13 x 19 cm, and are made continuous like a ring around the perimeter walls (Fig. 3): at the joint of two beam ends wrought iron ties have been used. At the positions of the opening for chimney in the cross-section of the wall, timber beams have been omitted (since there isn’t enough width, but also due to heating) and instead replaced with iron ties (denoted with a red arrow in Fig. 4). The ring beams have also been provided in the inner walls.
