# Geotechnical Study of Raspadalica Cliff Rockfall, Croatia

**Udovič, Dalibor; Kordić, Branko; Arbanas, Željko**

Source / Izvornik: **Applied Sciences, 2022, 12**

**Journal article, Published version**

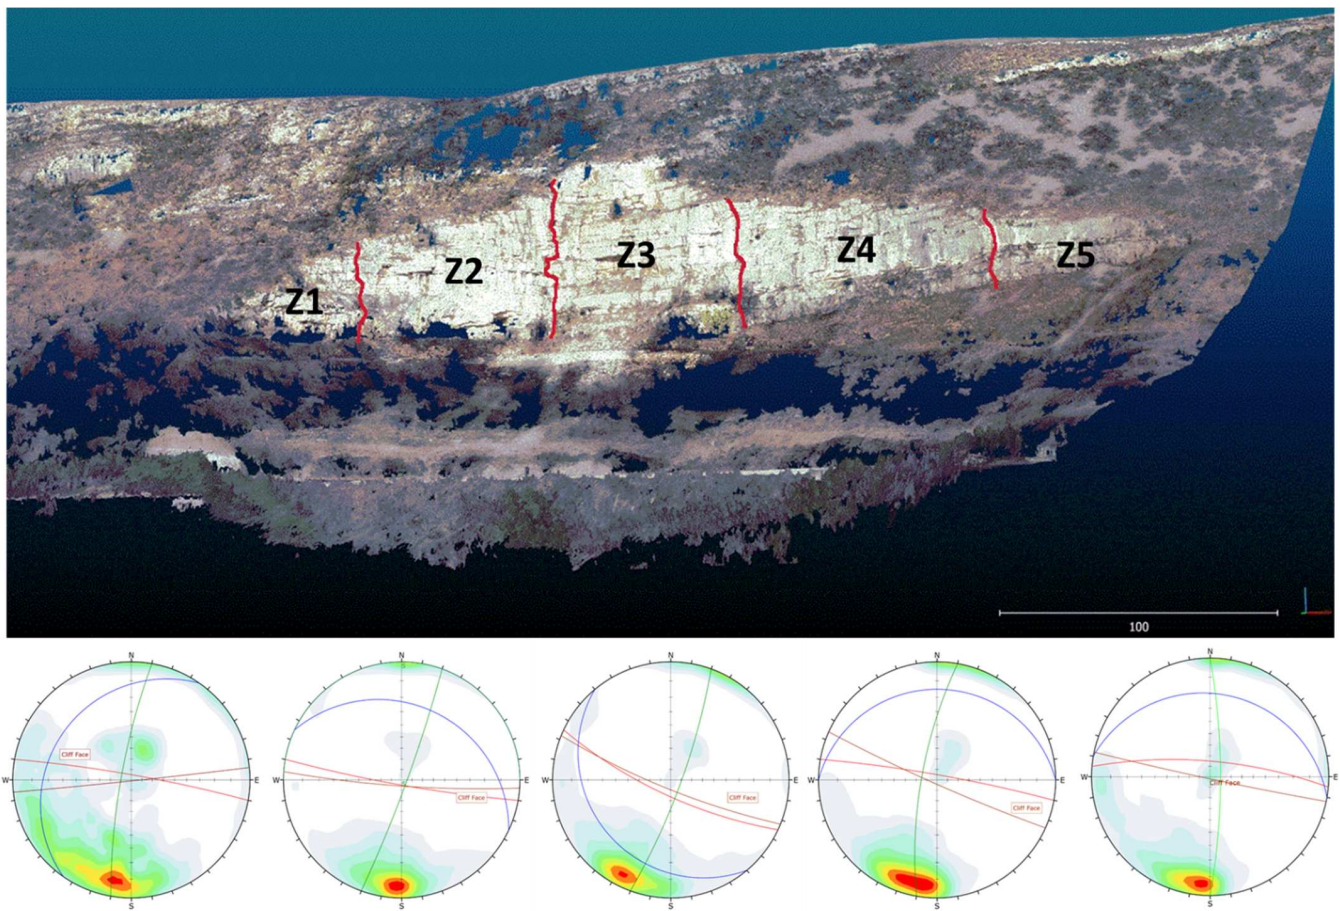
**Figure 7.** The 3D HR Point Cloud of the Raspadalica Cliff divided into five zones. For each zone the stereograph presentation of the main discontinuity sets (mean value) and orientation of the average cliff slope is presented. The concentration of plane poles quasi-parallel to cliff face is visible on each stereogram (from white (cold) with no or several poles to (hot) with high concentration of poles). Red is transversal of the average cliff face, other represent transversals of joint sets.

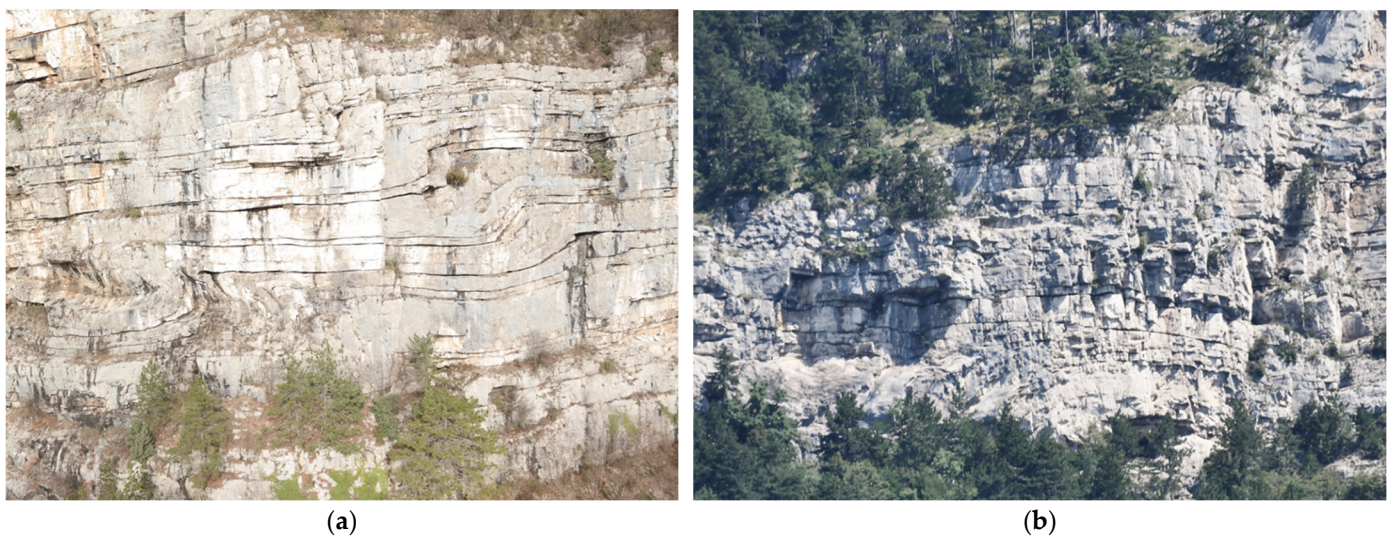
**Figure 8.** Folds identified at the Raspadalica Cliff face: (a) monocline type of fold (middle part) and horizontal inclined fold (left down) in the eastern part (in Zones Z3 and Z4); (b) the remains of the anticline fold western part of the cliff, in area of zone Z2 in the lower part of the figure.
