Geotechnical Study of Raspadalica Cliff Rockfall, Croatia

Abstract: The Raspadalica Cliff is an almost vertical 100 m high limestone cliff with a railway line at its foot and is known for numerous rockfall occurrences in the past. This article presents the results of the geotechnical study of the cliff based on a traditional geological and geotechnical field survey and remote sensing analysis. Both the traditional geological and geotechnical field survey and remote sensing surveys and analyses enabled the establishment of the structural model of the Raspadalica Cliff and the determination of the discontinuity sets and discontinuity features, such as orientation, spacing, persistence, roughness, discontinuity wall strength, aperture, degree of weathering of discontinuity wall, seepage conditions, and the presence and hardness of discontinuity filling. Kinematic analyses were performed on five cliff zones with slightly different structural features, indicating a relatively low probability of typical failures in the cliff rock mass that precede the rockfall occurrences. Although rockfall phenomena from the cliff face are relatively frequent, the kinematic analyses did not indicate a

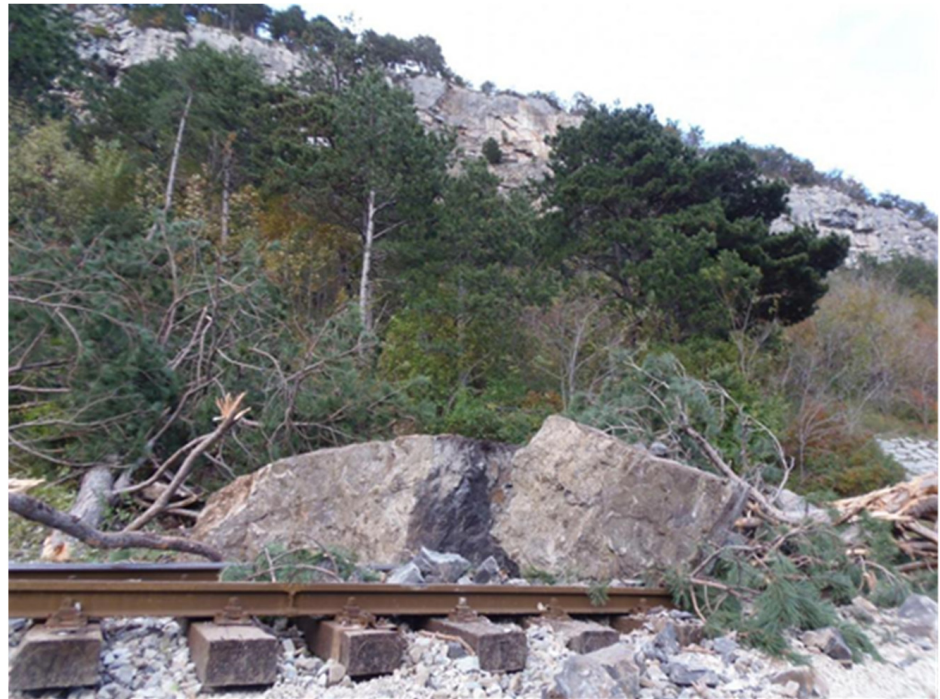
The last major rockfall occurred on 16 December 2013 (Figure 5), which caused an interruption to railway traffic lasting several months. Following this, the construction of rockfall protection measures was conducted based on field investigations [12] and rockfall

Figure 5. Photo of the rockfall originating from the Raspadalica Cliff on 16 December 2013.

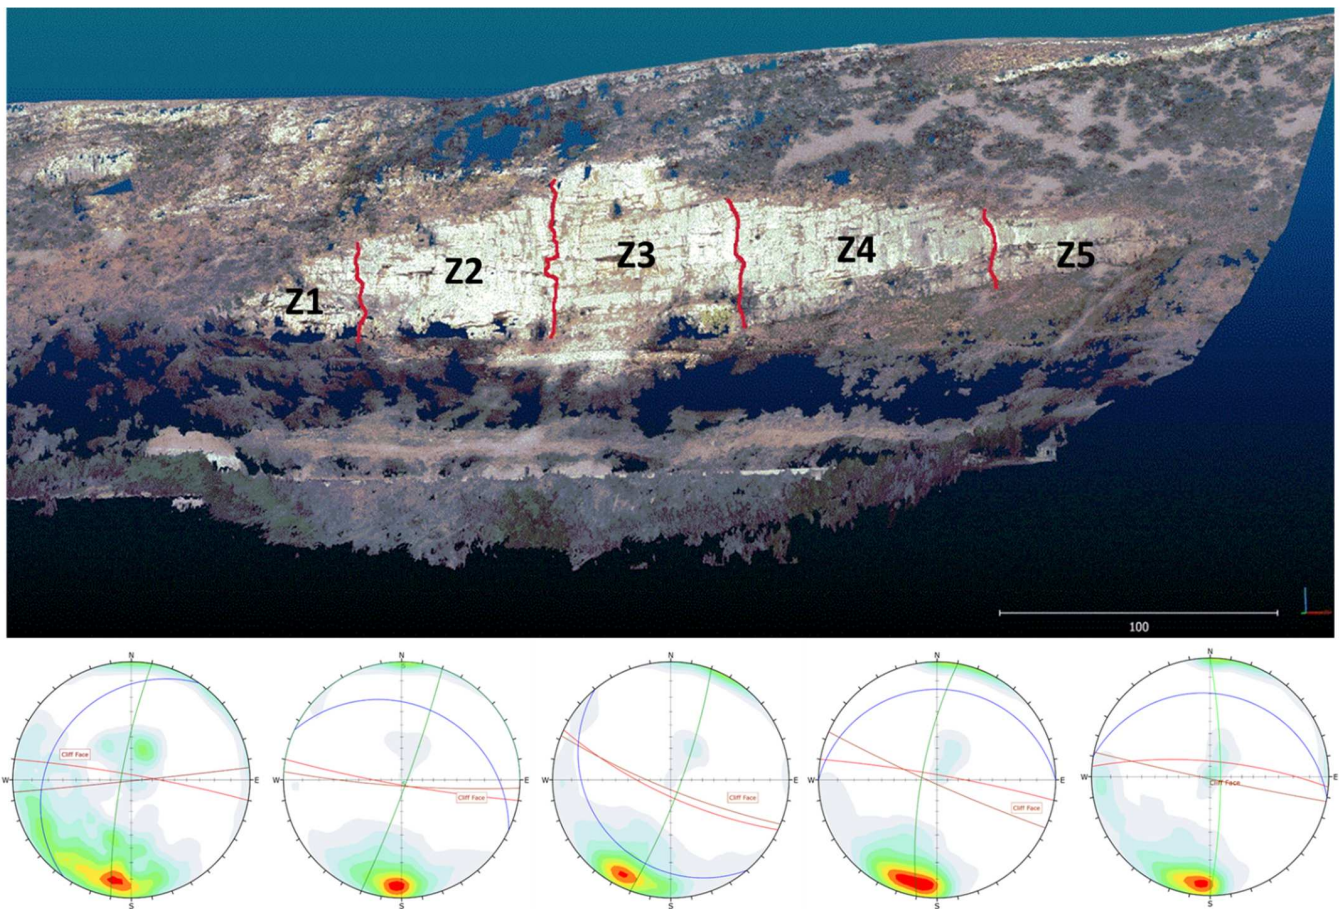
Figure 7. The 3D HR Point Cloud of the Raspadalica Cliff divided into five zones. For each zone the stereograph presentation of the main discontinuity sets (mean value) and orientation of the average cliff slope is presented. The concentration of plane poles quasi-parallel to cliff face is visible on each stereogram (from white (cold) with no or several poles to (hot) with high concentration of poles). Red is transversal of the average cliff face, other represent transversals of joint sets.

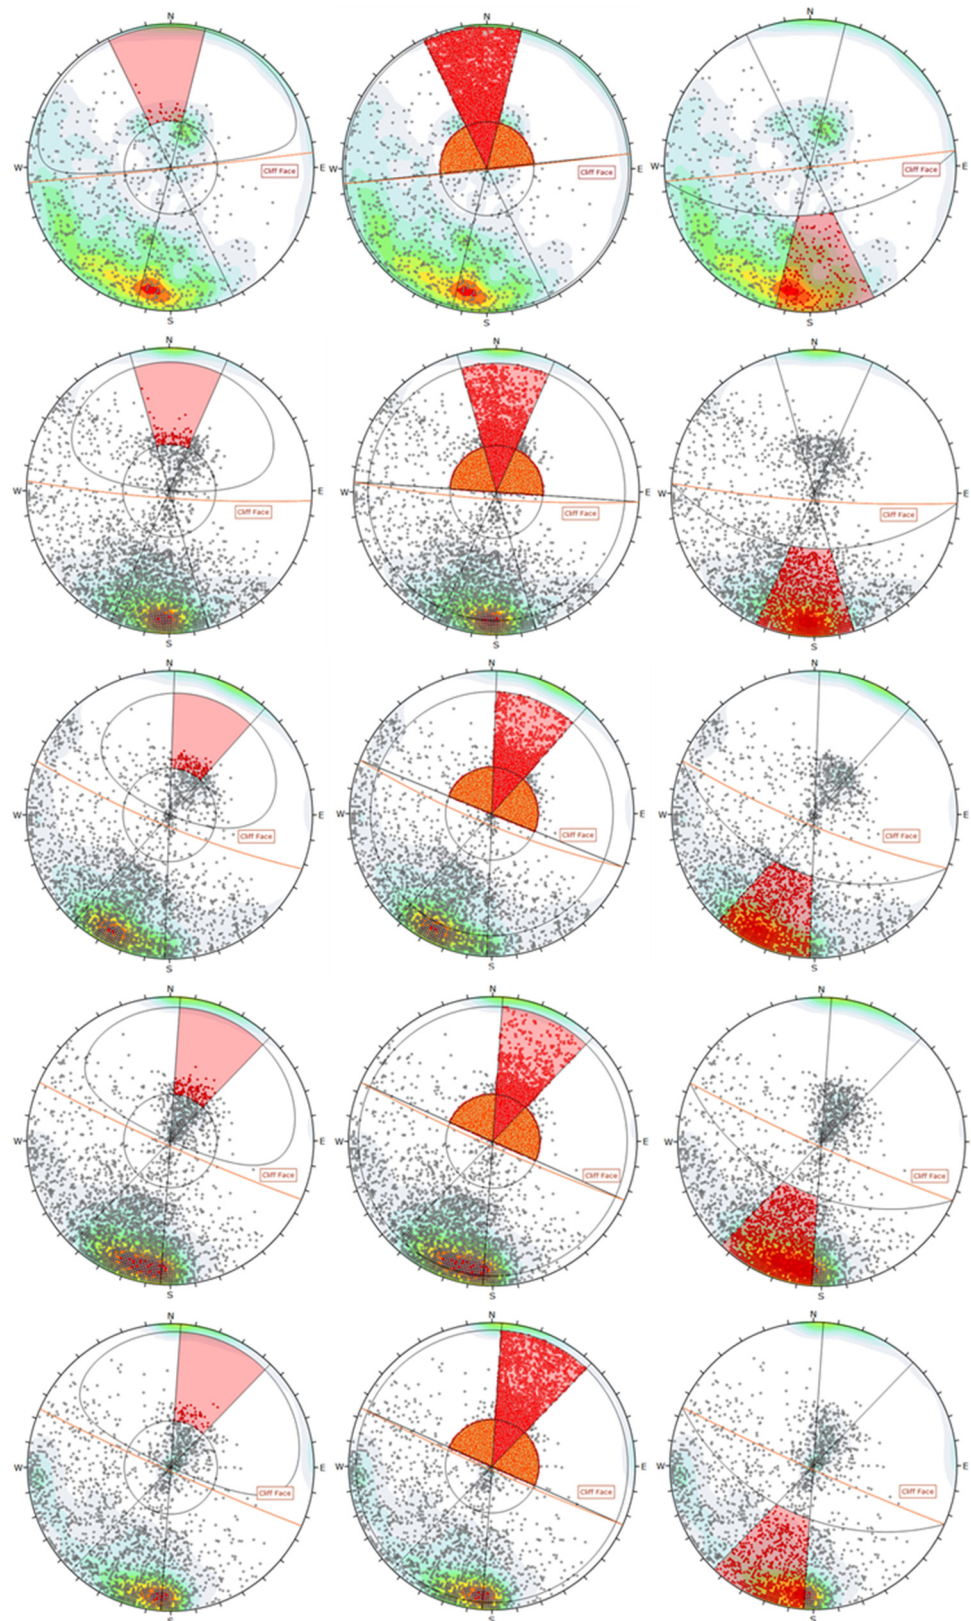
Figure 10. Kinematic analyses of the Raspadalica Cliff by cliff zones according to planar sliding, direct toppling and flexural toppling, conducted using Rocscience *Dips* software [91]. The results are presented in rows for each zone (e.g., Zone Z1 is in the first row). The results of planar sliding are in the first column, direct toppling in the second column, and flexural toppling in the third column.

According to the results of the kinematic analyses conducted for each zone of the cliff (Zones Z1 to Z5) presented in Figure 10 and Table 5, the probability of planar sliding and direct toppling in all five zones is relatively low, while the probability of flexural toppling has a relatively high failure (>40%). Analyzing the possibility of flexural toppling at the Raspadalica Cliff, it was determined that the rock mass conditions those have significant impact on occurrence of flexural toppling are not present at the Raspadalica Cliff. The process of flexural toppling is usually formed in slopes built of continuous columns of rock separated by well-developed, steeply dipping discontinuities breaking in flexure as they bend forward. Block–flexure toppling is characterized by pseudo-continuous flexure along long columns that are divided by numerous cross joints, which are not present at Raspadalica Cliff, and there is no evidence of any block–flexural toppling failure at the Raspadalica Cliff in the past. It is very clear that in a case of flexural toppling, rockfall occurrences should be evident at the top of the cliff and not in the middle part of the rock face, as it is at the Raspadalica Cliff. Analyzing toppling stability of single blocks at the top of the cliff as well as the stability of fictive single columns to the bottom of the cliff, taking into account unfavorable dimensions and maximal determined dip of the base, neglecting the impact of friction at the side walls of a block, centers of gravity of all blocks, and fictive lie inside their bases, confirming the stability regarding toppling. Additionally, based on determined bedding and joint set dips and dip direction, no change was found in the sense of increasing the dips of the layers in the upper part of the cliff that would point to development of flexural toppling mechanisms in the cliff rock mass.

Finally, it was concluded that flexural toppling, despite the relatively high percent of possible flexural failure (>40%), is just a result of kinematic conditions for flexural toppling built into *Rocscience Dips software* [91] but has no real basis in in situ phenomena and can be neglected in further stability analyses.

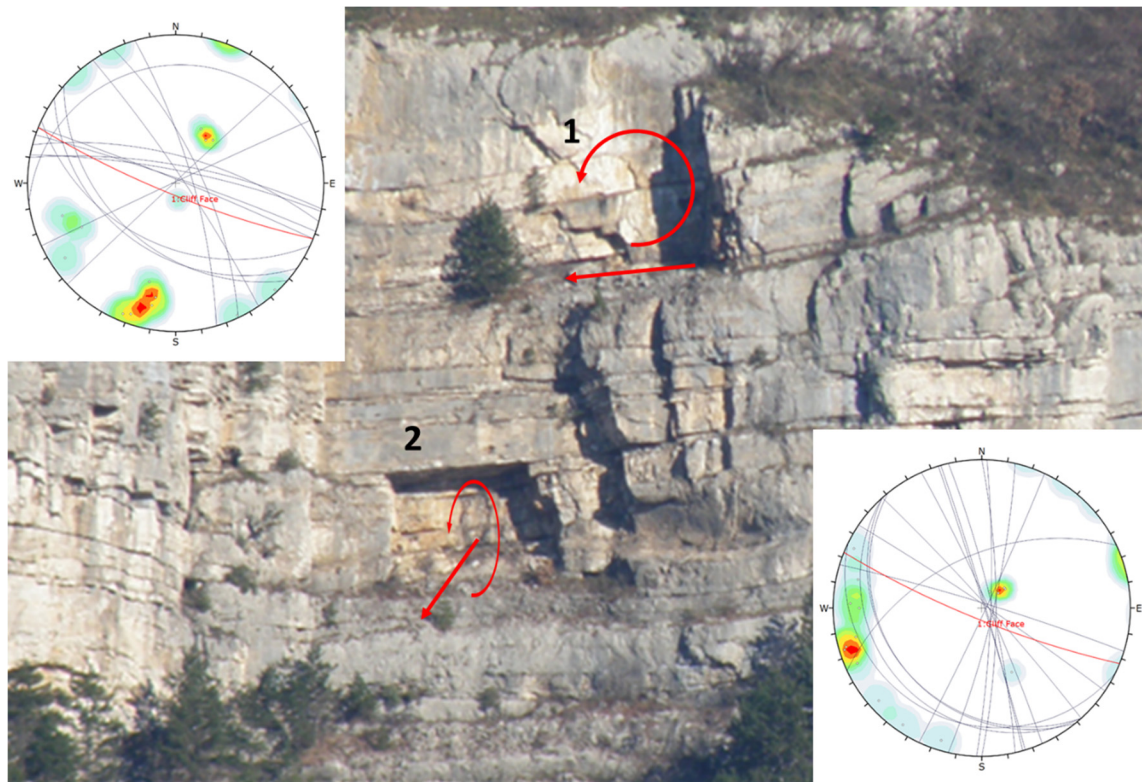
Figure 12 presents part of Zone 3 in the middle part of the cliff. Instability 1 in the upper part of the cliff face was caused by the joint influence of sliding and toppling mechanisms and both movements (displacement and rotation) were parallel to the cliff face. The stability analyses showed that the factor of safety (FoS) for each particular mechanism is satisfactory, and only a combination of mechanisms caused rock block detachment. Instability 2 in the lower part of the cliff face was caused by the joint influence of sliding and toppling mechanisms, and both movements (displacement and toppling (rotation)) were almost orthogonal to the cliff face. The bedding plane is too slightly inclined to cause the sliding of the rock block, while the bed above the fallen block prevented toppling (rotation), but the simultaneous action of the two mechanisms allowed rockfall to be triggered in conditions where additional forces were caused by rainfall infiltration and rise of horizontal forces caused by hydrostatic pressure.

Figure 12. A view of the central part of the Raspadalica Cliff (Zone 3) with two signs of previous rockfall instability (1, 2). Stereographic presentations of discontinuities are present in the figure (1 left up, 2 right down) and appropriate kinematic analysis do not indicate planar or toppling instabilities.

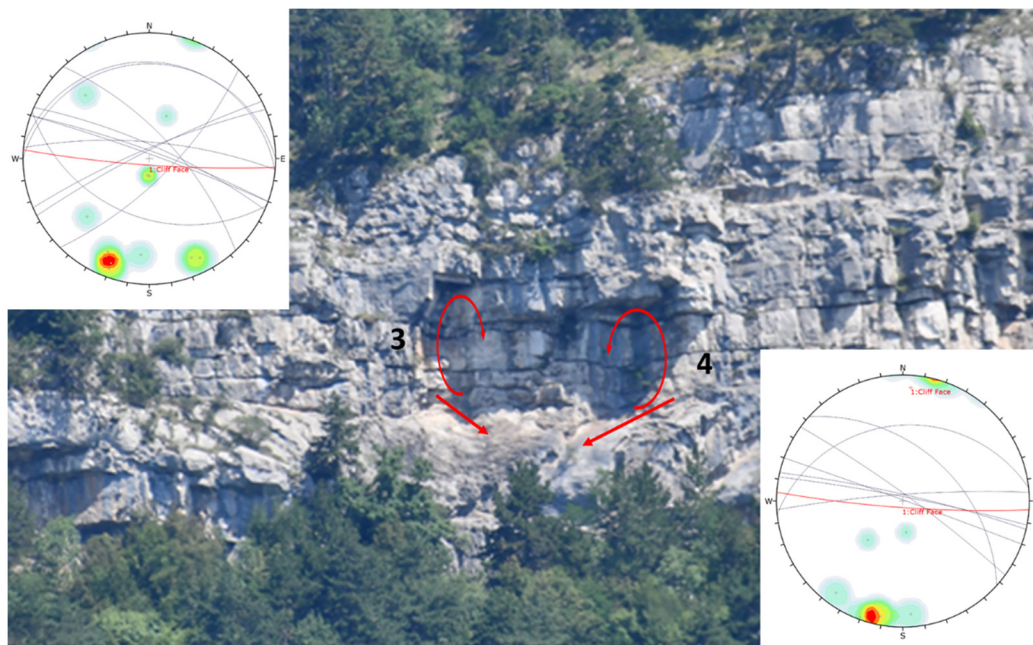
Figure 13 presents part of Zone 2 in the western part of the cliff. Instabilities 2 and 3 in the central part of the cliff face were caused by the joint influence of sliding and toppling mechanisms, and the direction of the instabilities was perpendicular to each other. The stability analyses showed that the factor of safety (FoS) for each particular mechanism was satisfactory, and only a combination of mechanisms caused the rock block detachments. The bedding planes are too slightly inclined to cause rock block sliding, while the bed above the fallen blocks prevented rotation, but the simultaneous action of two mechanisms allowed rockfall to be triggered in conditions where additional forces were caused by rainfall infiltration and rise of horizontal forces caused by hydrostatic pressure. It is not known whether these events occurred simultaneously or whether they were two separate processes.

Figure 13. A view of the western part of the Raspadalica Cliff (Zone 2) with two signs of previous rockfall instability (3, 4). Stereographic presentations of discontinuities are present in the figure (3 left up, 4 right down,) and appropriate kinematic analyses do not indicate planar or toppling instabilities.
