# Geotechnical Study of Raspadalica Cliff Rockfall, Croatia

Udovič, Dalibor; Kordić, Branko; Arbanas, Željko

Source / Izvornik: **Applied Sciences**, 2022, 12

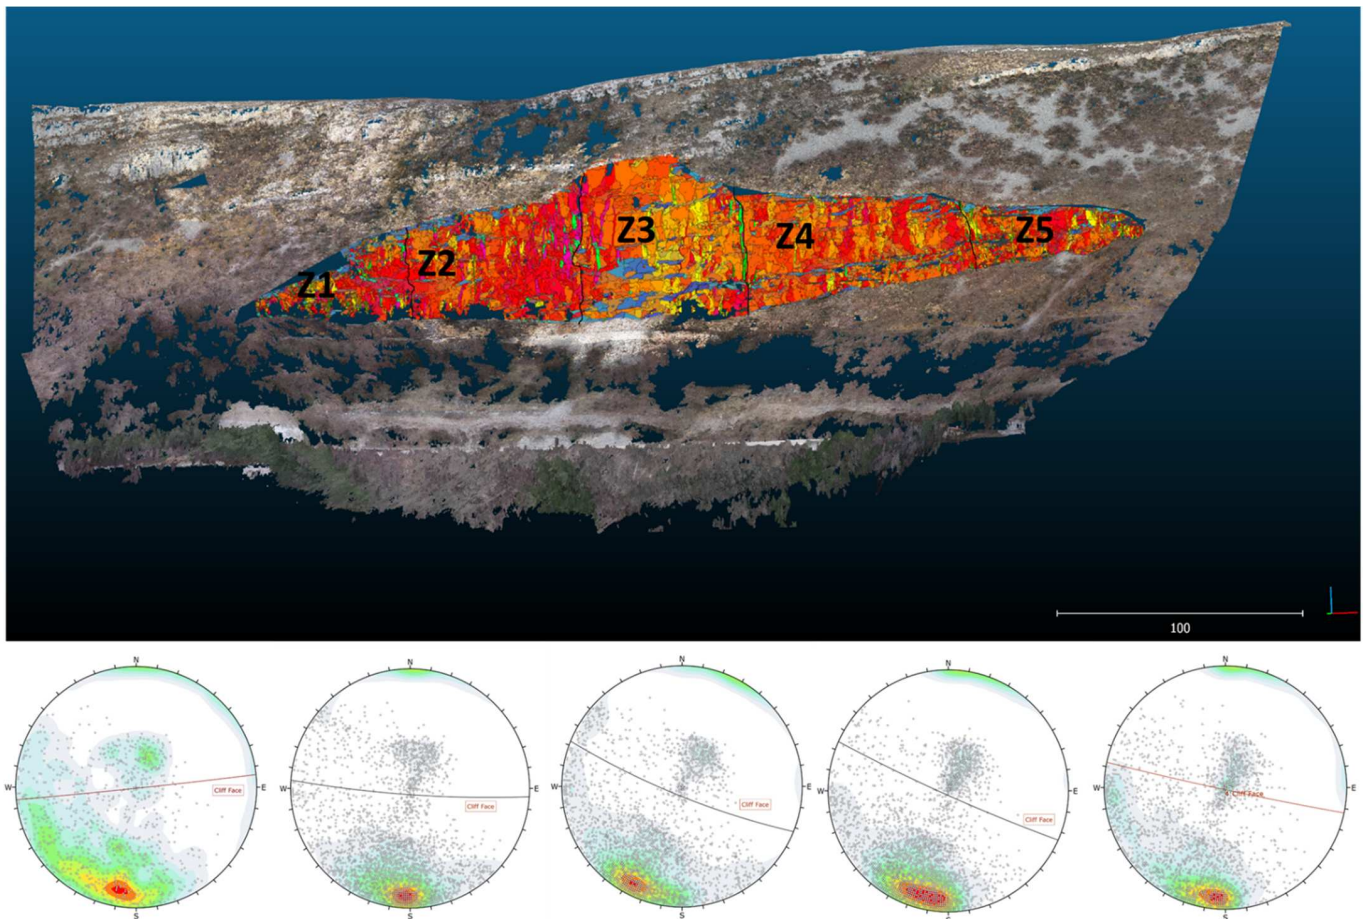
**Figure 9.** Three-dimensional HR Point Cloud of the Raspadalica Cliff with extracted facets using the *Cloud Compare Facet* plugin [43,61] (Fast Marching procedure). Orange and red to cyan facets represent Joint Set 1, parallel with the cliff face; green to yellow facets represent Joint Set 2, almost orthogonal to Joint Set 1; and blue facets represent Joint Set 3 (bedding).

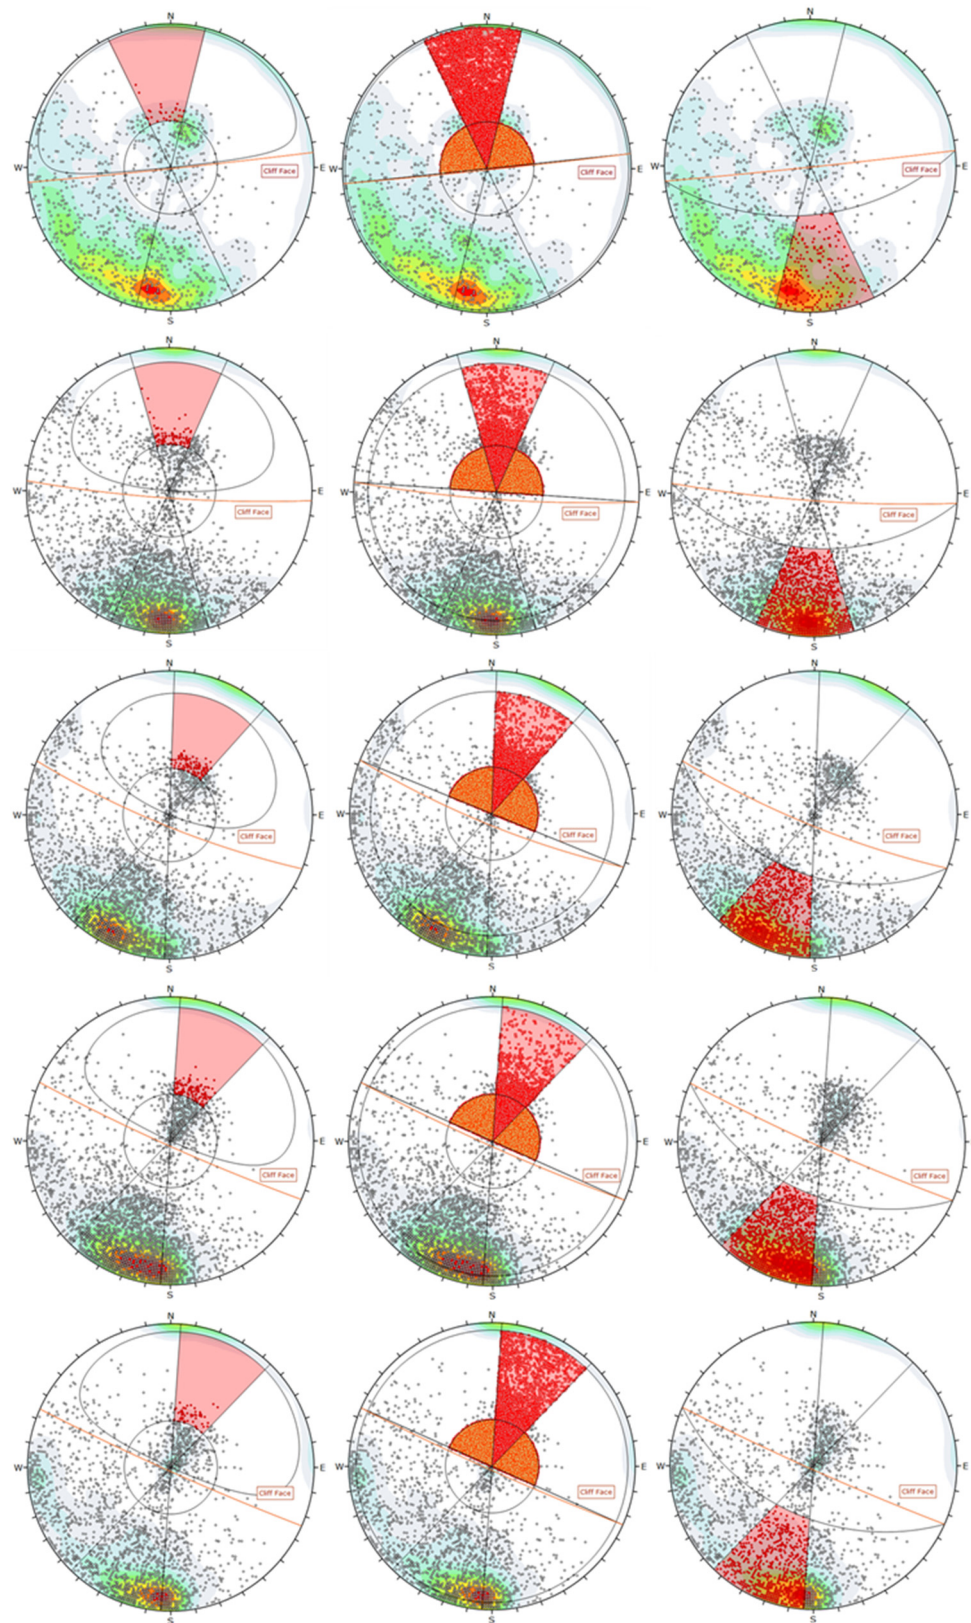
**Figure 10.** Kinematic analyses of the Raspadalica Cliff by cliff zones according to planar sliding, direct toppling and flexural toppling, conducted using Rocscience *Dips* software [91]. The results are presented in rows for each zone (e.g., Zone Z1 is in the first row). The results of planar sliding are in the first column, direct toppling in the second column, and flexural toppling in the third column.

According to the results of the kinematic analyses conducted for each zone of the cliff (Zones Z1 to Z5) presented in Figure 10 and Table 5, the probability of planar sliding and direct toppling in all five zones is relatively low, while the probability of flexural toppling has a relatively high failure (>40%). Analyzing the possibility of flexural toppling at the Raspadalica Cliff, it was determined that the rock mass conditions those have significant impact on occurrence of flexural toppling are not present at the Raspadalica Cliff. The process of flexural toppling is usually formed in slopes built of continuous columns of rock separated by well-developed, steeply dipping discontinuities breaking in flexure as they bend forward. Block–flexure toppling is characterized by pseudo-continuous flexure along long columns that are divided by numerous cross joints, which are not present at Raspadalica Cliff, and there is no evidence of any block–flexural toppling failure at the Raspadalica Cliff in the past. It is very clear that in a case of flexural toppling, rockfall occurrences should be evident at the top of the cliff and not in the middle part of the rock face, as it is at the Raspadalica Cliff. Analyzing toppling stability of single blocks at the top of the cliff as well as the stability of fictive single columns to the bottom of the cliff, taking into account unfavorable dimensions and maximal determined dip of the base, neglecting the impact of friction at the side walls of a block, centers of gravity of all blocks, and fictive lie inside their bases, confirming the stability regarding toppling. Additionally, based on determined bedding and joint set dips and dip direction, no change was found in the sense of increasing the dips of the layers in the upper part of the cliff that would point to development of flexural toppling mechanisms in the cliff rock mass.

Finally, it was concluded that flexural toppling, despite the relatively high percent of possible flexural failure (>40%), is just a result of kinematic conditions for flexural toppling built into *Rocscience Dips software* [91] but has no real basis in in situ phenomena and can be neglected in further stability analyses.
