Ties in unreinforced masonry structures: Case study in Krk

Conference presentation / Izlaganje na skupu

TIES IN UNREINFORCED MASONRY STRUCTURES: CASE STUDY IN KRK

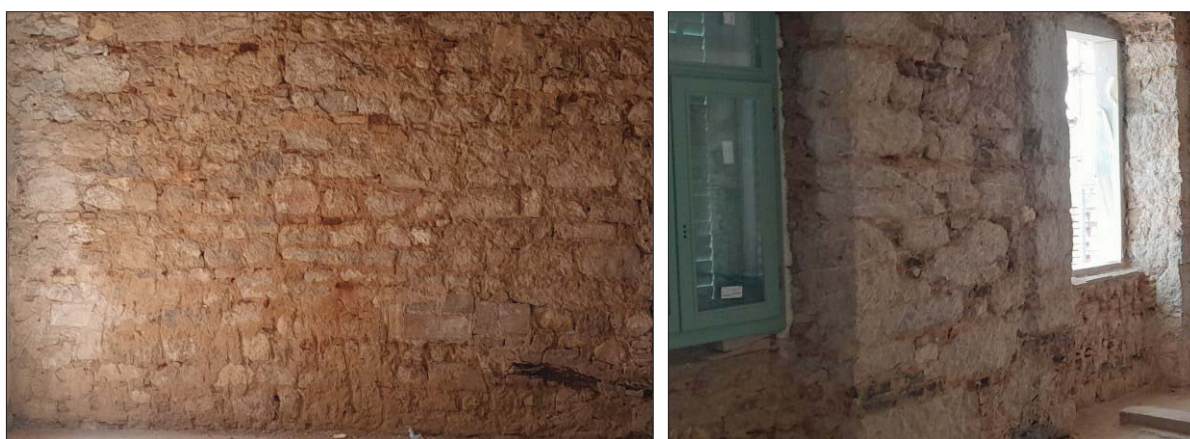
Figure 2. Masonry typology.

The floor structures are made of timber beams and boards, as common in this region, while the roof structure is a king-post, covered with tiles. The walls may be categorized into rubble stone masonry (wall thickness 65 cm), though some later added walls are built of brick. The stone blocks are mostly of the same size, with considerably larger dimensions at the corners or at the openings (Fig. 2)

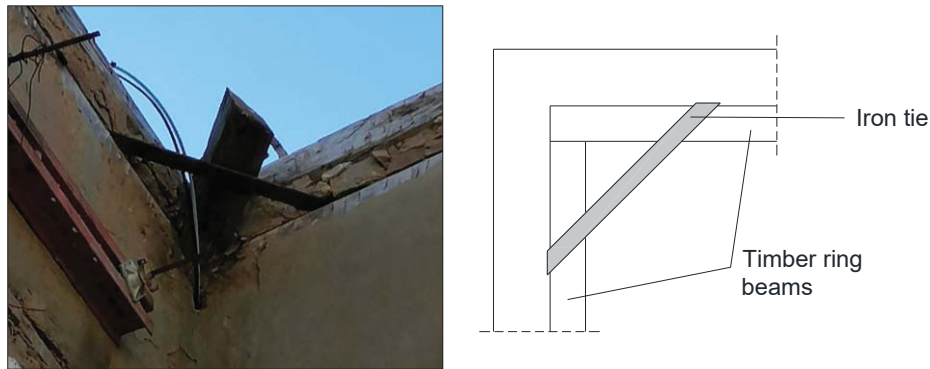
Figure 6. Connection of timber ring beams at a corner via iron ties.

The ring beams at one corner of the attic walls have been additionally connected by a cross iron tie at the top to prevent their separation (Fig. 6).

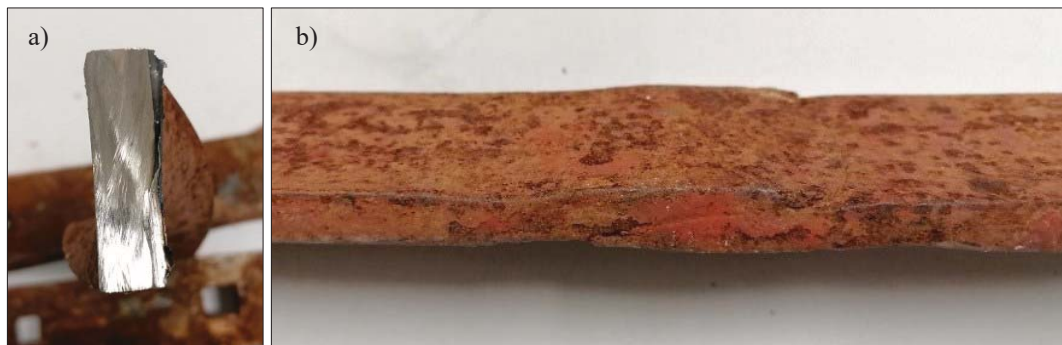
Table 1 shows the mean values of the measured weight percentage w of individual elements and their standard deviation SD obtained using glow-discharge spectrometer (GDS)[14]. The cross-section was prepared by polishing. According to the very low carbon content, a soft but very ductile material can be expected, what will be confirmed by tensile testing.

Figure 9. a) Cross section of a diagonal tie; b) Detail of forged connection confirming it is wrought iron.

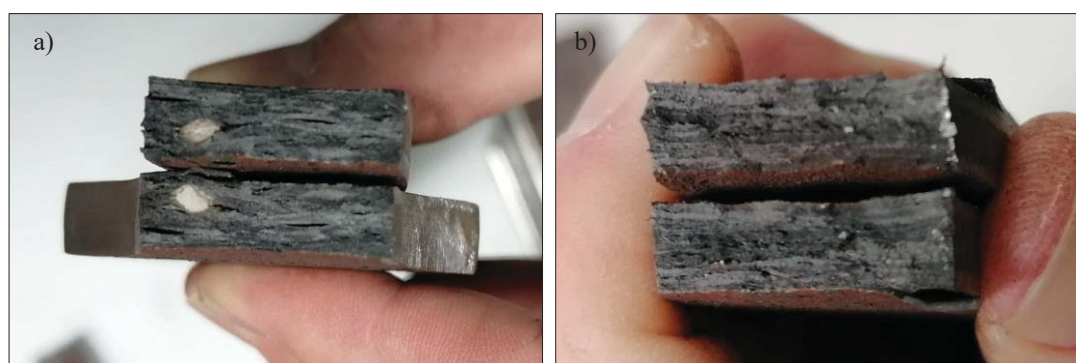
Fig. 14 presents the fracture surfaces of two specimens, where the foliar fractures may be noted. Specimen 2 had a smaller tensile strength and significantly smaller deformation A_t , what can be attributed to the defect in the cross section visible as a white spot in Fig. 14a.

Figure 14. Fracture surfaces: a) Specimen 2; b) Specimen 3.
