Fatigue Behaviour of Aluminium Members with Different Notch Root Shapes

Source / Izvornik: **Buildings, 2022, 12**

Keywords: notch; aluminium profile; fatigue; wind action; stress concentration; unitised curtain wall

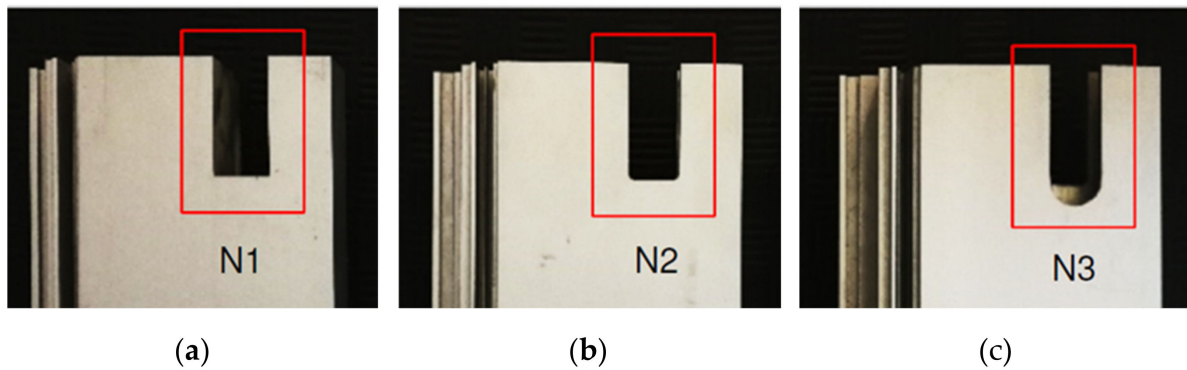
Figure 4. Shape of root notch: (a) sharp, N1, (b) rounded, N2, (c) semi-circular, N3.

It was known that the most structurally resilient root shape in this case would be a semi-circle with a diameter equal to the width of the notch (Figure 4c). Due to a requirement to minimise the cross-section of the frame, the semi-circular root was not practical, as it would reduce the available vertical gap for the movement, as discussed later. Hence, root corners were rounded with a radius equal to the radius of the milling bit, typically close to the thickness of the aluminium wall (Figure 4b), which corresponds to the diameter of the

smallest bit typically used for the milling of aluminium. Machining by sawing results in sharp corners on the notch (Figure 4a), which is known to be the worst condition for stress concentration. All three geometries of the notch (Figure 4) were tested, and the results were compared to numerical models. It is important to note that the width of the notches was constant, but the shape of the root of the notches was variable: sharp corners, rounded corners, and the full semi-circular root.

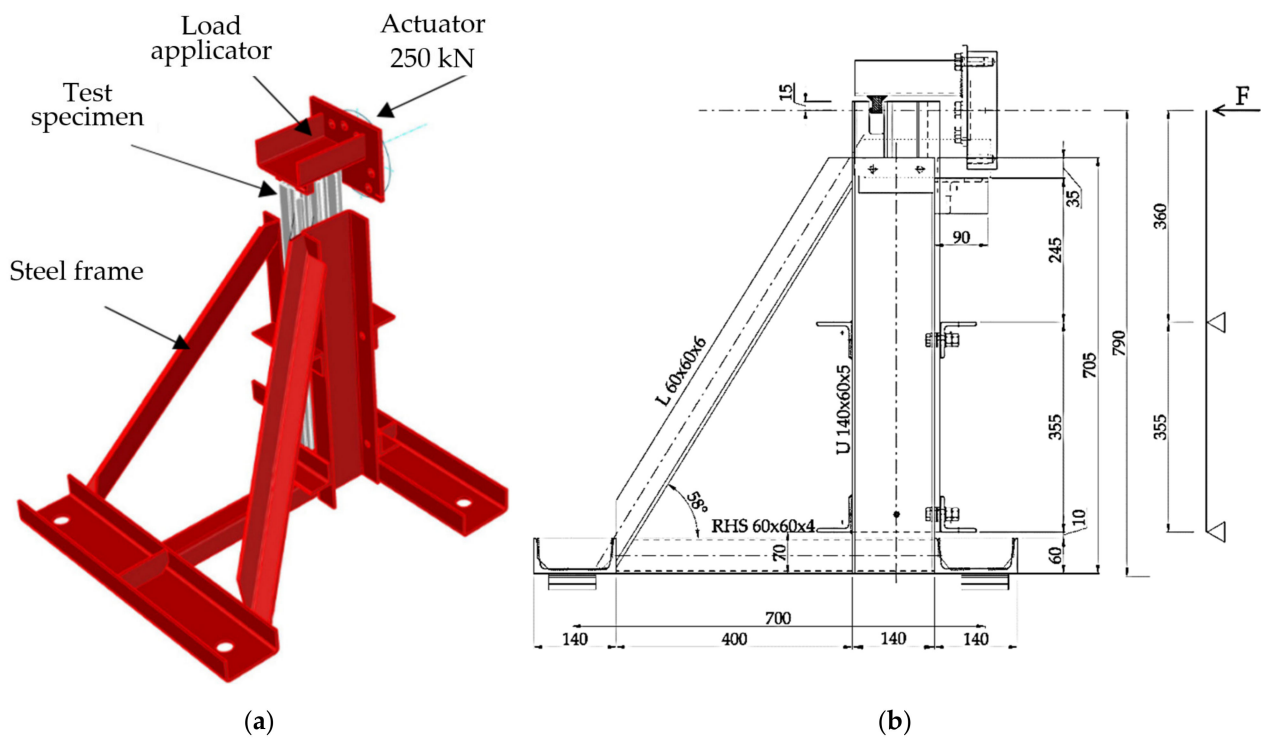
Figure 8. (a) Test setup; (b) test frame and the structural system (mm).

The specimen was held in the steel frame (Figure 8b) at two points 355 mm apart, and the horizontal load F was applied at the top end of the profile (Figure 8a).

The point of application for load F was 15 mm below the top end of the profile, forming a 360 mm structural cantilever. The tests were conducted by gradually increasing the applied load under displacement control of the actuator at a constant speed of 0.025 mm/s until the specimen fractured.

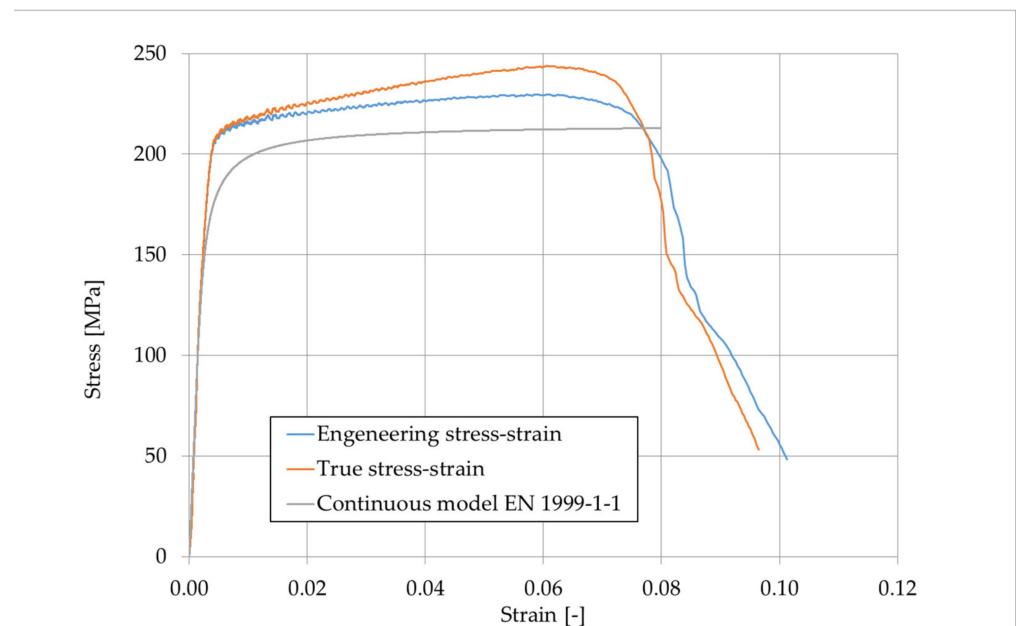
Figure 14. Engineering, true and standardised stress–strain curves for Al1.

Engineering and true stress–strain curves for the dog-bone coupon Al1 are shown on Figure 14. The standardised stress–strain curve for alloy EN AW 6063 T6, defined by [18] (E.2.2.2), is included.

The analysis was performed using material nonlinearity. Two strain–stress curves were used, one true, calculated from tested dog-bone coupon Al1 (chosen, conservatively, for having the lowest strength of all 3 coupons), as per Figure 14, and the other as provided by [18] (E.2.2.2).
