Fatigue Behaviour of Aluminium Members with Different Notch Root Shapes

Nebojša Buljan, Davor Skejić, Paulina Krolo and Mladen Lukić

Keywords: notch; aluminium profile; fatigue; wind action; stress concentration; unitised curtain wall

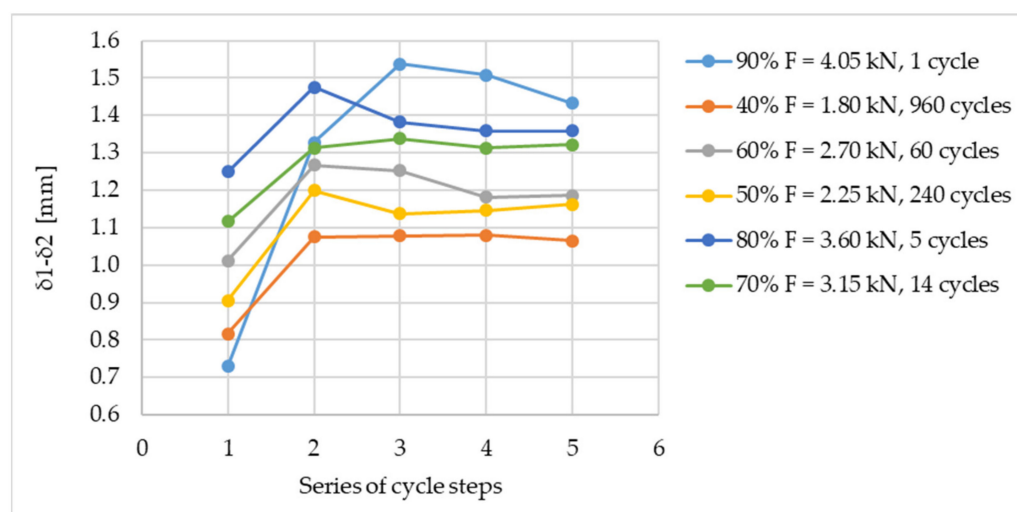
Figure 11 shows the diagram of the maximal opening of the notch, expressed as the difference between deflections δ_1 and δ_2 (readings of LVDT_1 and LVDT_2, respectively) for each set of cycles (single F_i) in each series for the specimen with the sharp notch (C_N1_1). It can be noted that there was a slight increase in the opening of the notch ($\delta_1 - \delta_2$) after the first series for $F_i = 90\%$ F and $F_i = 40\%$ F load cycles. This could be caused by the onset of the crack in the root of the notch, but this pattern was not observed on other specimens and there is no definite proof of that hypothesis. For subsequent series of cycle steps, it can be observed that a stable value of measured deflections and slight fluctuations were attributed to the tolerance of the applied force due to the precision limits of the hydraulic press.

Figure 11. Opening of the notch, sharp notch specimen C_N1_1.
