# Fatigue Behaviour of Aluminium Members with Different Notch Root Shapes

Source / Izvornik: **Buildings, 2022, 12**

**Abstract:** In unitised curtain walls, the transfer of horizontal loads, mainly wind loads, from the upper into the lower unit is achieved through the head/notch interlocking connection. Optimisation of the machining process would require a sharp root of the notch, causing an increase in the stress concentration. In order to predict fatigue resistance during design life, the influence of the radius at the root of the notch has been tested in both static and cyclic regimes. The cyclic regime is based on the load history equivalent of 50 years of wind exposure. Numerical simulations on the test assembly have been conducted in order to verify their adequacy for future research on similar issues. The experimental results demonstrated that, for the given specimen shape and alloy, a sharp notch would not lead to premature failure, and such a detail is safe from the purview of damage-tolerant design.

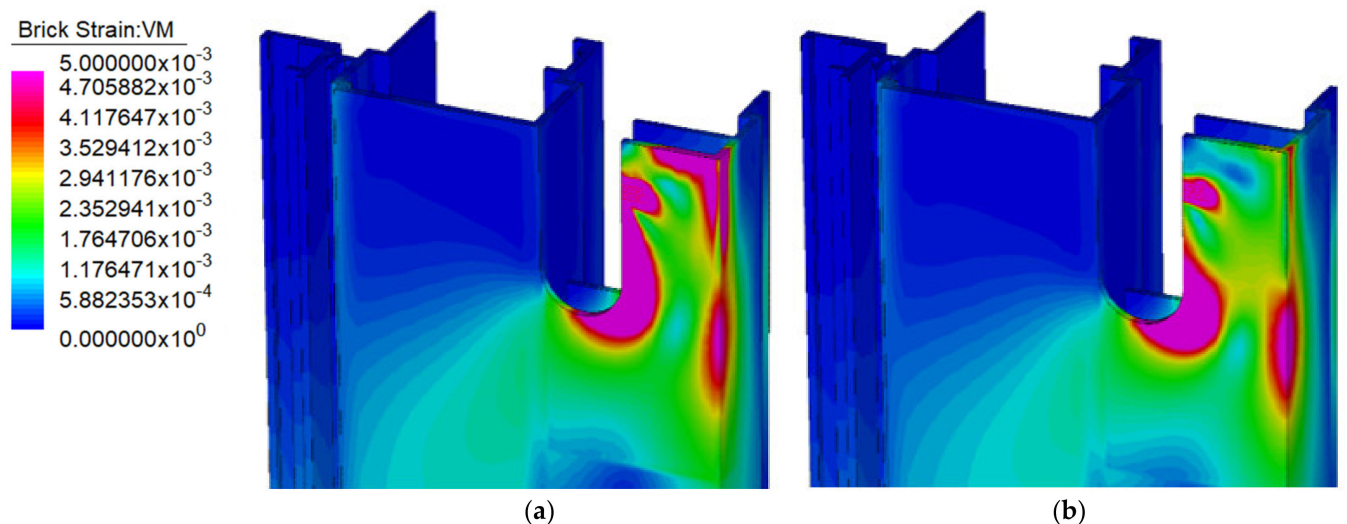
**Figure 19.** Strain in the model of the semi-circular notch 55 mm: (a) True stress–strain curve (coupon A11), load 5.5 kN; (b) nominal stress–strain curve (alloy EN AW 6063 T6), load 5.0 kN.

For the semi-circular notch, two different geometries were modelled, Figures 19 and 20. The difference between them was the total depth of the notch. Tested specimens had an initial depth of 55 mm, to which a semi-circular machining with a radius of 12.5 mm was performed, resulting in a total depth of 67.5 mm. In order to match the total depth of the other two geometries, an additional model with a semi-circular root was created, which had a total depth of 55 mm, including the semi-circular part, equal to the sharp and rounded notches. Hence, a 67.5 mm notch was representative of tested specimens, whereas a 55 mm notch had the same notch depth as other tested geometries.
