# Large gravitational collapse structure on a rocky coast (Kvarner, NE Adriatic Sea)

*Source / Izvornik:* **Geologia Croatica, 2023, 76, 105 - 112**

**Journal article, Published version**

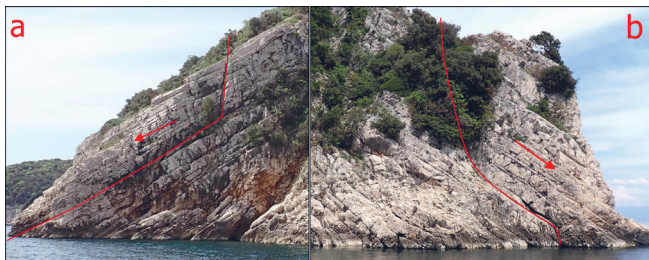
**Figure 5.** Structural interpretation of a possible slide in layered Upper Cretaceous limestones: a) south side, b) north side. Both red arrows are oriented to the east.

Rock mass surrounding the rock collapse consists of the Upper Cretaceous rudist limestones. The limestones show a distinct layering, with bedding planes uniformly inclined to the southeast with a dip angle of 28°. The layers are 10 to 100 cm thick. In addition to bedding planes, vertical or oblique fissures are also visible. This kind of structural fabric can favour the collapse of both sides of the described collapse structure (Figures 5a and 5b).

driven waves, discontinuities likely serve as initial patterns for the development of instability. Discontinuities that are diagonal to bedding planes, and discontinuity planes with dip vectors that form an oblique dihedral angle with the bedding planes dip vector, both contribute significantly to the development of instability. The aforementioned discontinuities are more persistent than others and run transverse to the bedding plane (Figure 5).

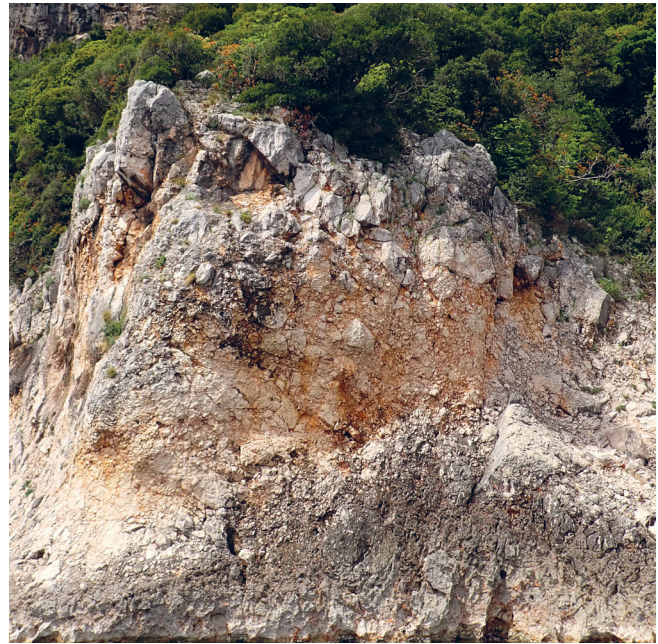
**Figure 6.** Cataclastic breccia in collapse structure (Photo: Ć. Benac).

The rock mass in the collapse structure consists of cataclastic breccias. The size of the angular fragments ranges from a few centimetres to blocks over one metre in diameter. The matrix consists of calcitic reddish clay (Figure 6).
