# Large gravitational collapse structure on a rocky coast (Kvarner, NE Adriatic Sea)

*Source / Izvornik:* **Geologia Croatica, 2023, 76, 105 - 112**

**Journal article, Published version**

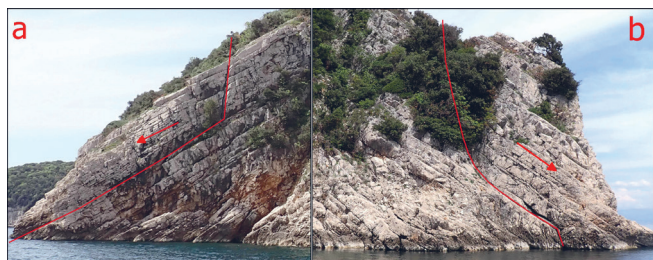
**Figure 5.** Structural interpretation of a possible slide in layered Upper Cretaceous limestones: a) south side, b) north side. Both red arrows are oriented to the east.

Rock mass surrounding the rock collapse consists of the Upper Cretaceous rudist limestones. The limestones show a distinct layering, with bedding planes uniformly inclined to the southeast with a dip angle of 28°. The layers are 10 to 100 cm thick. In addition to bedding planes, vertical or oblique fissures are also visible. This kind of structural fabric can favour the collapse of both sides of the described collapse structure (Figures 5a and 5b).

driven waves, discontinuities likely serve as initial patterns for the development of instability. Discontinuities that are diagonal to bedding planes, and discontinuity planes with dip vectors that form an oblique dihedral angle with the bedding planes dip vector, both contribute significantly to the development of instability. The aforementioned discontinuities are more persistent than others and run transverse to the bedding plane (Figure 5).
