# Post-Nourishment Changes of an Artificial Gravel Pocket Beach Using UAV Imagery

*Source / Izvornik:* **Journal of marine science and engineering, 2022, 10**

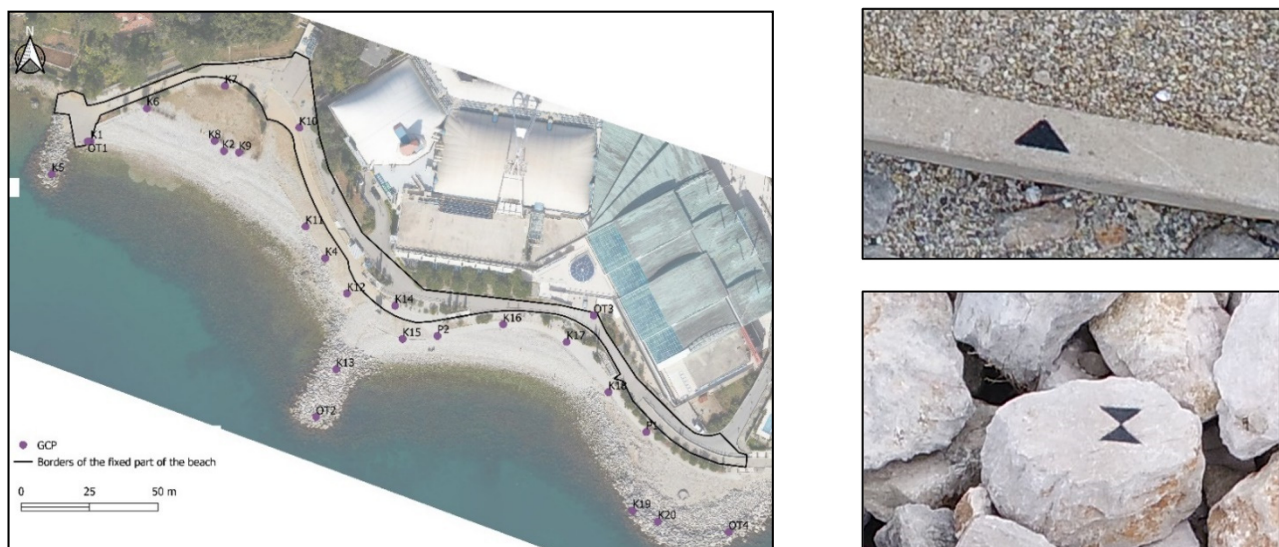
**Figure 3.** (a) Study site with marked locations of ground control points (K1, K2, K4–K20, P1, P2 and OT1–OT4); (b) GCP markers.

Prior to the first survey, twelve ground control points were marked along stable parts of the beach, namely the promenade and groynes (see Figure 3) by the Geodetic institute Croatia (GZR). Coordinates for the GCPs in the Croatian Terrestrial Reference System HTRS96 (EPSG: 3765) were obtained with a total station Leica FlexLine TS06plus (Leica Geosystems AG, Heerbrugg, Switzerland), which provides the high accuracy of around 1.5 mm [62]. In April 2020, additional 16 GCPs were marked and old GCPs were surveyed again to check whether they remained stable. The GCPs are distributed around the entire analysed beach area to avoid extrapolation in the area of the interest. Once they were marked (Figure 3), the aerial surveys using Unmanned Aerial Vehicles (UAVs) were relatively quick. Usually it would take about an hour to complete the beach survey.
