Post-Nourishment Changes of an Artificial Gravel Pocket Beach Using UAV Imagery

Source / Izvornik: **Journal of marine science and engineering, 2022, 10**

The aim of this particular study is to utilise UAV surveys and SfM photogrammetry to assess beach nourishment performance of the Ploče beach in storm conditions. The objectives are to evaluate accuracy of UAV surveys, which can then be applied in estimating different beach parameters and to assess beach nourishment performance in terms of beach volumes and other parameters—such as changes in the beach elevation, the shoreline position and the beach areas.

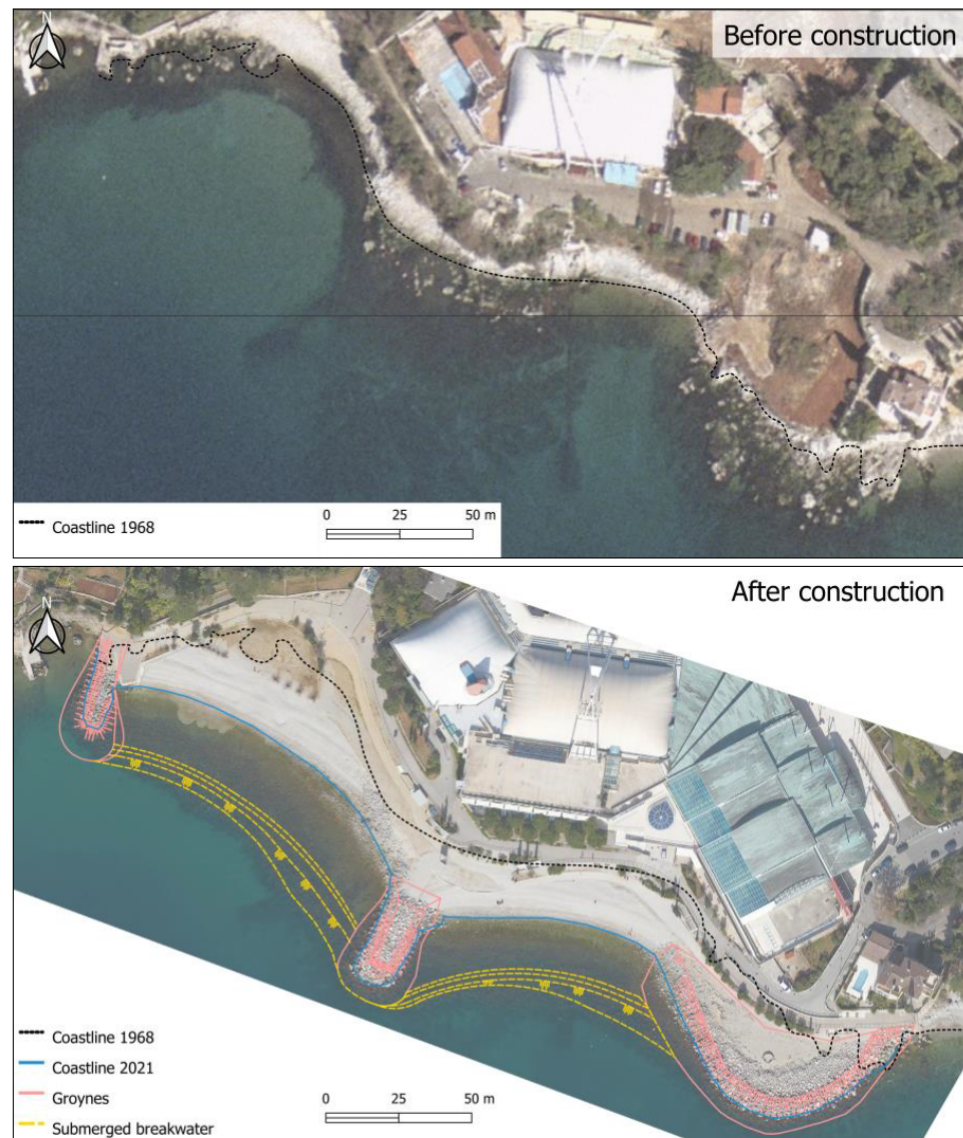
Figure 2. Study site (top) before the construction [52] and (bottom) after construction.

The Ploče beach is the largest beach complex in the city of Rijeka, with a total area of 14,000 m². The beach is located at the western outskirts, 6 km from the city centre (Figure 1). This artificial beach was built in 2011 as a part of the Rijeka swimming pool complex. The new beach is constructed across two existing natural embayments. It is protected by three groynes, which are extended from existing headlands. The middle groyne separates it into two pocket beaches—the eastern and the western beach, both about 130 m wide (Figure 2). A submerged breakwater about 2 m wide was built at the steep seabed (Figure 2) with the crest at 2.5 m depth. At the landward side, the beach is backed up by a promenade. Once these structures were built, the existing beaches were extended by adding material on the beach. The material used for the construction of the beach is gravel with D₅₀ of 32 mm and supplied from the river Drava in northern Croatia.

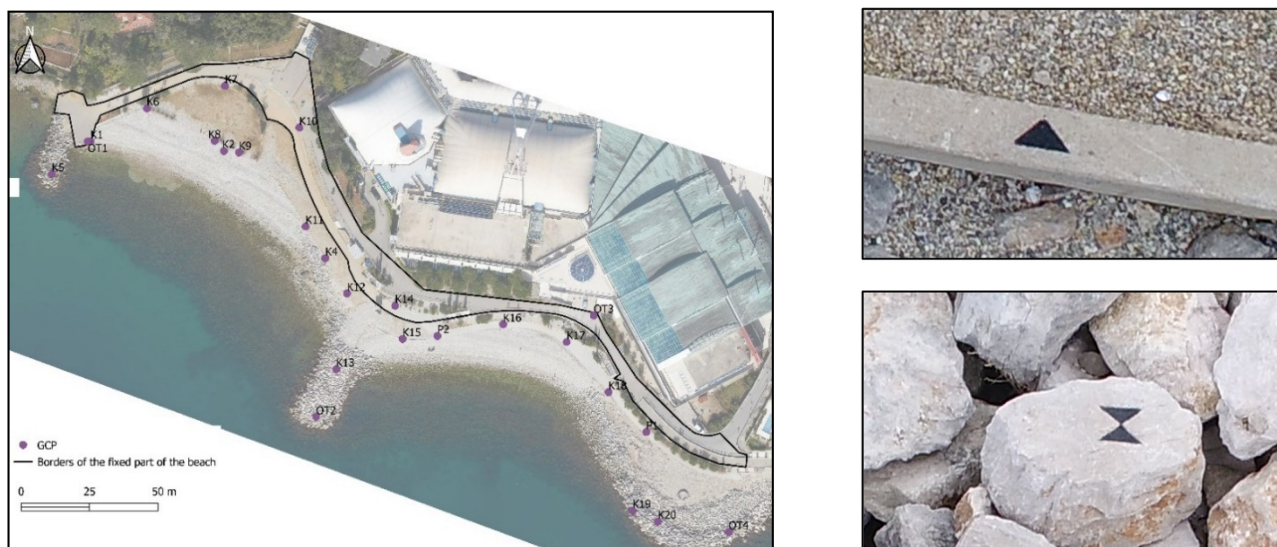
Figure 3. (a) Study site with marked locations of ground control points (K1, K2, K4–K20, P1, P2 and OT1–OT4); (b) GCP markers.

Prior to the first survey, twelve ground control points were marked along stable parts of the beach, namely the promenade and groynes (see Figure 3) by the Geodetic institute Croatia (GZR). Coordinates for the GCPs in the Croatian Terrestrial Reference System HTRS96 (EPSG: 3765) were obtained with a total station Leica FlexLine TS06plus (Leica Geosystems AG, Heerbrugg, Switzerland), which provides the high accuracy of around 1.5 mm [62]. In April 2020, additional 16 GCPs were marked and old GCPs were surveyed again to check whether they remained stable. The GCPs are distributed around the entire analysed beach area to avoid extrapolation in the area of the interest. Once they were marked (Figure 3), the aerial surveys using Unmanned Aerial Vehicles (UAVs) were relatively quick. Usually it would take about an hour to complete the beach survey.

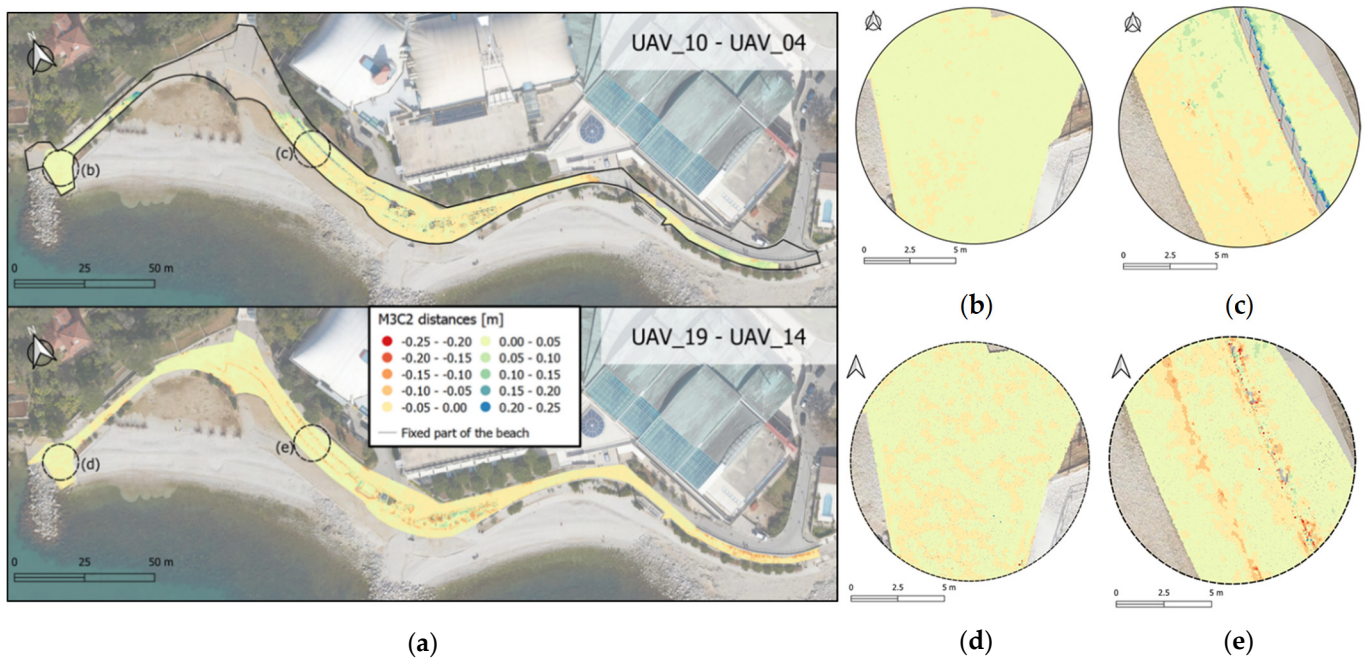
Figure 4. Vertical accuracy; (a) M3C2 distances on concrete promenade; (b,c) inserts of M3C2 from UAV_10-4; (d,e) inserts of M3C2 from UAV_19-14.

Only a few comparison results are given for illustration purposes here; between 10th and 4th and 19th–14th surveys (Figure 4). The mean value of M3C2 distances for these cases were 0.0 and -0.04 m, respectively. The spatial distribution of the M3C2 calculated distances found the accuracies to be mostly between -0.05 and 0.05 m, and the results are shown in Figure 4. Larger values for the distance are only found in places where vegetation, fence or sediment from the beach is present or where an occasional pedestrian was ‘caught’ during the survey.

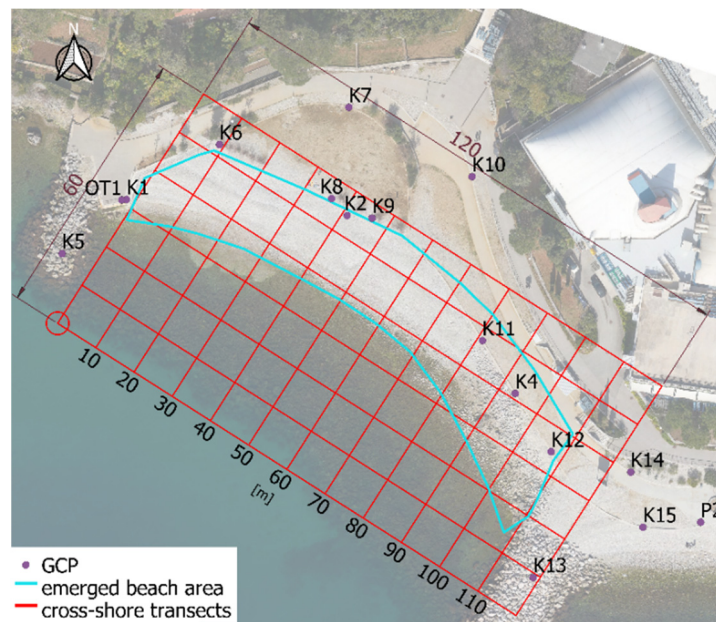
Figure 5. Location of cross-shore transects marked 10–110; blue polygon shows the extent of the area for beach area and volume calculations.

Cross-shore changes are evident in cross-shore transects. Figure 11 shows elevation changes at both ends of the beach and in the middle, at 20, 50 and 90 m (see Figure 5).

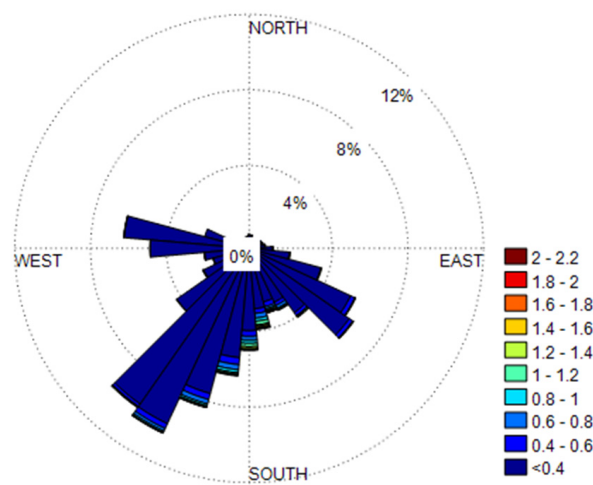
Figure 6. Wave rose for all wave measurements.

Waves are measured by the Hydrographic Institute of the Republic of Croatia with the Datawell wave rider (type MKIII) in the immediate vicinity of the Ploče beach (45° 19.588' N; 14° 23.738' E, WGS 84, free movement within the radius of the position), offshore of port Rijeka [73]. The standard wave statistics is provided every 30 min between 1 January 2020 and 30 January 2021. Additionally, an ADCP was deployed offshore of the beach from 30 January 2021 to spring 2021 but its data were not used in this study. The wave rose in Figure 6 summarizes the wave heights and directions recorded by the wave buoy between 1 January 2020 and the end of January 2021. For the most of time, calm conditions and waves up to 0.4 m height were recorded. Figure 7 shows that the events with higher wave heights take place before April and after September with exception of two short lasting storm during the summer. It is also evident from Figure 7 that the largest recorded waves are from S to SSE directions.

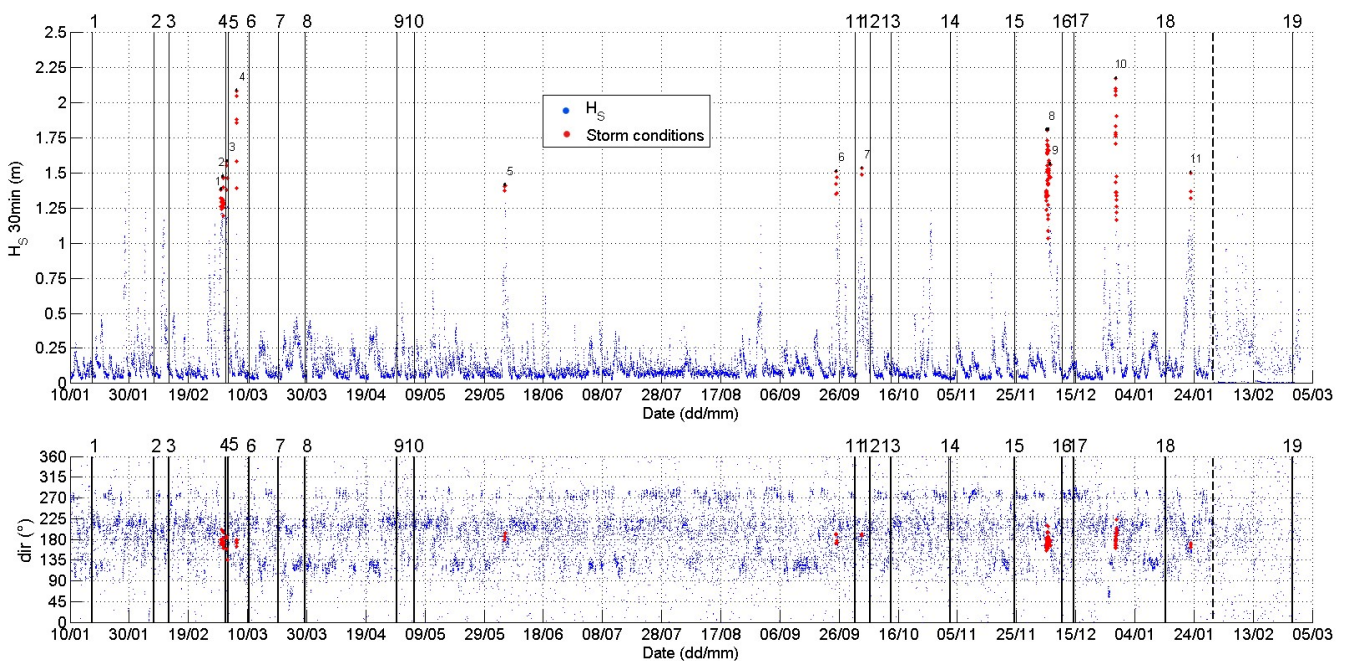
Figure 7. Identified storm events. A dashed line represents the stop of the wave buoy measurement and the start of the ADCP data (30 January 2021).

Storm events are identified by using a threshold of the 99.5th percentile of the significant wave height data [74] recorded at the wave buoy, which is 1.26 m. A minimum duration of storm was set to 1 h [75] and the time between storms to 10 h. For the significant wave height threshold of 1.26 m and set duration conditions, eleven storms were identified. This includes weak and strong storms [76,77]. A storm in March (1 March) and two in December (5 and 28 December) lasted for more than 4, 19 and 8 h respectively.

The next three surveys did not record significant changes on the beach. The sixteenth survey conducted on 10 December 2020 shows the scale of damage caused by storm events on 5 and 6 December, when the maximum significant wave height was 1.8 m. Because of the heavy rain the water started to flow through the beach body again, causing concentrated erosion in the middle part of the cell. The material from lower beach was pushed to the upper beach by waves on the western part of the beach. The site was flooded again and some material ended up on the promenade. Only four days later the beach was surveyed again (UAV_17). Because there was no wave activity in this period (Figure 7), the changes were mainly found at the lower parts of the beach.

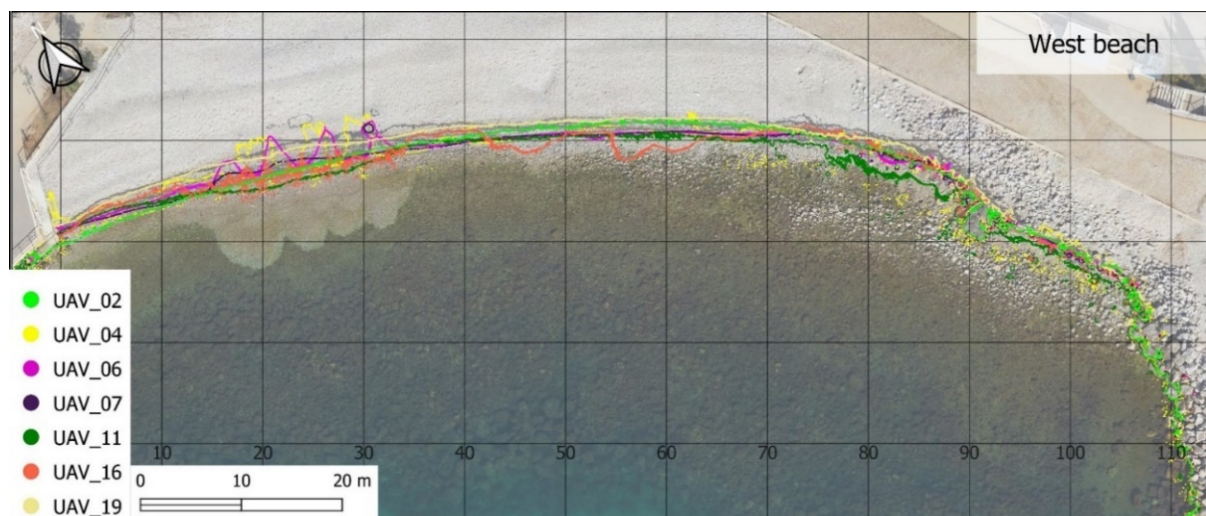
Figure 8. Shoreline changes.

Shoreline changes were analyzed at 0 m above sea level and they are given in the Figure 8. Shorelines derived from surveys after storms and nourishments are shown in colour, while the rest are in grey.

Between the 2nd and 3rd survey, (UAV_02 and UAV_03), the shoreline moved onshore due to first storm after nourishment. It also rotated slightly west (clockwise) on the western part of the beach. The western end of the shoreline moved about 1.8 m inland, while it stayed at approximately the same position on the other side. After the first wave energetic event, the beach stabilize, There was no further rotation and the results generally show pronounced onshore sediment migrations.

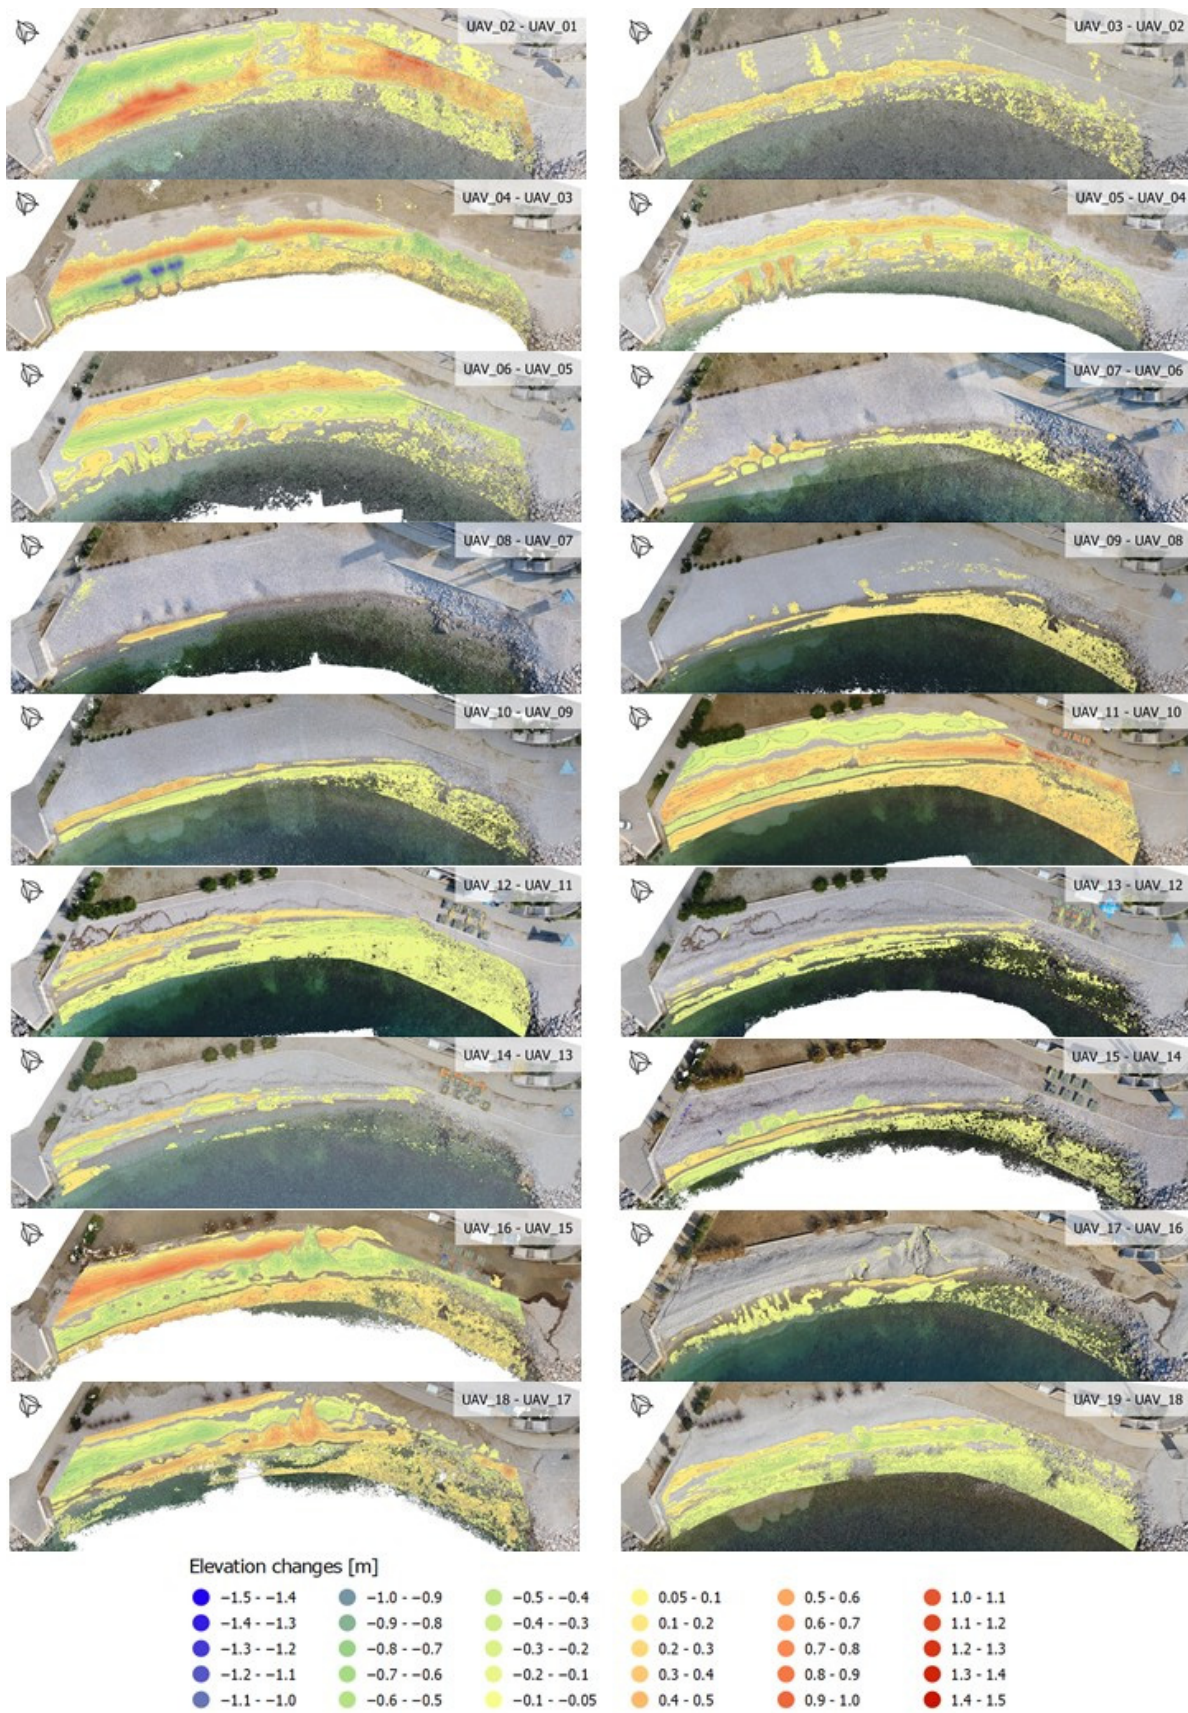
Figure 9. Beach elevation changes (emerged) between successive surveys.

The first significant elevation changes took place between the third and fourth survey caused by the first storm event on 1 March 2020. The measured significant wave height was up to 1.47 m. A berm formed on the higher parts of the beach as a result of the wave activity. The wave action was accompanied by heavy rainfall on 1 and 2 March 2020. Overall 46.3 mm of rain fell in just over 16 h. The promenade on the beach was flooded and there was the fresh water spring outburst through the beach body (Figure 10). Resulting changes were accretion, namely berms, on the upper beach on the western side, and erosion on the eastern side. In addition, the areas of concentrated erosion (1.2 m deep), associated with the fresh water outburst can be seen on the western side of the beach. They are marked in blue in Figure 9 (UAV_04–UAV_03).

Survey UAV_05 was conducted the day after the flood. The wave height increased ($H_{s,max} = 1.56$ m) and the fresh water was still flowing through the beach. Formation of the berm higher up on the beach can be seen in Figure 9.

The project provided unique opportunity for evaluating behaviour and *longevity* of beach nourishment as result of storms. *Longevity* is defined here in a loose sense, meaning time before significant sediment loss occur. As part of the Beachex project, the Ploče beach was nourished at the end of January 2020 and it was exposed to a number of high energy events, including four storm events defined as events with $H_s > 1.26$ m and duration of at least 1 h. The beach volumes seem to be quite stable, which is evident from analysed beach volumes (Figure 12). A positive trend of the beach area for which uncertainty of estimates are negligible, has been observed between first nourishment and second nourishment. Some fluctuations of the beach area were observed after storm events, but overall the beach area increased until May. The local council re-nourished the beach again in May to extend the bathing area. By the end of the surveys in February 2021, the beach area had decreased as a result of at least five storm events. It is worth mentioning that these changes represent less than 6% of the average beach area. Most of the sediment has been lost from the eastern part of the beach. This is evident from the elevation changes both in plan and through transects (Figures 9 and 11).

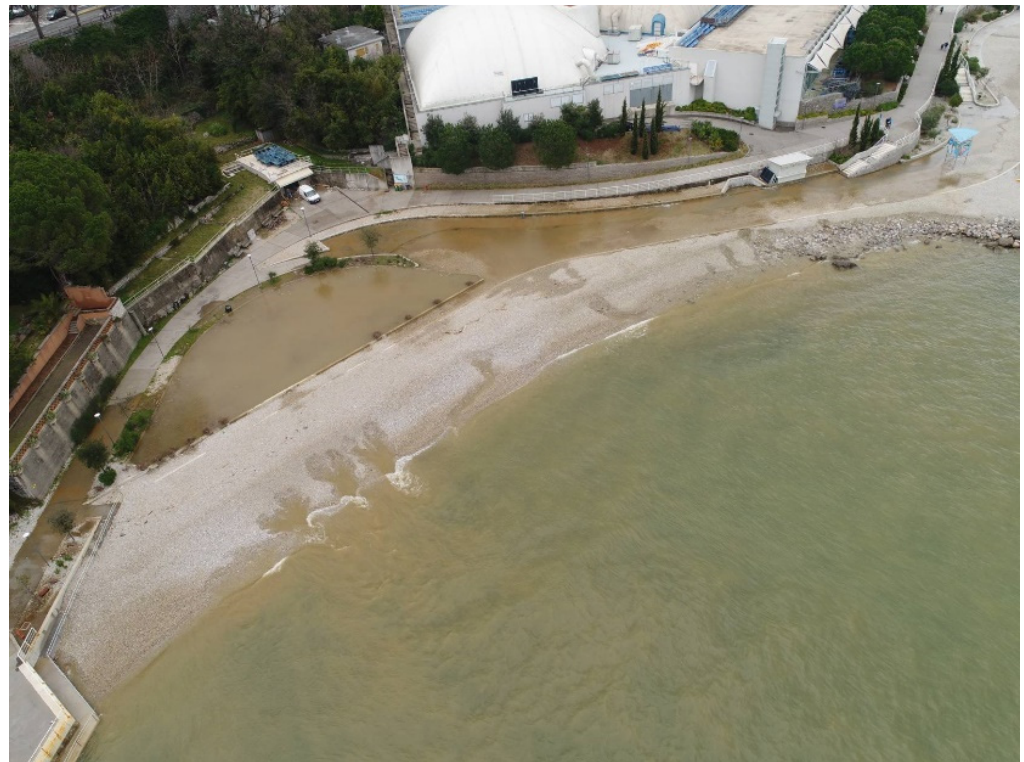
Figure 10. Flooding and outbursts on the beach, 2 March 2020.

Prior to survey UAV_04, three ‘pockets’ formed due to the fresh water springs outbursts through the beach body on the western part of the beach, causing the local erosion and onshore shoreline move by an average of 3.4 m (transects 20–30, Figure 8). Beach recovered by infilling of eroded zones between 6th and 7th survey. Shoreline moved back offshore for almost the same distance (3.47 m). A similar process occurred prior to survey UAV_16, except that this time the spring outbursts took place in the central part of the beach (transects 40–60, Figure 8). This time the shoreline moved offshore due to formation of sediment lobes at fresh water outbursts, with the greatest distances being approximately 2.5 and 3.6 m. In the period up to the 17th survey, the beach stabilized again under smaller waves.

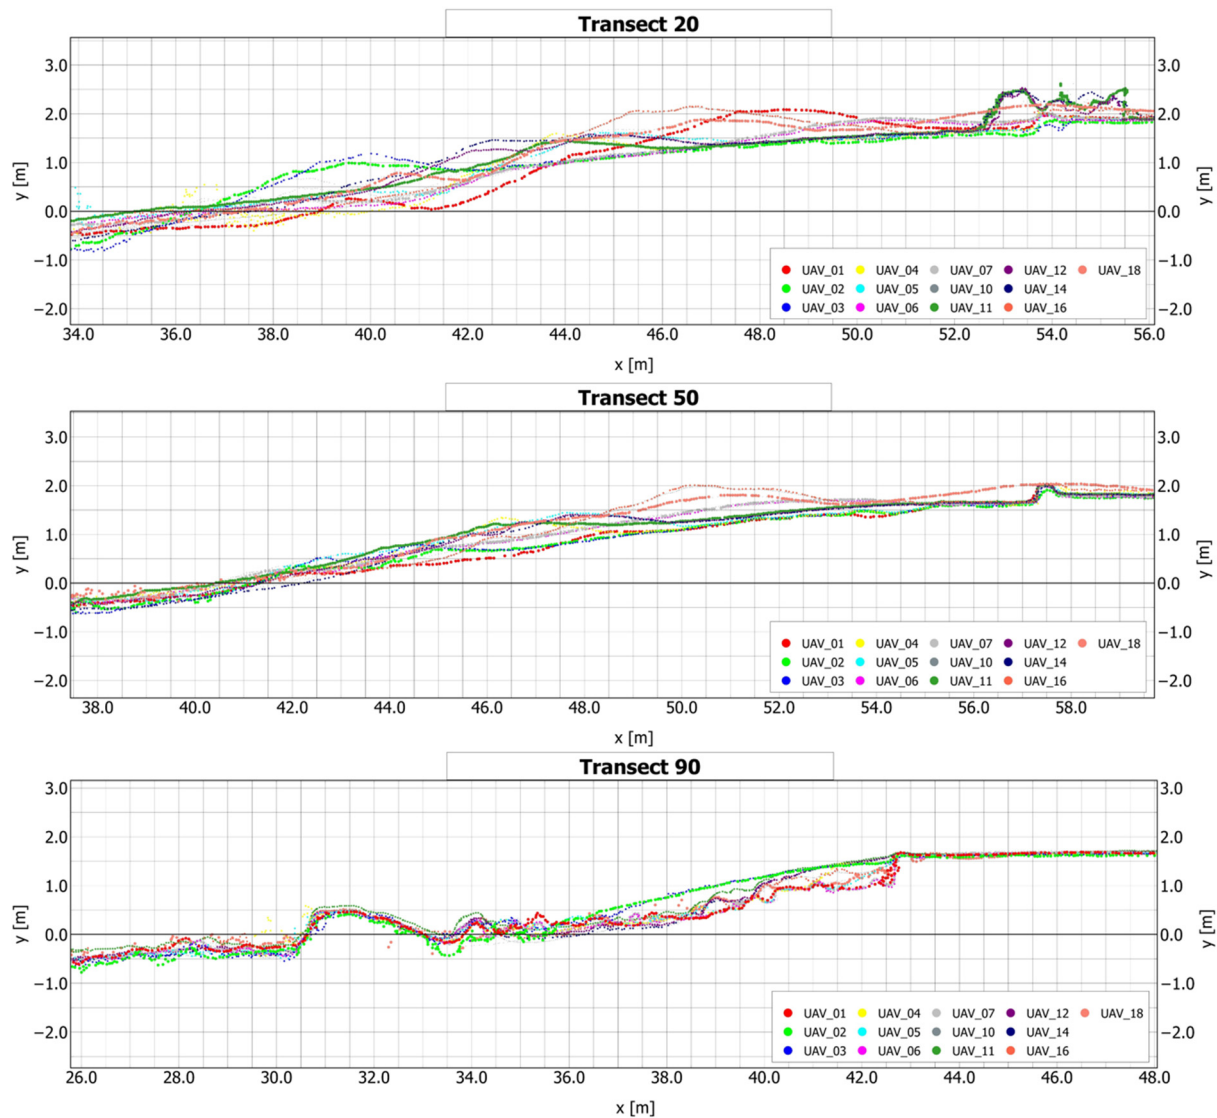
Figure 11. Elevation changes in transects at the west (**top**), in the middle (**middle**) and at the east end of the beach (**bottom**).

Changes in the transects 20 and 50 show that the berms (0.2 m high) form under the influence of waves, immediately after the nourishment (UAV_03 and UAV_12)). They stayed at almost the same places until the stronger storms hit the beach causing them to move further onshore (UAV_04, UAV_06 and UAV_16). In the middle transect, the berm moved (horizontally) for 3.7 m due to steepening of the beach profile by the 4th survey. The material from the lower beach face was moved by wave run-up into a berm on the upper beach. The berm stayed at more or less the same location and was approximately the same size, until the wave conditions changed. At the time of the 6th survey (after storms 3 and 4), it moved further onshore for additional 5.8 m. The storm on 3 October, which took place after the second beach nourishment and flattening (UAV_12), formed the new berm. It moved 1.45 m, and stayed there until the storms on 5 and 6 December, when it moved further offshore for 2.6 m. The strongest waves coming from the south quadrant

The same pattern of berm formation is observed at the western end (transect 20), while on the eastern side (transect 90) there is no berm. Because of erosion, material added through nourishments is very quickly removed, leaving the rubble underlayer exposed on this side of the beach.

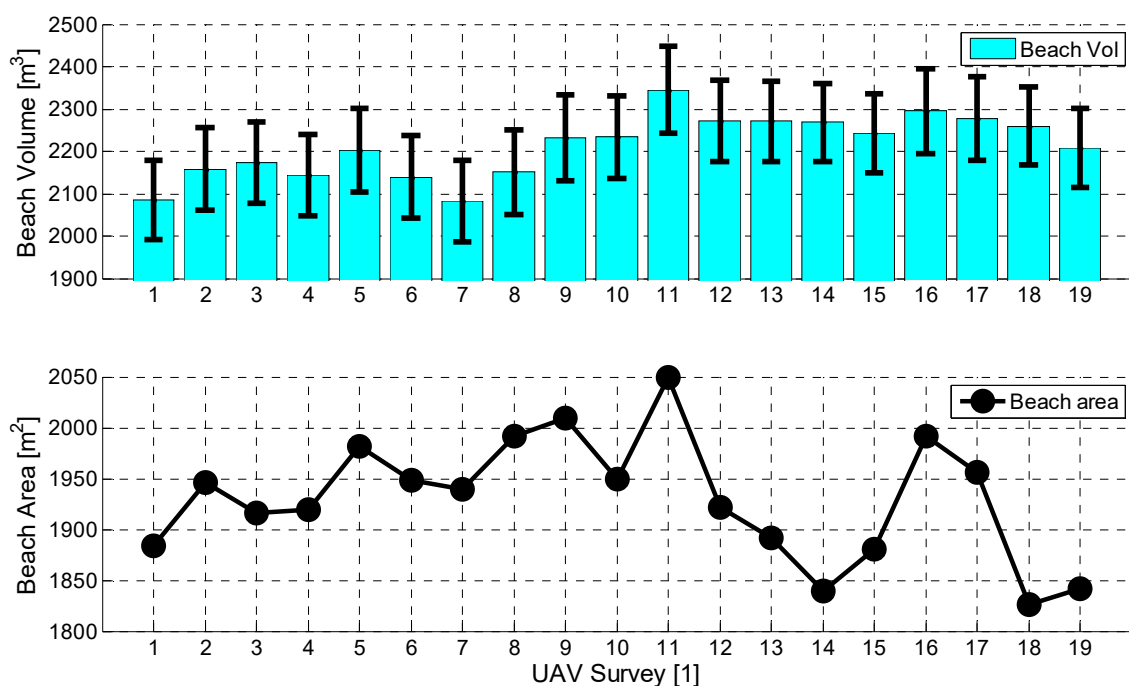
Figure 12. Beach volumes (top) and beach areas (bottom) during surveying.

The results of the volume changes, including error bars, are given in Figure 12 top. The beach area was also calculated and shown in the Figure 12 bottom. The average area is about 1900 m² and it changed only slightly from 1841 m² in survey UAV_14 to 2049 m² in UAV_11. The largest area was recorded just after the summer season after the beach was renourished and flattened.

Emerged beach volumes range from 2085 ± 47 m³ (UAV_01) to 2345 ± 51 m³ (UAV_11). The significance of the error estimates is further discussed in Section 5.1.
