Source / Izvornik: **Industrial Archaeology Review, 2022, 44, 19 - 35**

Structures of the First Industrial Age in Rijeka, Croatia — from Timber to Iron

Adriana Bjelanović, Nana Palinić & Marko Franković

Rijeka; industrial architecture; construction; timber; iron; warehouses; tobacco factory; corn mill

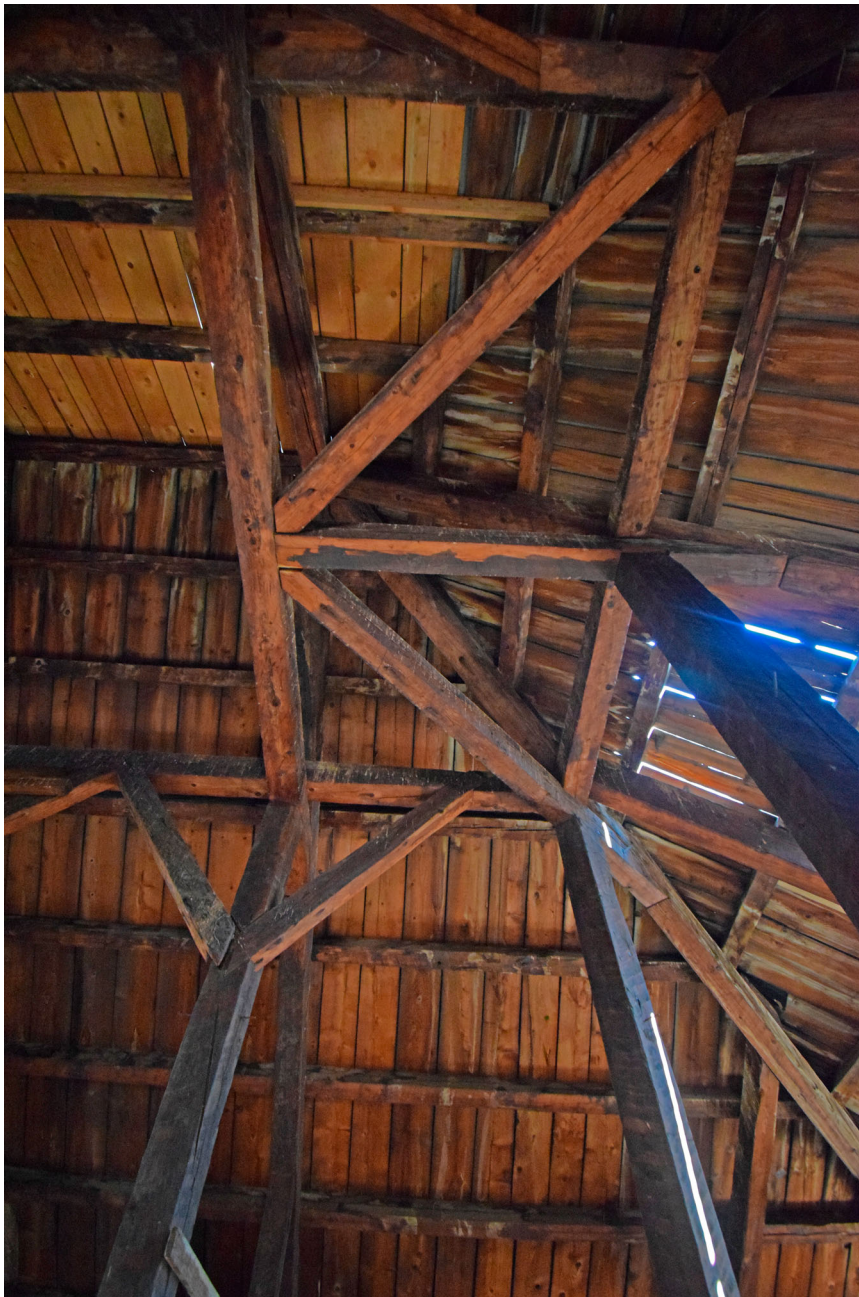
Figure 9. Tobacco Factory T-building, roof structure detail (Marko Franković, 2018).

Although the roof structure mainly matches the original concept of this kind of traditional structural system, it is a variant structure of this typology.²² There is no secondary truss (since the secondary beams support sheathing boards and roof cover), so every transverse section of the roof represents a principal
