Fatigue Behaviour of Aluminium Members with Different Notch Root Shapes

Buljan, Nebojša; Skejić, Davor; Krolo, Paulina; Lukić, Mladen

Source / Izvornik: **Buildings, 2022, 12**

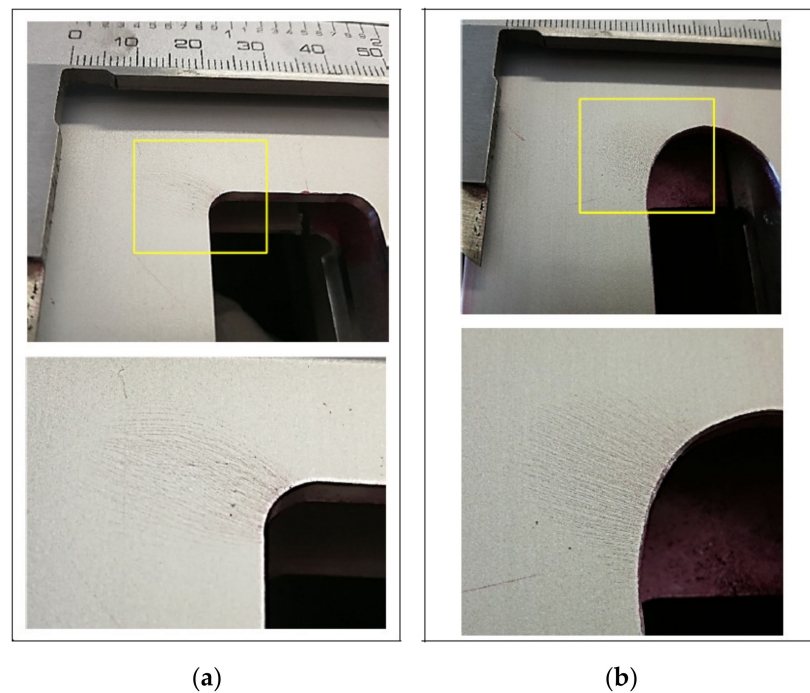
Figure 13. Microcracking of the surface of specimens with the rounded and semi-circular root: (a) C_N2_1; (b) C_N3_1.

Cracking of the specimens with the rounded (Figure 13a) and semi-circular roots (Figure 13b), did not occur. In the zone approximately 20 mm around the crack, a net of microcracks radiating from the internal corner of the notch was visible. It is important to note that all specimen surfaces were anodized with aluminium trioxide, which has a higher modulus of elasticity and higher hardness than the parent material below. For high strains, the anodized surface will crack before the alloy material below. It is not uncommon for anodized surfaces with a thickness of around 30 μm or more to experience microcracking caused by the temperature expansion of the parent material. Such a surface becomes “crazed” with crisscrossing lines. This also happened in this test, but due to the high strain. Microcracks are present only in the surface finish (anodization), while the material below was not cracked, apart from a main crack that grew through the full thickness of the aluminium wall and was observable from both sides of the aluminium wall.

This microcracking of the surface finish was also visible on specimens with rounded roots and with semi-circular roots. However, on these specimens, no cracks in the aluminium alloy wall occurred. The aluminium material around the root of the notch did under-go a yield, observable from the residual deformation, which is approximately 1 mm at the opening of the notch, but without initiating cracks (Figure 13a,b).

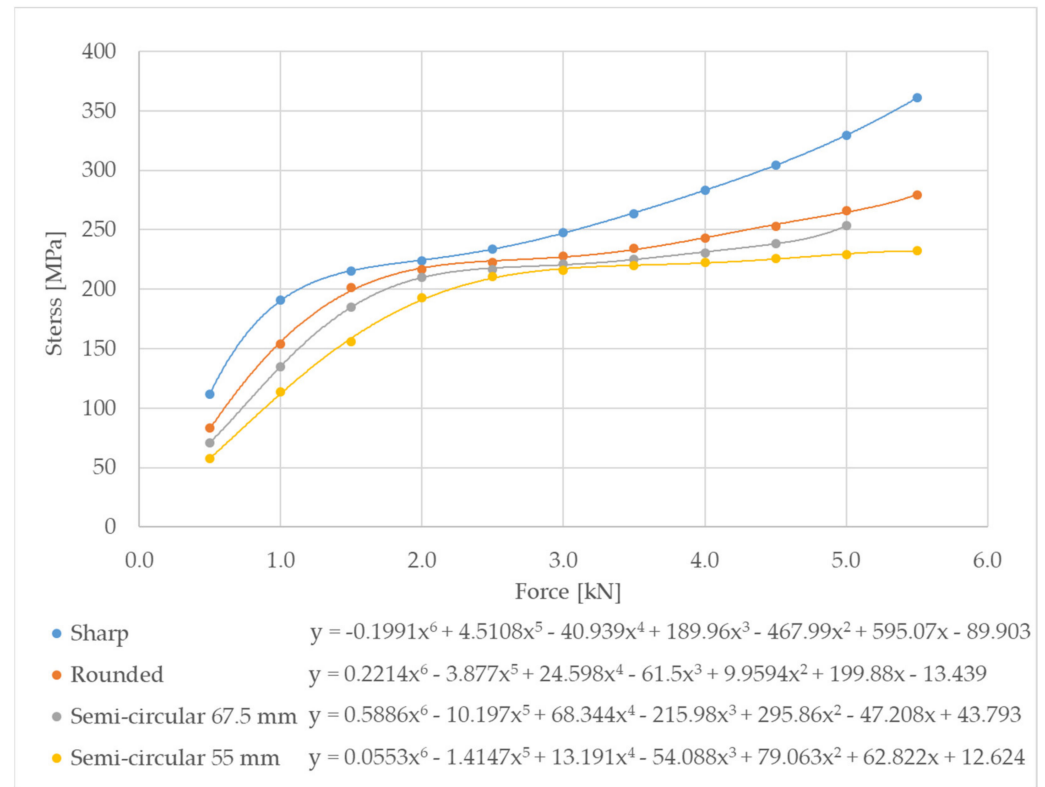
Figure 24. Von Mises stress–strain regression curves for $\Delta\sigma_i$.

Numerical simulations were performed for the load in steps of 0.5 kN, which did not necessarily match the values of the load used for the cyclic testing (Table 3). In order to assess the hotspot stress range ($\Delta\sigma_i$) for each cycle, the resulting von Mises stresses from the numerical model were used to generate stress–strain curves through the polynomial regression of each notch type. Figure 24 shows the regression curve for the sharp notch. Hotspot stress ranges ($\Delta\sigma_i$) for each cycle were assessed from the obtained curves. Models with the true stress–strain curve for dog-bone coupon A11 were used.

For each geometry of the notch, the hotspot stress ($\Delta\sigma_i$) for each cycle was assessed from the respective regression curve. The endurance (N_i) for each cycle was calculated using Formula (7), and the total damage for each cycle was calculated using Formula (8). The results of this procedure for the sharp notch are shown in Table 9.
