# Hydrometric and Water Quality Properties of the Medulin Pond (Republic of Croatia)

Source / Izvornik: **17th International Symposium on Water Management and Hydraulic Engineering, 2022, 205 - 213**

## HYDROMETRIC AND WATER QUALITY PROPERTIES OF THE MEDULIN POND (REPUBLIC OF CROATIA)

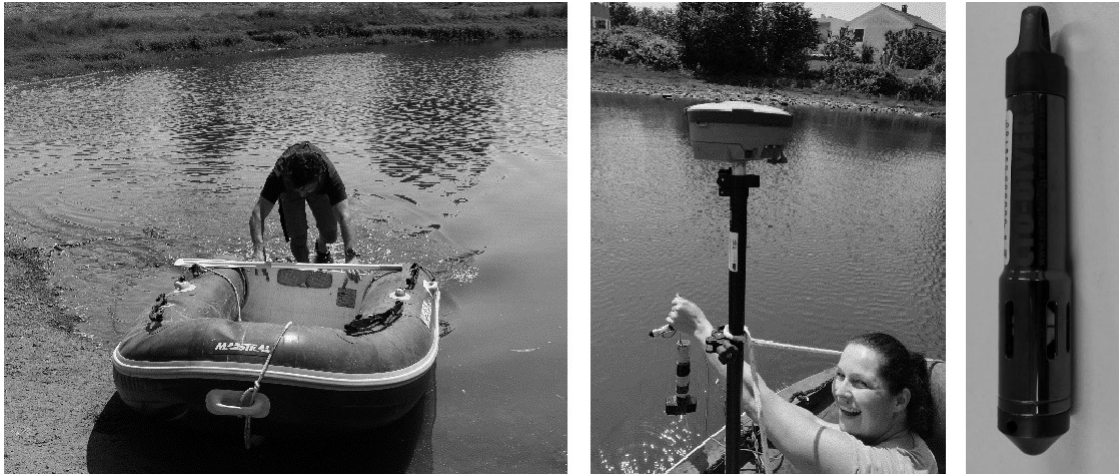
Hydrometric measurement under this research encompasses bathymetry and temperature stratification in the Medulin pond. Bathymetry is provided by usage of the CTD – diver (Van Essen Instruments B.V., Nederland), Topcon positioning system HiPer V for geodetic surveying, and a small inflatable boat. With an inflatable boat is possible to navigate on the surface of the pond, and with geodetic surveying equipment is possible to take precise georeferenced points on which the depth of the water is measured by the CTD-diver [7]. CTD-diver also provides information about the temperature of the water and its conductivity. Used equipment in hydrometric measurement is shown in Figure 5.

Figure 5. Equipment used for the bathymetry measurement (from left to right): Inflatable boat, Topcon positioning system HiPer V and CTD – diver [7]

The bathymetry data was recorded on the 20 June 2022, on the same day when water quality sampling is done. The bathymetry was measured by usage of the small inflatable boat on which the Topcon positioning system HiPer V for geodetic surveying was attached. Also, the CTD diver was attached to the aggrigator and rope, and the depth measuring was conducted by constantly immersing the CTD diver in the water. Since the CTD diver is equipped with a temperature sensor, by moving all around the pond it was possible to take 122 depth and temperature points. In the

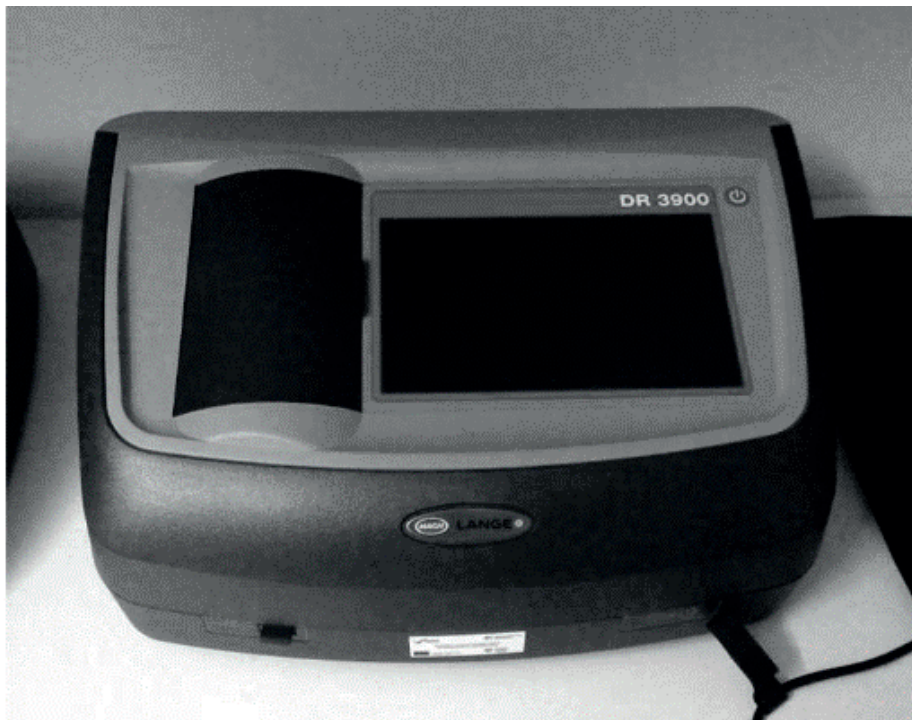
Water quality measurements are carried out by water sampling and water analyses in Hydrotechnical Laboratory at the Faculty of Civil Engineering in Rijeka. The water quality parameters are measured by the Spectrophotometer – Hach DR 3900 as shown in the Figure 6 [7].

Figure 6. Equipment used for water quality measurement: Spectrophotometer – HACH DR 3900 [7]

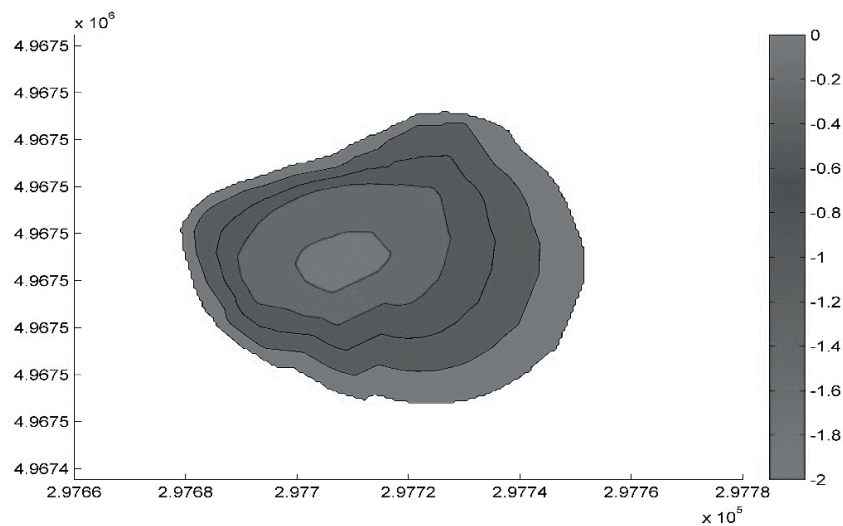
Since on the north-west part of the pond was not possible to measure depth because of water lilies, the collected data was processed with help of the software Matlab 7.11.0 (R210b) from MathWorks in order to approximate the depths in that area. In the same software 2D visualization of the bathymetry is prepared and shown in Figure 8.

**Figure 8.** The 2D representation of the Medulin pond bathymetry

The collected depth and geodetic data points have shown that the water surface area at the time of measurement was 3237,8 m<sup>2</sup> and the water level is placed at 12.80 m.a.s.l. The maximum measured depth is 1,57 m and placed around the middle of the pond. The pond is very shallow, and there is no vertical temperature stratification. The measured temperature of water at the surface and bottom of the pond was 27°C while the air temperature was at the time of measurement 33°C.
