Historic timber roof structures, assessment and analysis on example of roof structure "TU Graz Alte Technik"

Master's thesis / Diplomski rad

**Historic Timber Roof Structures,
Assessment and Analysis on
example of Roof Structure
“*TU Graz Alte Technik*”**

Institute of Timber engineering and Wood technology
Faculty of Civil Engineering

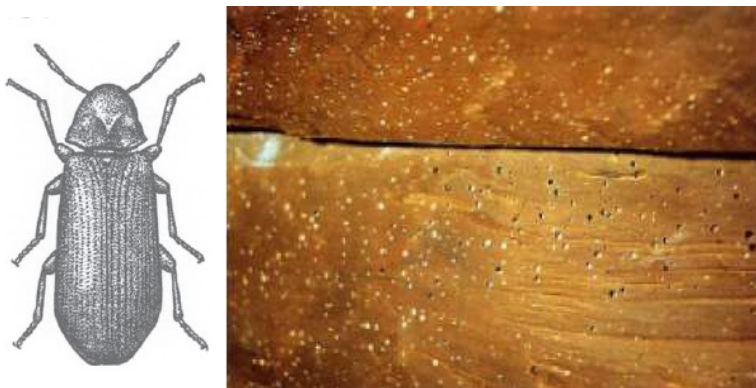
Figure 1.36 left: Common furniture beetle [48], right: Entry and exit holes from common furniture beetle [42]

This beetle can be found in Central Europe and it attacks usually softwood (e.g. Spruce). Adults are few millimetres in size and brown Figure 1.36 left. Larvae are a few millimetres in size and yellow. Gallery holes have 1,0-4,0mm in diameter and exit holes are circular with 1,5-2,0mm in diameter, Figure 1.36 right. While boring it produces recognisable Cream-coloured, lemon-shaped pellets. The boundary and optimal living conditions are shown in Figure 1.34. Metamorphosis to adult from larva usually takes form 2-4 years depending on conditions, and adults are emerging between May and August. It can cause damage to the wood depending on the size of infestation. Mechanical degradation is depending on the remaining cross section. (cf. [48] [49] [42] [50])

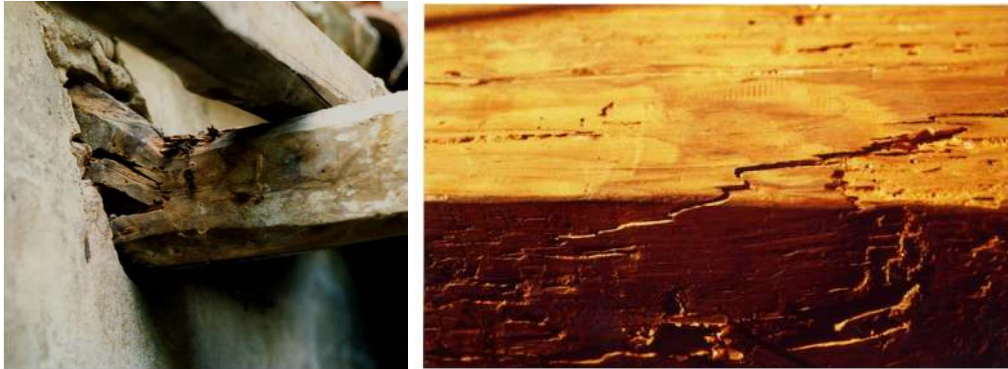
Figure 1.42. left: Decayed beam – result of the fungal attack; right: Cracked beam – indicates a brittle fracture (bending failure) due to the overload [57]

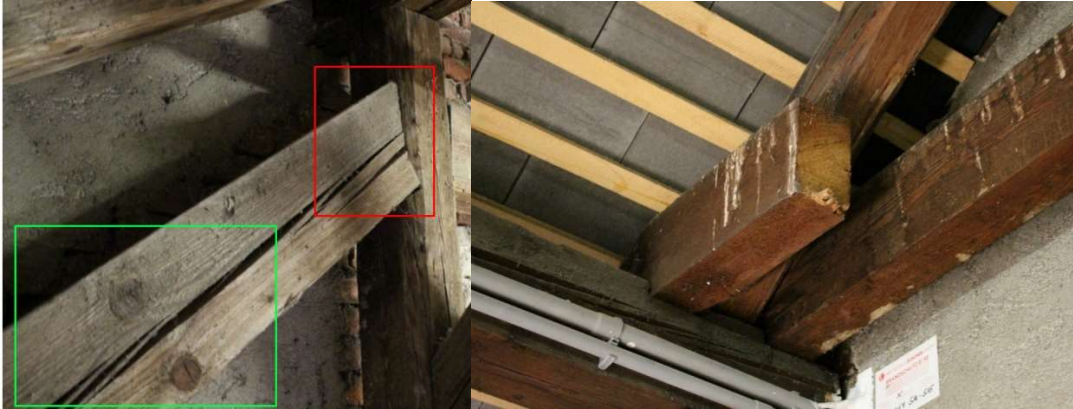
Figure 1.44. left: Cracks in brace at “TU Graz Alte Technik” (green uncritical, red critical) right: Removed collar beam in order to provide room for chimneys “TU Graz Alte Technik”

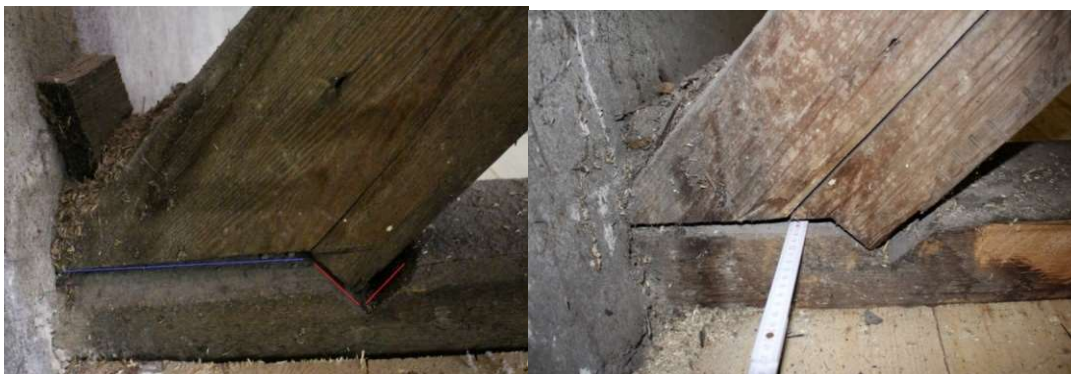
Figure 2.22 left: Rear /heeled notch with marked load transfer planes; right: The gap in notched connection

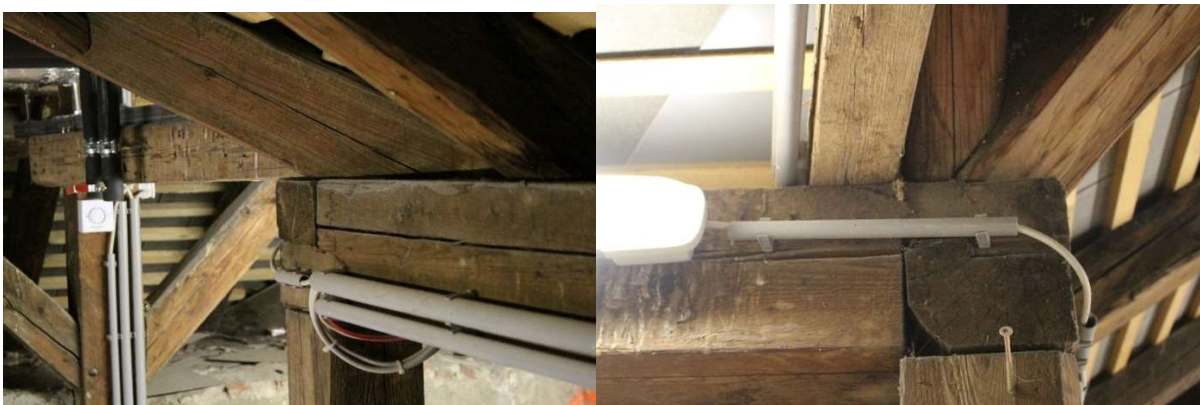
Figure 2.24. left: Half lapped connection with a notch on the upper edge; right: Half lapped connection with a notch on the bottom edge

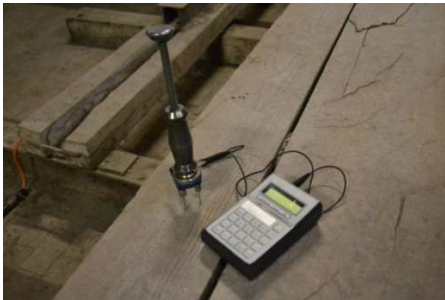
Figure 3.11. Hygrometer Gann Hydrometers M4050 [18]

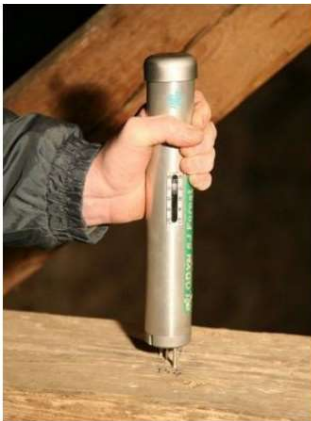
Figure 3.13. Pilodyn [61]

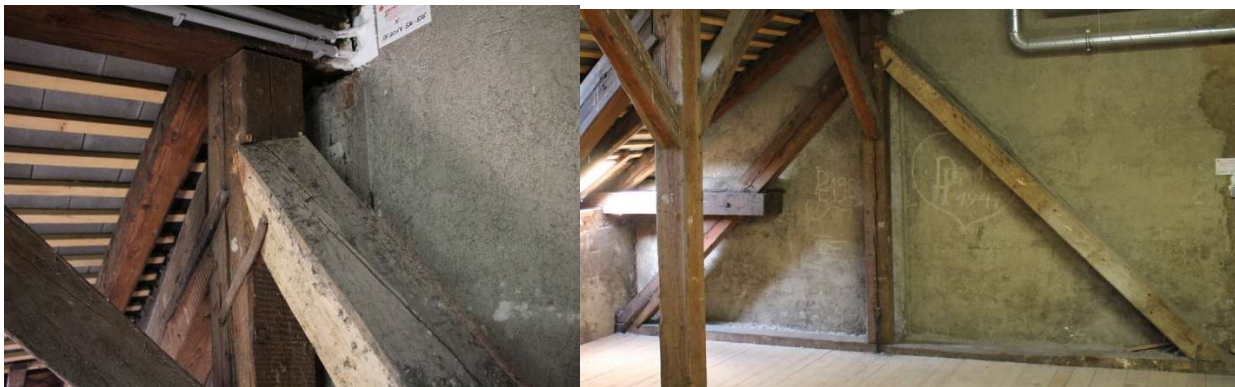
Figure 4.1. left: Connection Brace-Post (Photo:6500); right: Brace on axis 14 (Photo:6644)

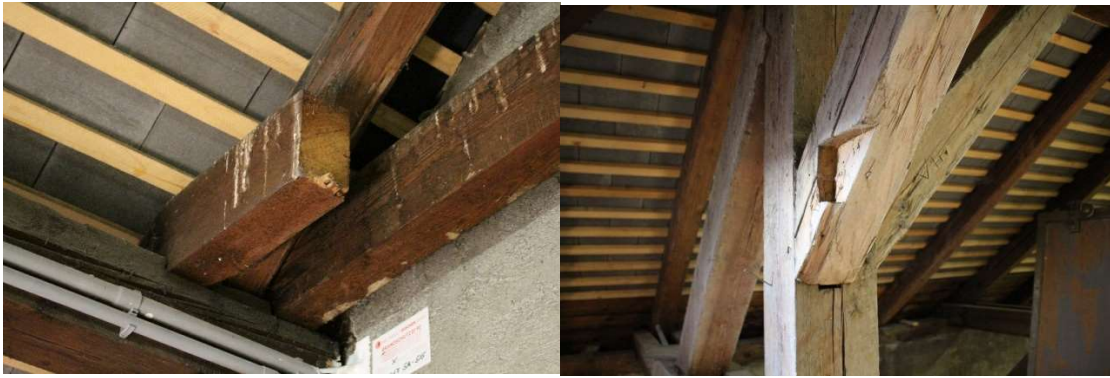
Figure 4.2. left: Cut Collar beam (Photo 6525); right: Damaged Knee brace (Photo: 6624)

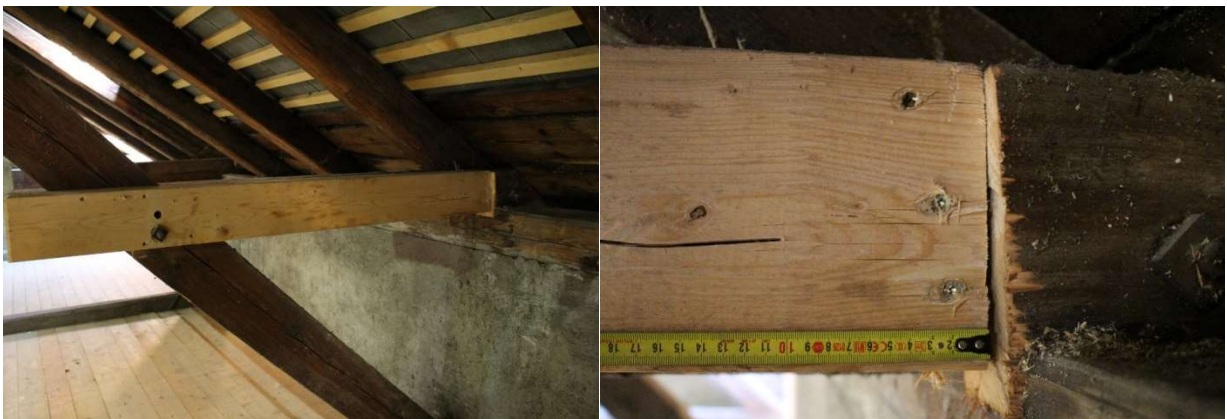
Figure 4.3. left: Changed short tie axis 3 (Photo6604); right: Connection of the new short tie to the old short tie (Photo:6468)

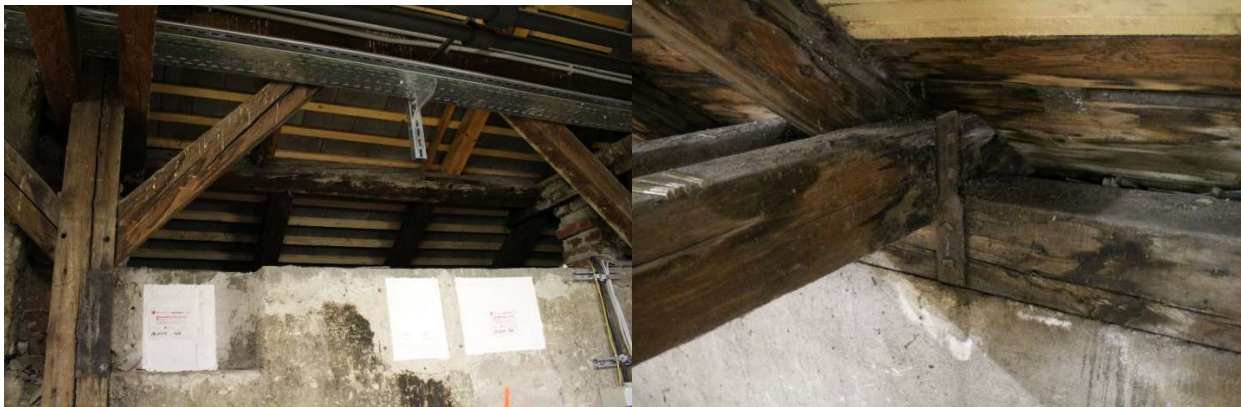
Figure 4.4. left: The white colour of the transversal beams and dark stripes on the knee brace; right: Sap fungi and wood oxidation

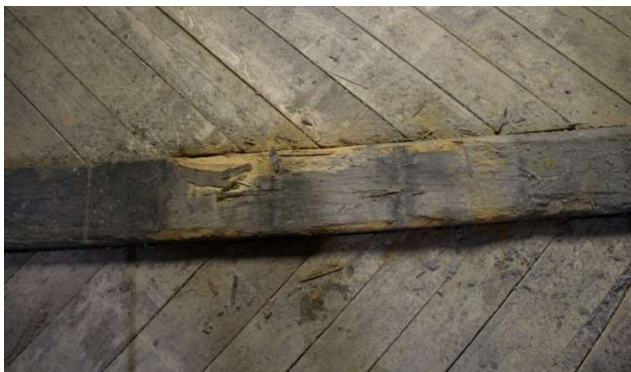
Figure 4.5. Damage to the tie beam due to the House longhorn beetle

Attack by this insect is also found in the roof structure of TU Graz Alte Technik. The infestation is found during survey on one member Figure 4.5.

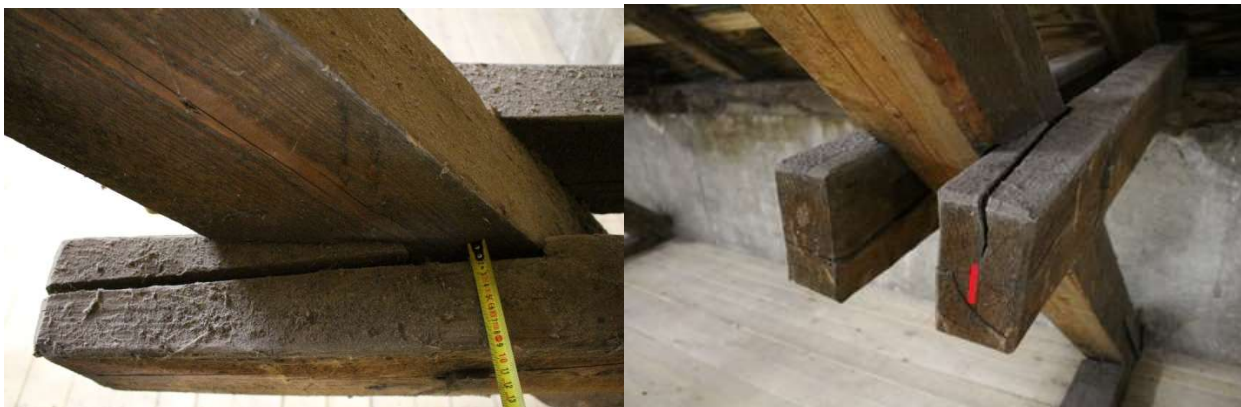
Figure 4.6. Cracks in connection brace-short tie

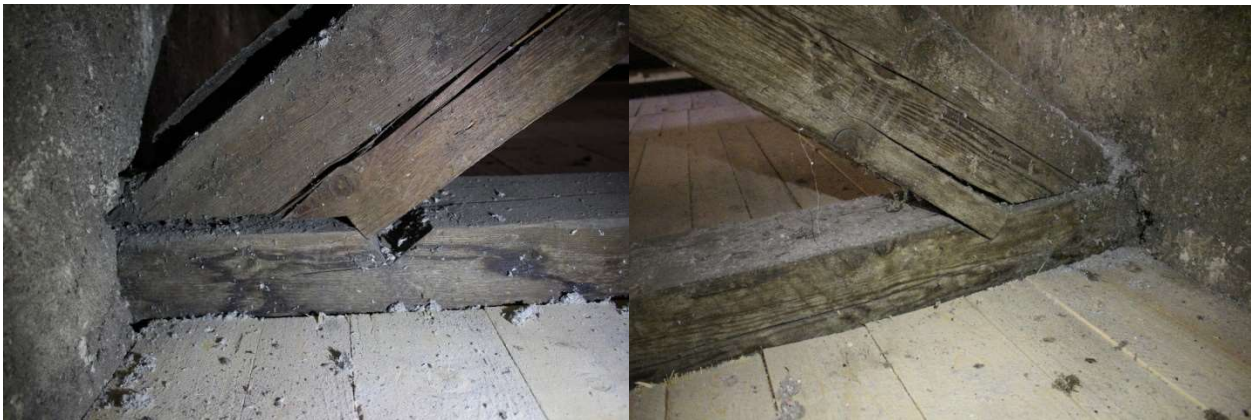
Figure 4.7. *left: Partly disconnection of the connection brace-tie beam; right: Cracks due to the load transfer*

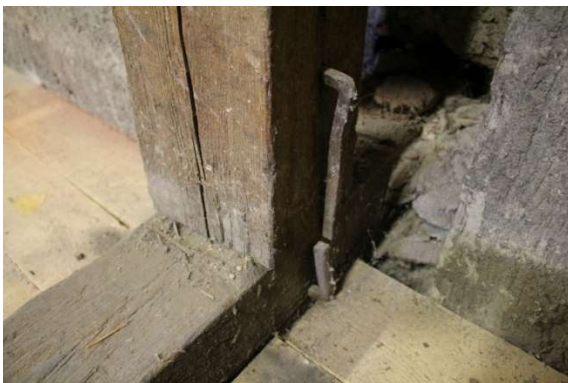
Figure 4.8. *Failure of the iron cramp on axis 11 (north post)*

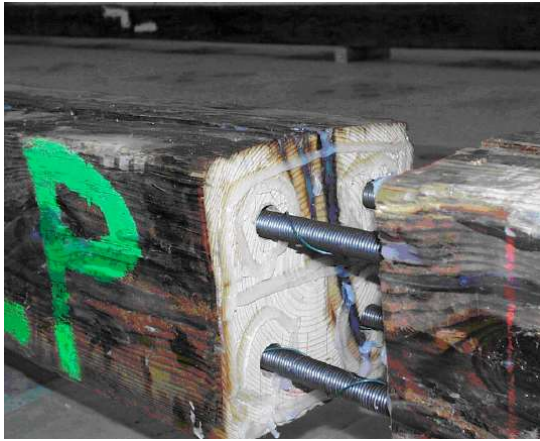
Figure 6.6 Glued in rods [82]

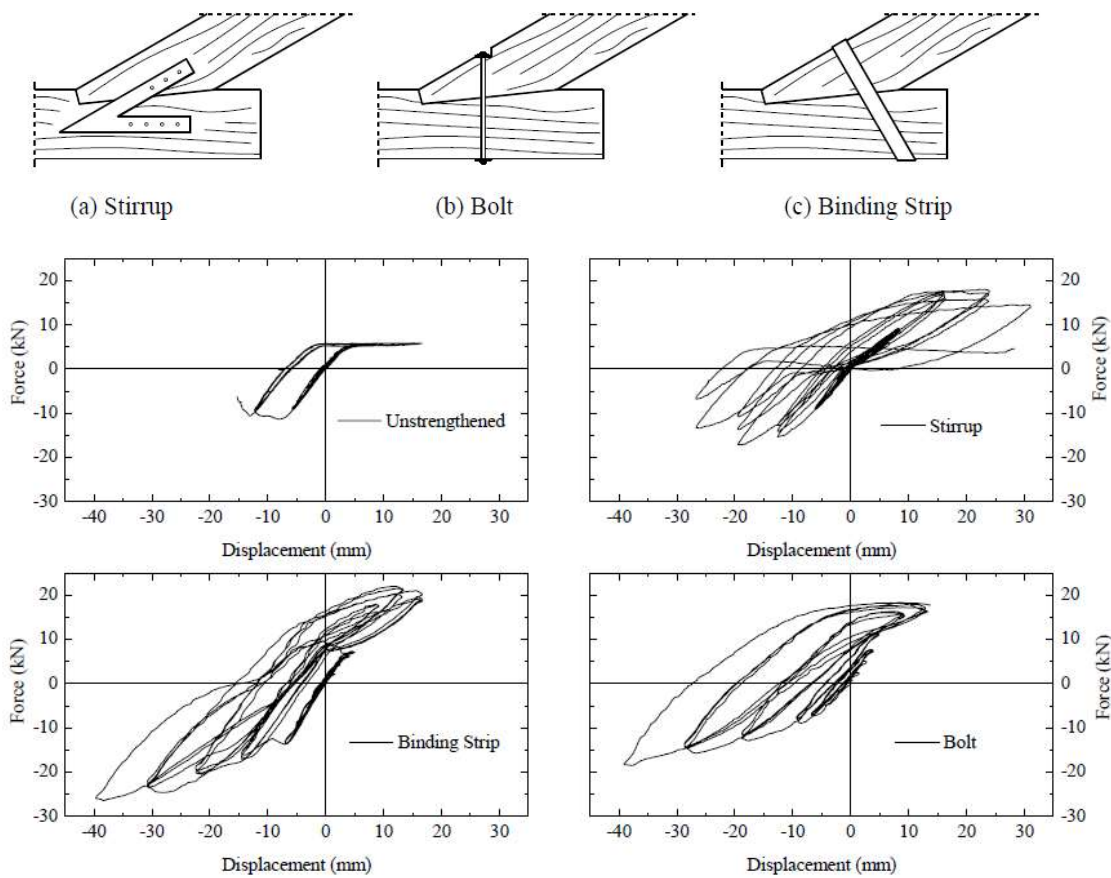
Figure 6.10. up: Sketches of the strengthened connections [83]; down: Force-displacement response for the cyclic loading [83]
