Structures of the First Industrial Age in Rijeka, Croatia — from Timber to Iron

Adriana Bjelanović, Nana Palinić & Marko Franković

To cite this article: Adriana Bjelanović, Nana Palinić & Marko Franković (2022) Structures of the First Industrial Age in Rijeka, Croatia — from Timber to Iron, *Industrial Archaeology Review*, 44:1, 19-35, DOI: [10.1080/03090728.2022.2060549](https://doi.org/10.1080/03090728.2022.2060549)

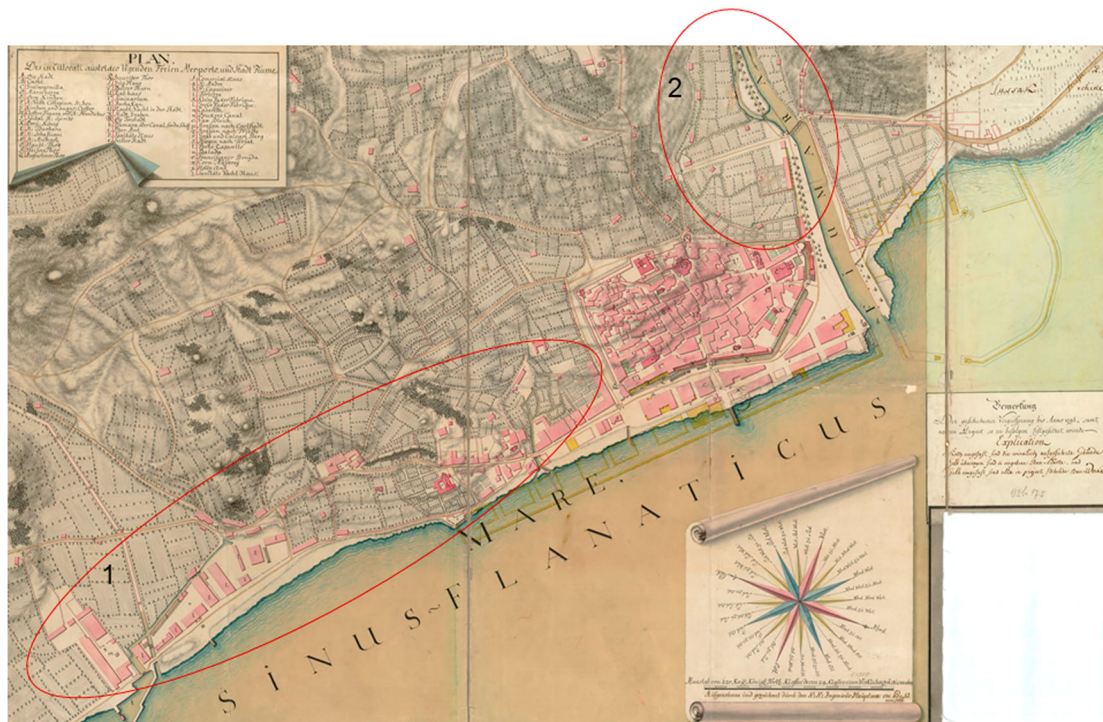
Figure 1. Rijeka, the main production zones of the first industrial age on the plan of the city from the end of 18th century made by Mayor von Benko: 1. central zone; 2. zone along the river Rječina (HR-DARI, original in Österreichisches Staatsarchiv, Kriegsarchiv, sign. Glh 175 Fiume). State Archives in Rijeka (HR-DARI), reproduced with permission.
