Fatigue Behaviour of Aluminium Members with Different Notch Root Shapes

Abstract: In unitised curtain walls, the transfer of horizontal loads, mainly wind loads, from the upper into the lower unit is achieved through the head/notch interlocking connection. Optimisation of the machining process would require a sharp root of the notch, causing an increase in the stress concentration. In order to predict fatigue resistance during design life, the influence of the radius at the root of the notch has been tested in both static and cyclic regimes. The cyclic regime is based on the load history equivalent of 50 years of wind exposure. Numerical simulations on the test assembly have been conducted in order to verify their adequacy for future research on similar issues. The experimental results demonstrated that, for the given specimen shape and alloy, a sharp notch would not lead to premature failure, and such a detail is safe from the purview of damage-tolerant design.

Keywords: notch; aluminium profile; fatigue; wind action; stress concentration; unitised curtain wall

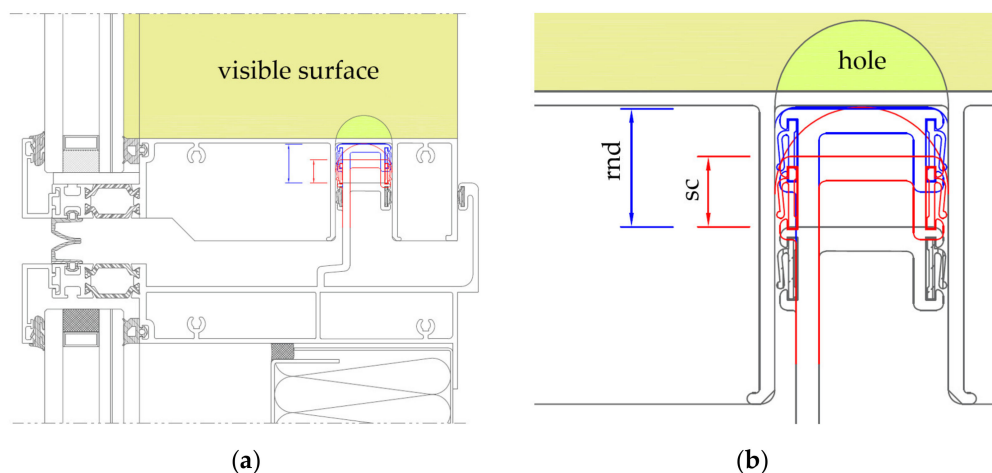
Figure 7. (a) Stack joint; (b) enlarged detail showing the vertical movement capacity.

with the semi-circular notch (red contour in Figure 7). The position of the semi-circular notch would need to be higher to enable the same movement capacity as the rounded notch, but this is not possible, as, in that case, the semi-circular part of the notch would protrude over the horizontal transom and enter the area visible to the user (green hole in Figure 7), leaving it open for the passage of air and water into the building. However, the semi-circular notch was investigated as well for comparison. For test, specimens with a semi-circular notch at a total depth of 67.5 mm were used. Numerical modelling was performed for both semi-circular geometries, at 55 mm and 67.5 mm of the notch depth.

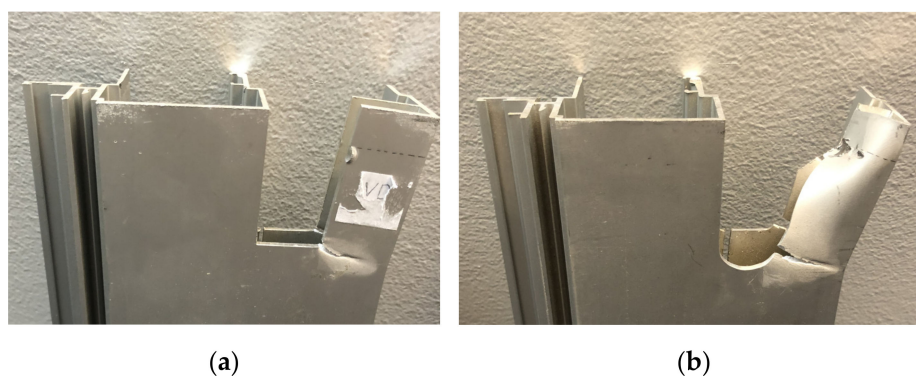
Figure 10. Fracture in monotonic tests: (a) Sharp notch specimen M_N1_1; (b) Semi-circular specimen M_N3.

It should be noted that specimens with the sharp notch (Figure 10a), as expected, had lower breaking forces (6.78 kN and 6.99 kN), which was, on average, 82% of the breaking force for specimens with rounded or semi-circular notches (8.08 kN, 8.61 kN, and 8.45 kN). Since the opening of the notch was measured at the time of the fracture, there was a notable difference for various specimens. This value depended on the mode of the breakage and comprised localized plastic effects; for M_N3, this value was highest as the wall buckled, which can be seen in Figure 10b.

Specimens with the sharp notch failed through the crack at the root of the notch due to the concentration of tensile stress (Figure 10a). Specimens with the rounded or semi-circular notch experienced local buckling of the aluminium wall at the load application point prior to the fracture, so the material at the root of the notch was exposed to the combined stress due to the rotation of the aluminium wall (Figure 10b). The rotation of the aluminium wall was a secondary effect caused by the buckling of the wall, which shifted the application point of the load out of the plane of the wall.

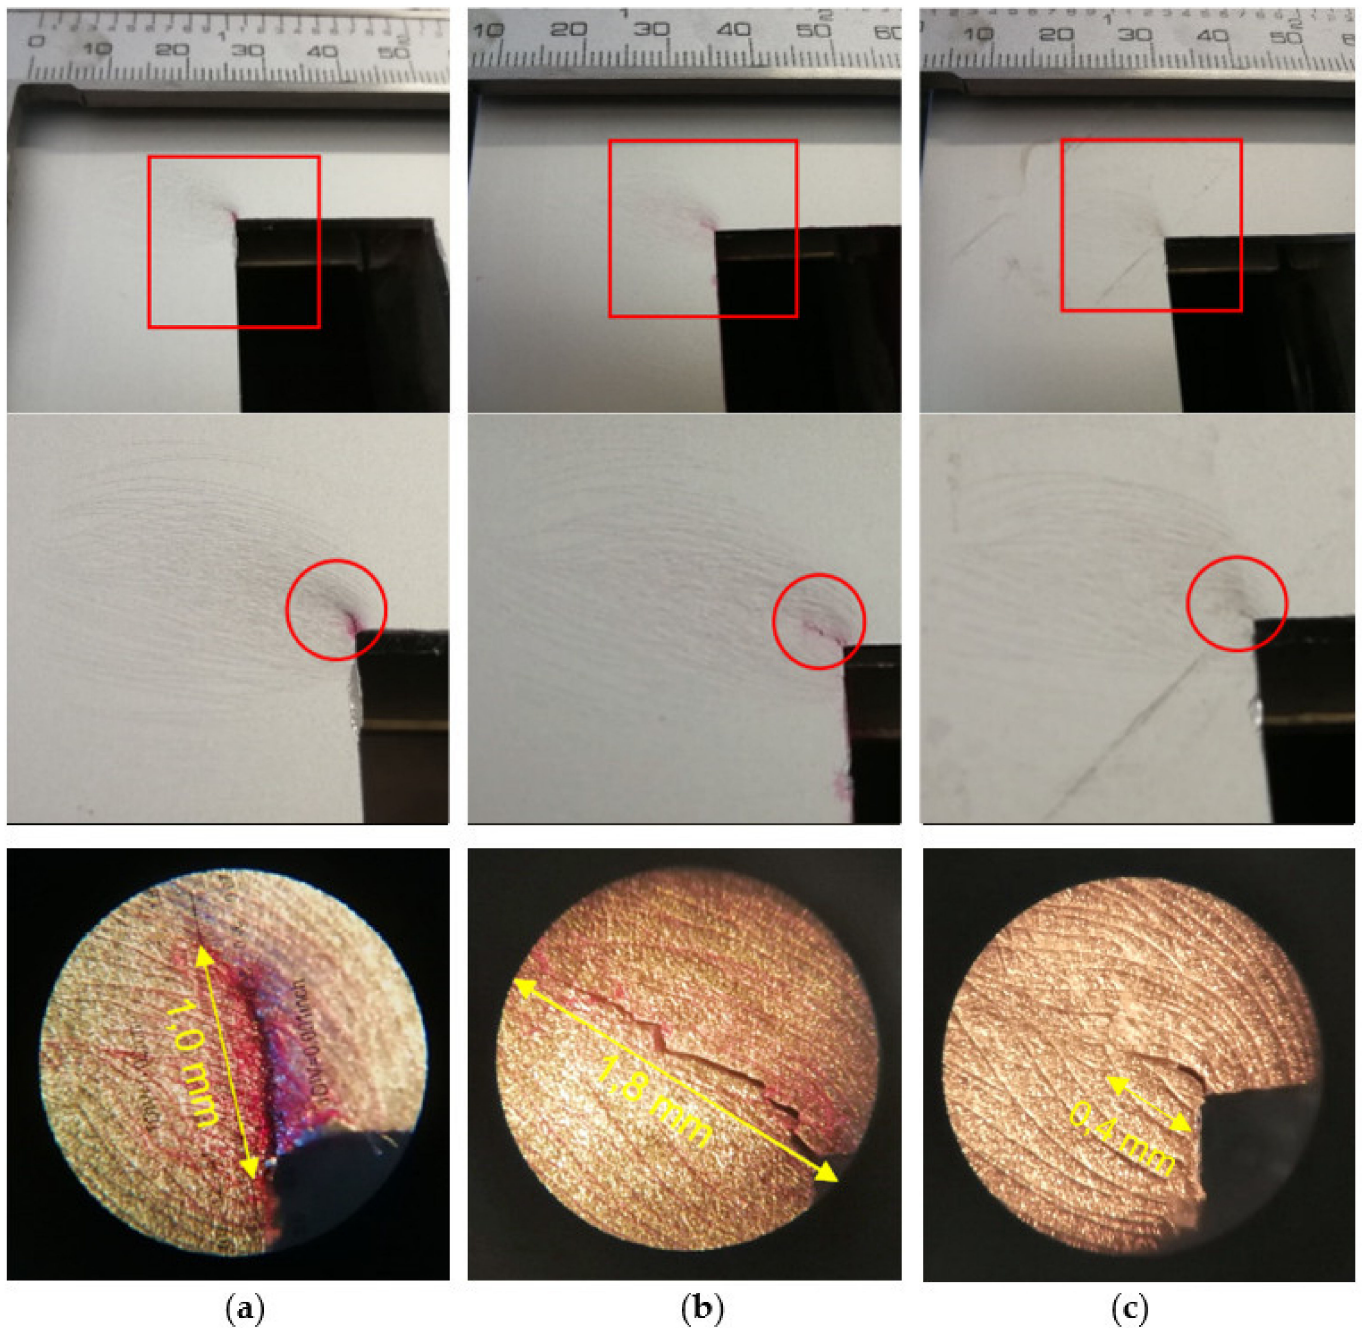
Figure 12. Cracks in specimens with the sharp root: (a) C_N1_1, (b) C_N1_2, (c) C_N1_3.

In all 3 specimens with the sharp root notch (C_N1_1, C_N1_2 and C_N1_3), a crack developed at the root of the notch (Figure 12). The stress concentration during the cyclic loading caused the crack propagating 1–2 mm in the direction bisecting the internal corner of the notch, which was in the range of 35° to 55° . The length of the fracture was measured using a microscope Elcometer 900 graduated $\times 50$. It was not possible to identify the cycle at which the crack appeared nor its propagation rate. The apparent slight differences in the colour of surfaces in Figure 12, enlarged details, are due to the light conditions and to residues from the red liquid penetrant used to emphasise surface irregularities; in fact, all samples had the same surface finish.

In tested specimens with a sharp notch, this behaviour was observed. The nucleation of the crack happened early during the test, but throughout the entire cycling, it remained stable. It is assumed that the crack remained within the plastic zone (Figure 3), and did not grow out of it. This was confirmed by numerical modelling, which showed that the plastic zone was much deeper (20–40 mm) than the length of the cracks, which were experimentally determined in the range of 1–2 mm; see Figure 12.

All specimens with the sharp root notch exhibited full-penetration cracks propagating at 45° for a length of 1–2 mm. The crack geometry was consistent in shape for all 3 specimens. It should be noted that the propagation of cracks was very limited to the vicinity of the sharp internal corner and the length of cracks was lower than the thickness of the aluminium wall (2.5 mm). This indicates that such a situation should remain stable for the duration of the building's design service life and that repeated loading would not result in progressive collapse of such a detail. Thus, specimens with a sharp notch fulfil the requirements for the damage-tolerant design according to [21]. Buildings with such a notch design can be deemed safe for use. This reasoning does not take into account other non-structural performance requirements, such as possible breach of the air barrier, possible water penetration, or aesthetic issues related to such a crack.

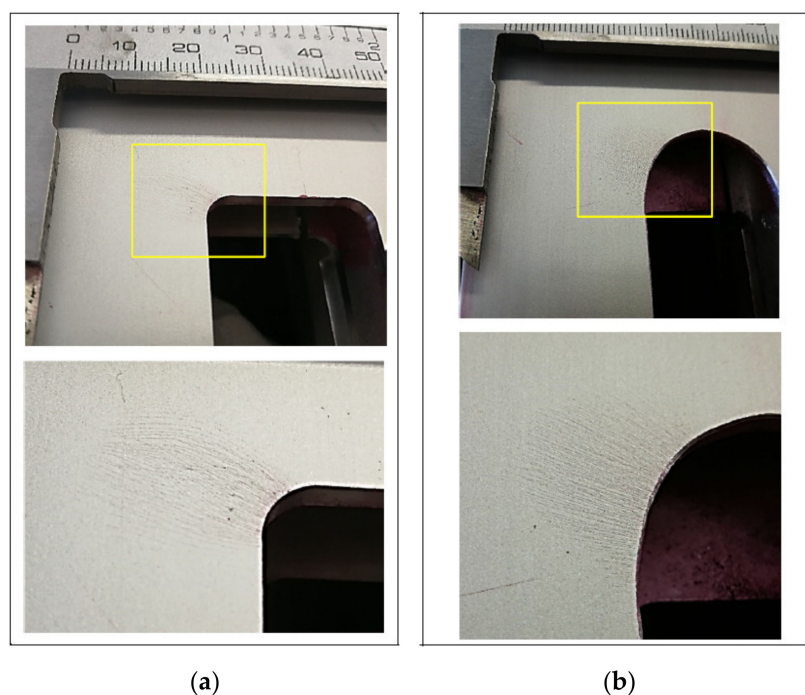
Figure 13. Microcracking of the surface of specimens with the rounded and semi-circular root: (a) C_N2_1; (b) C_N3_1.

Cracking of the specimens with the rounded (Figure 13a) and semi-circular roots (Figure 13b), did not occur. In the zone approximately 20 mm around the crack, a net of microcracks radiating from the internal corner of the notch was visible. It is important to note that all specimen surfaces were anodized with aluminium trioxide, which has a higher modulus of elasticity and higher hardness than the parent material below. For high strains, the anodized surface will crack before the alloy material below. It is not uncommon for anodized surfaces with a thickness of around 30 μm or more to experience microcracking caused by the temperature expansion of the parent material. Such a surface becomes “crazed” with crisscrossing lines. This also happened in this test, but due to the high strain. Microcracks are present only in the surface finish (anodization), while the material below was not cracked, apart from a main crack that grew through the full thickness of the aluminium wall and was observable from both sides of the aluminium wall.

This microcracking of the surface finish was also visible on specimens with rounded roots and with semi-circular roots. However, on these specimens, no cracks in the aluminium alloy wall occurred. The aluminium material around the root of the notch did under-go a yield, observable from the residual deformation, which is approximately 1 mm at the opening of the notch, but without initiating cracks (Figure 13a,b).

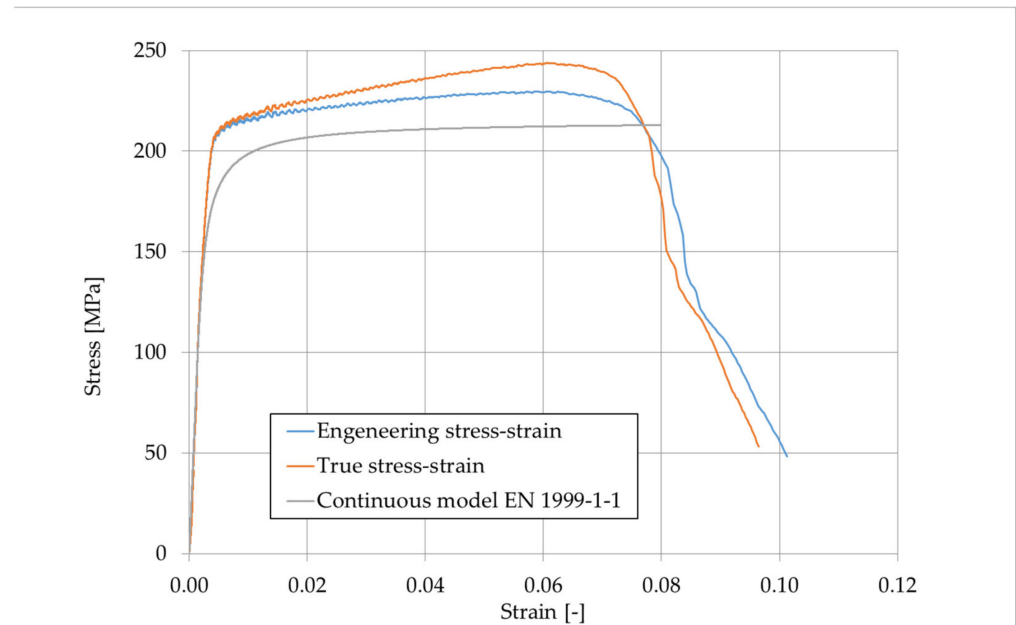
Figure 14. Engineering, true and standardised stress–strain curves for Al1.

Engineering and true stress–strain curves for the dog-bone coupon Al1 are shown on Figure 14. The standardised stress–strain curve for alloy EN AW 6063 T6, defined by [18] (E.2.2.2), is included.

The analysis was performed using material nonlinearity. Two strain–stress curves were used, one true, calculated from tested dog-bone coupon Al1 (chosen, conservatively, for having the lowest strength of all 3 coupons), as per Figure 14, and the other as provided by [18] (E.2.2.2).

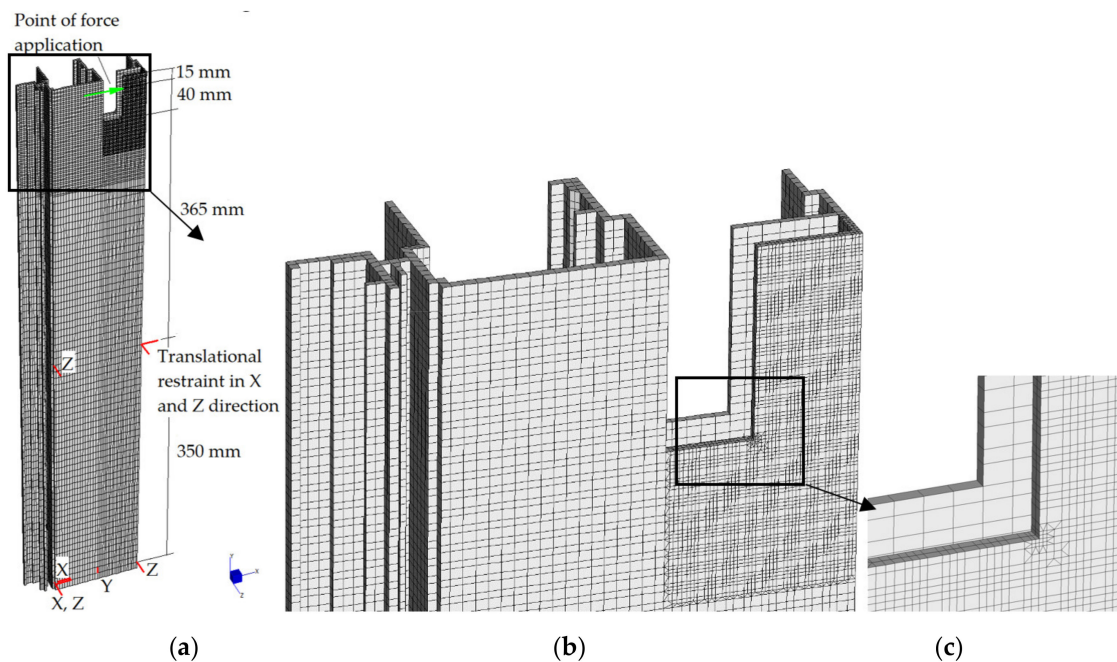
Figure 15. Element mesh: (a) entire model, (b) upper part, and (c) mesh around the root of the notch.

Specimens with all 3 notch geometries were numerically modelled by FEM software Straus7 R2.4.6–Strand7 [19] using solid, 8-node brick elements. The size of elements was 2.5–5 mm, with one element through the thickness of the profile wall (Figure 15a), maintaining the aspect ratio of elements in the zone around the root of the notch higher than 0.4 [20]. In the zone around the notch, the density of the mesh was increased to 2 elements in the thickness of the aluminium wall and the size of the elements was reduced to 0.5–2.5 mm (Figure 15b).

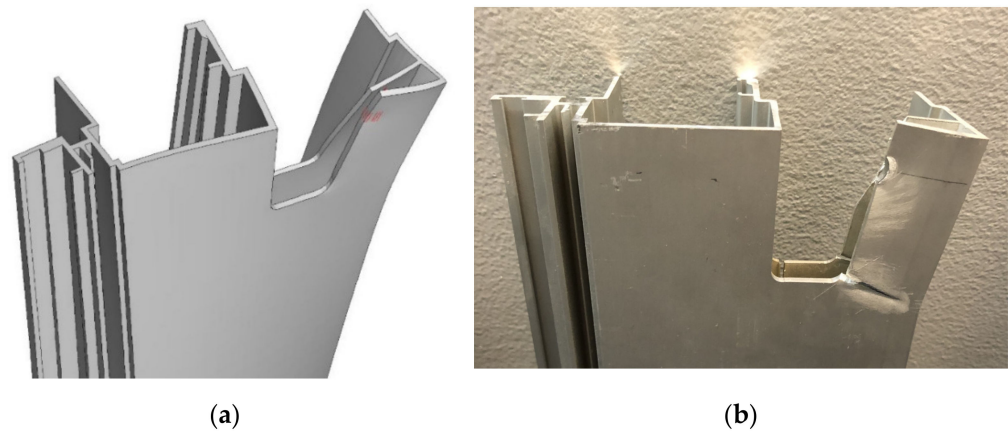
Figure 16. Deformed shape of the specimen N1: (a) numerically and (b) experimentally obtained.

The deformed shape obtained by numerical simulation is shown on Figure 16a, and the deformation of the profile obtained by testing is shown in Figure 16b.

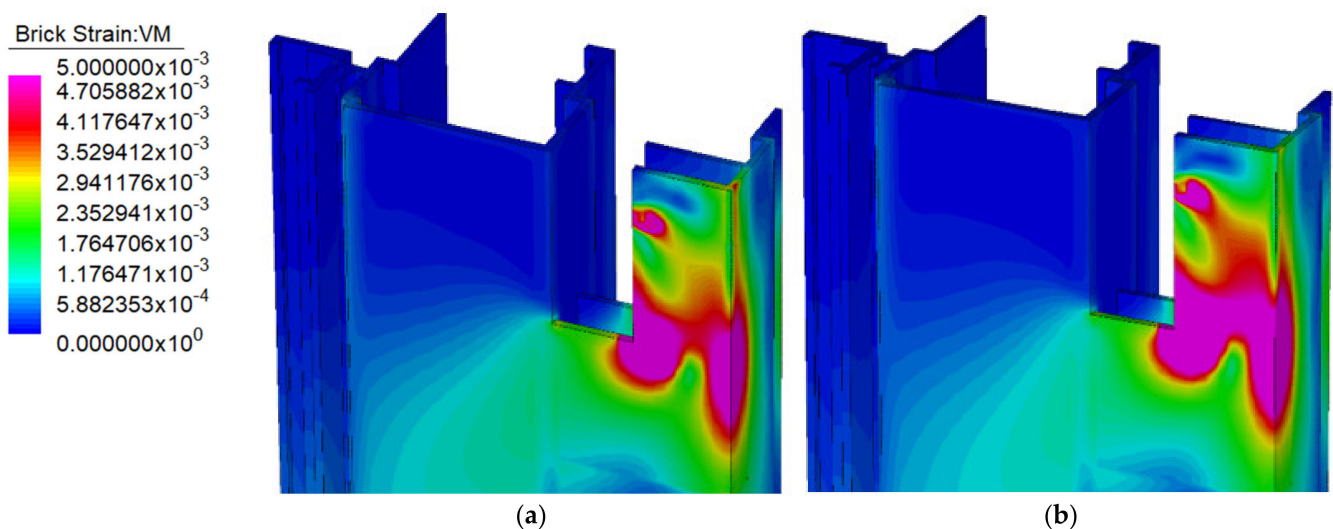
Figure 17. Strain in the model of the sharp notch: (a) True stress–strain curve (coupon A11), load 5.5 kN; (b) standardised stress–strain curve (alloy EN AW 6063 T6), load 5.0 kN.

The highest achieved force for models using the true stress–strain curve was 5.5 kN, and the highest achieved force for models using the standardised stress–strain curve (alloy EN AW 6063 T6) was 5.0 kN. Models of the semi-circular notch at 67.5 mm achieved 0.5 kN less force: 5.0 kN and 4.5 kN. The distribution of the strain for all models is shown in Figures 17–20. The wide area of the yielding can be seen (magenta) around the root of the notch.
