# Fatigue Behaviour of Aluminium Members with Different Notch Root Shapes

Source / Izvornik: **Buildings, 2022, 12**

**Abstract:** In unitised curtain walls, the transfer of horizontal loads, mainly wind loads, from the upper into the lower unit is achieved through the head/notch interlocking connection. Optimisation of the machining process would require a sharp root of the notch, causing an increase in the stress concentration. In order to predict fatigue resistance during design life, the influence of the radius at the root of the notch has been tested in both static and cyclic regimes. The cyclic regime is based on the load history equivalent of 50 years of wind exposure. Numerical simulations on the test assembly have been conducted in order to verify their adequacy for future research on similar issues. The experimental results demonstrated that, for the given specimen shape and alloy, a sharp notch would not lead to premature failure, and such a detail is safe from the purview of damage-tolerant design.

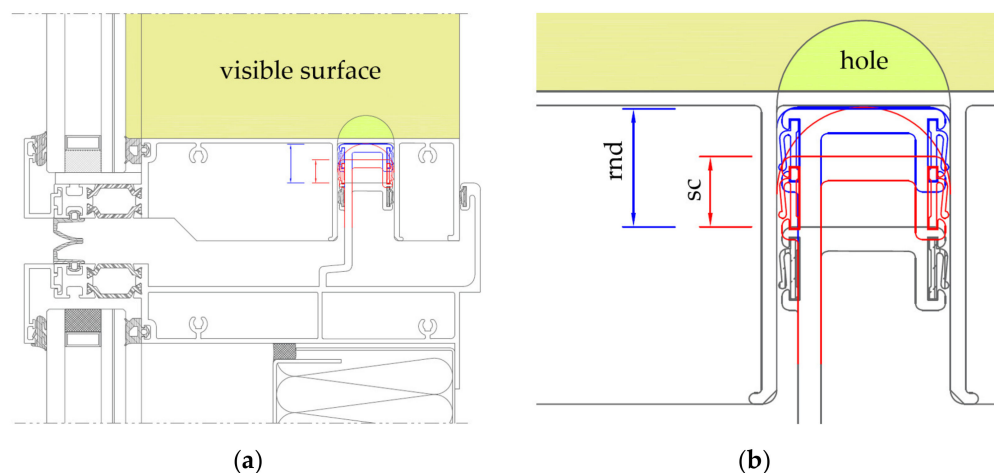
with the semi-circular notch (red contour in Figure 7). The position of the semi-circular notch would need to be higher to enable the same movement capacity as the rounded notch, but this is not possible, as, in that case, the semi-circular part of the notch would protrude over the horizontal transom and enter the area visible to the user (green hole in Figure 7), leaving it open for the passage of air and water into the building. However, the semi-circular notch was investigated as well for comparison. For test, specimens with a semi-circular notch at a total depth of 67.5 mm were used. Numerical modelling was performed for both semi-circular geometries, at 55 mm and 67.5 mm of the notch depth.

**Figure 7.** (a) Stack joint; (b) enlarged detail showing the vertical movement capacity.

It should be noted that the total depth of the semi-circular notch was 67.5 mm, which allowed for a straight length of 55 mm plus a radius of 12.5 mm for the semi-circle. In practice, the semi-circular notch was not used due to geometric constraints. The vertical section through the stack joint between two façade units is shown in Figure 7a. The enlarged detail in Figure 7b shows the vertical movement capacity of the stack joint when the gap between two units closes. The grey chicken head shows the nominal position as-designed. The blue chicken head shows the closed position if the rounded notch was used. The red chicken head shows the closed position if the semi-circular notch was used. It can be observed that the movement capacity of the semi-circular notch (sc) was smaller than that of the rounded notch (rnd), as the movement of the chicken head was limited by the contact

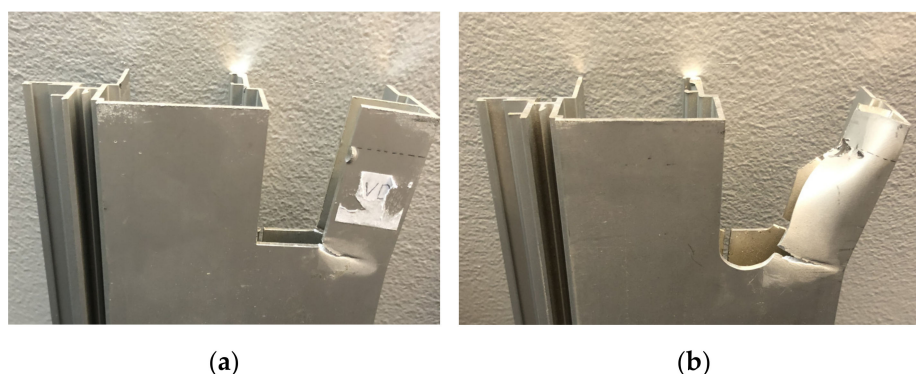
It should be noted that specimens with the sharp notch (Figure 10a), as expected, had lower breaking forces (6.78 kN and 6.99 kN), which was, on average, 82% of the breaking force for specimens with rounded or semi-circular notches (8.08 kN, 8.61 kN, and 8.45 kN). Since the opening of the notch was measured at the time of the fracture, there was a notable difference for various specimens. This value depended on the mode of the breakage and comprised localized plastic effects; for M\_N3, this value was highest as the wall buckled, which can be seen in Figure 10b.

**Figure 10.** Fracture in monotonic tests: (a) Sharp notch specimen M\_N1\_1; (b) Semi-circular specimen M\_N3.

Specimens with the sharp notch failed through the crack at the root of the notch due to the concentration of tensile stress (Figure 10a). Specimens with the rounded or semi-circular notch experienced local buckling of the aluminium wall at the load application point prior to the fracture, so the material at the root of the notch was exposed to the combined stress due to the rotation of the aluminium wall (Figure 10b). The rotation of the aluminium wall was a secondary effect caused by the buckling of the wall, which shifted the application point of the load out of the plane of the wall.
