Fatigue Behaviour of Aluminium Members with Different Notch Root Shapes

Abstract: In unitised curtain walls, the transfer of horizontal loads, mainly wind loads, from the upper into the lower unit is achieved through the head/notch interlocking connection. Optimisation of the machining process would require a sharp root of the notch, causing an increase in the stress concentration. In order to predict fatigue resistance during design life, the influence of the radius at the root of the notch has been tested in both static and cyclic regimes. The cyclic regime is based on the load history equivalent of 50 years of wind exposure. Numerical simulations on the test assembly have been conducted in order to verify their adequacy for future research on similar issues. The experimental results demonstrated that, for the given specimen shape and alloy, a sharp notch would not lead to premature failure, and such a detail is safe from the purview of damage-tolerant design.

Keywords: notch; aluminium profile; fatigue; wind action; stress concentration; unitised curtain wall

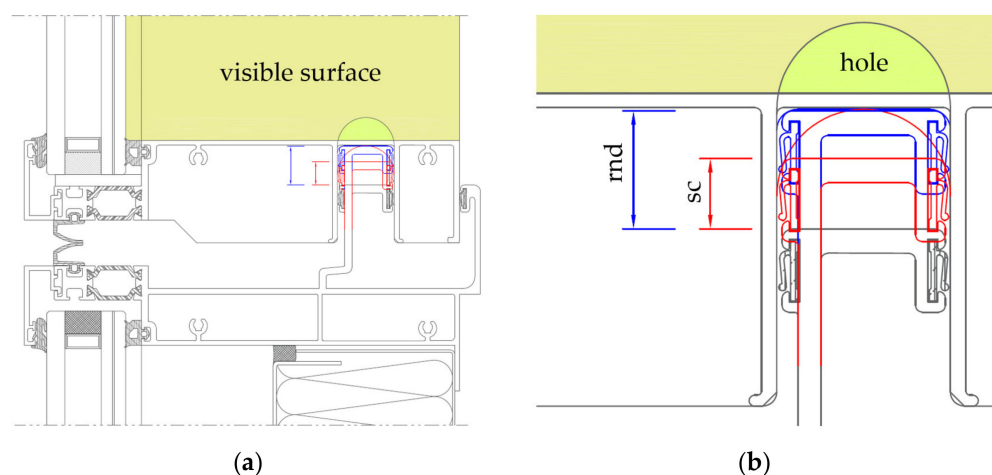
with the semi-circular notch (red contour in Figure 7). The position of the semi-circular notch would need to be higher to enable the same movement capacity as the rounded notch, but this is not possible, as, in that case, the semi-circular part of the notch would protrude over the horizontal transom and enter the area visible to the user (green hole in Figure 7), leaving it open for the passage of air and water into the building. However, the semi-circular notch was investigated as well for comparison. For test, specimens with a semi-circular notch at a total depth of 67.5 mm were used. Numerical modelling was performed for both semi-circular geometries, at 55 mm and 67.5 mm of the notch depth.

Figure 7. (a) Stack joint; (b) enlarged detail showing the vertical movement capacity.

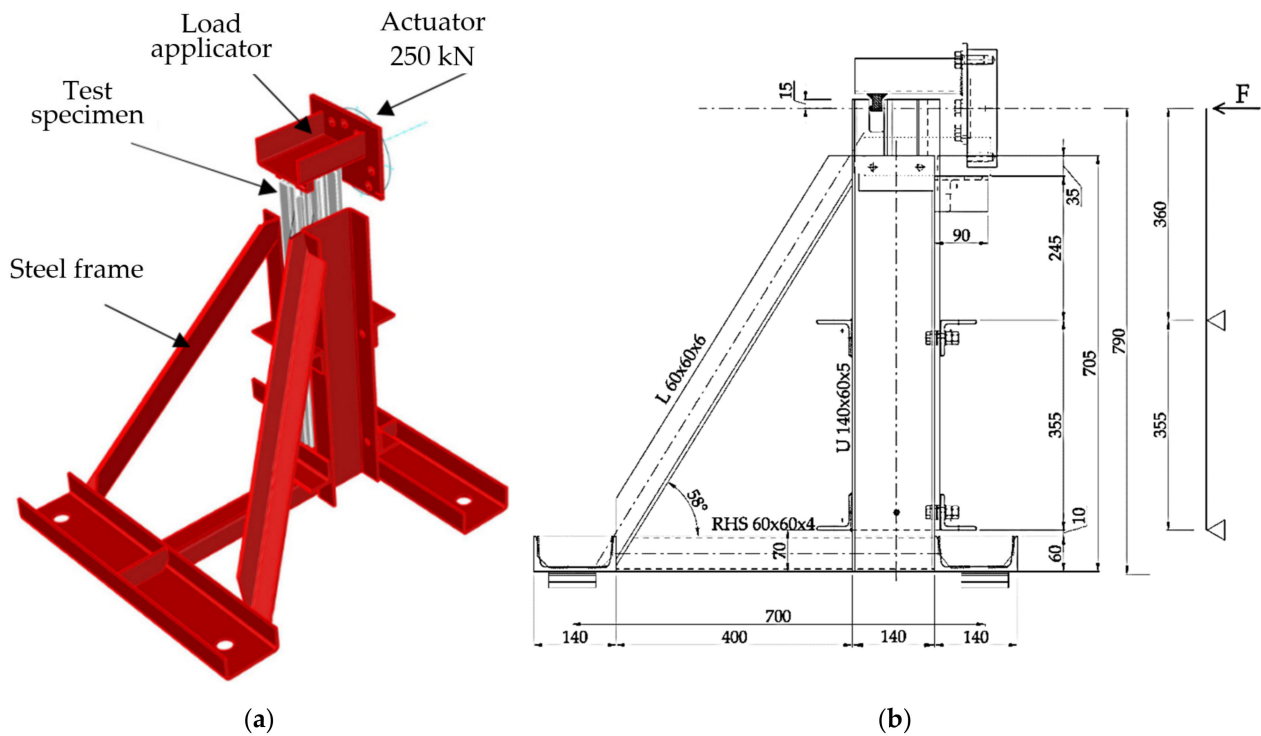
The specimen was held in the steel frame (Figure 8b) at two points 355 mm apart, and the horizontal load F was applied at the top end of the profile (Figure 8a).

The point of application for load F was 15 mm below the top end of the profile, forming a 360 mm structural cantilever. The tests were conducted by gradually increasing the applied load under displacement control of the actuator at a constant speed of 0.025 mm/s until the specimen fractured.

Figure 8. (a) Test setup; (b) test frame and the structural system (mm).

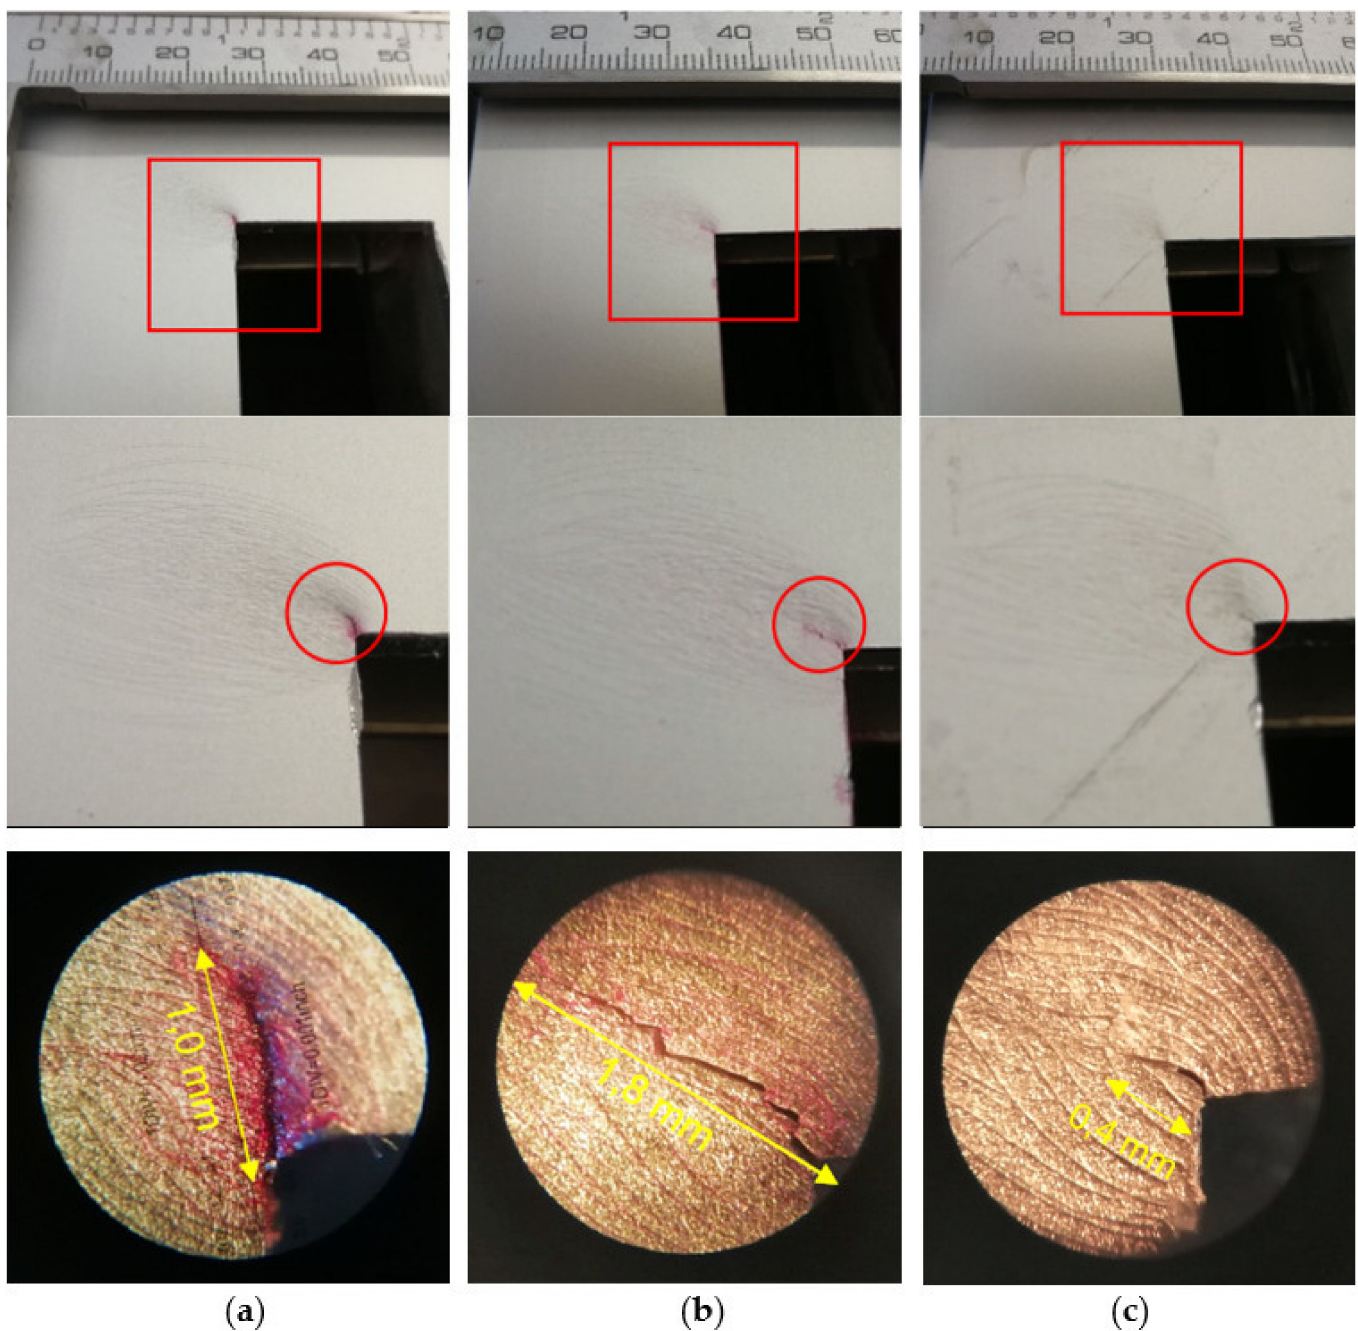
In all 3 specimens with the sharp root notch (C_N1_1, C_N1_2 and C_N1_3), a crack developed at the root of the notch (Figure 12). The stress concentration during the cyclic loading caused the crack propagating 1–2 mm in the direction bisecting the internal corner of the notch, which was in the range of 35° to 55° . The length of the fracture was measured using a microscope Elcometer 900 graduated $\times 50$. It was not possible to identify the cycle at which the crack appeared nor its propagation rate. The apparent slight differences in the colour of surfaces in Figure 12, enlarged details, are due to the light conditions and to residues from the red liquid penetrant used to emphasise surface irregularities; in fact, all samples had the same surface finish.

Figure 12. Cracks in specimens with the sharp root: (a) C_N1_1, (b) C_N1_2, (c) C_N1_3.

In tested specimens with a sharp notch, this behaviour was observed. The nucleation of the crack happened early during the test, but throughout the entire cycling, it remained stable. It is assumed that the crack remained within the plastic zone (Figure 3), and did not grow out of it. This was confirmed by numerical modelling, which showed that the plastic zone was much deeper (20–40 mm) than the length of the cracks, which were experimentally determined in the range of 1–2 mm; see Figure 12.

All specimens with the sharp root notch exhibited full-penetration cracks propagating at 45° for a length of 1–2 mm. The crack geometry was consistent in shape for all 3 specimens. It should be noted that the propagation of cracks was very limited to the vicinity of the sharp internal corner and the length of cracks was lower than the thickness of the aluminium wall (2.5 mm). This indicates that such a situation should remain stable for the duration of the building's design service life and that repeated loading would not result in progressive collapse of such a detail. Thus, specimens with a sharp notch fulfil the requirements for the damage-tolerant design according to [21]. Buildings with such a notch design can be deemed safe for use. This reasoning does not take into account other non-structural performance requirements, such as possible breach of the air barrier, possible water penetration, or aesthetical issues related to such a crack.

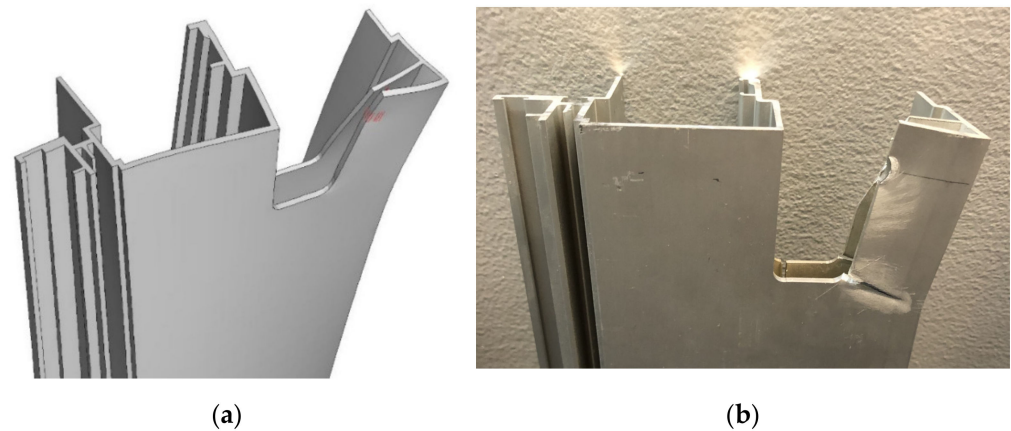
The deformed shape obtained by numerical simulation is shown on Figure 16a, and the deformation of the profile obtained by testing is shown in Figure 16b.

Figure 16. Deformed shape of the specimen N1: (a) numerically and (b) experimentally obtained.

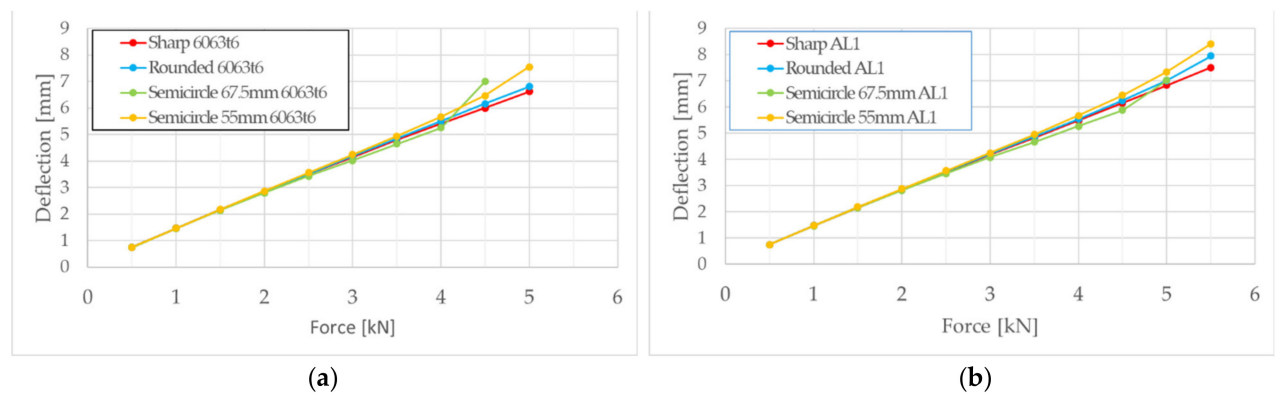
Figure 22. Deflection-force curves for the (a) nominal and (b) true stress–strain curves.
