# Fatigue Behaviour of Aluminium Members with Different Notch Root Shapes

Source / Izvornik: **Buildings, 2022, 12**

**Keywords:** notch; aluminium profile; fatigue; wind action; stress concentration; unitised curtain wall

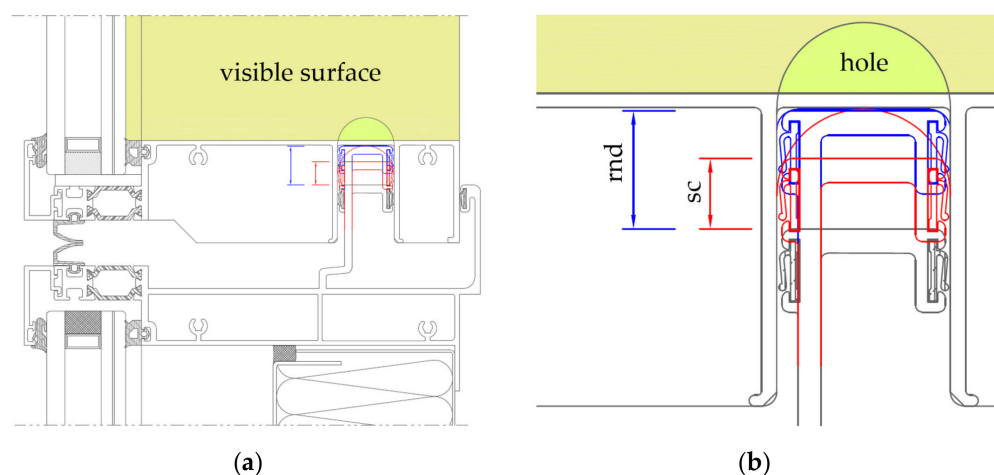
**Figure 7.** (a) Stack joint; (b) enlarged detail showing the vertical movement capacity.

It should be noted that the total depth of the semi-circular notch was 67.5 mm, which allowed for a straight length of 55 mm plus a radius of 12.5 mm for the semi-circle. In practice, the semi-circular notch was not used due to geometric constraints. The vertical section through the stack joint between two façade units is shown in Figure 7a. The enlarged detail in Figure 7b shows the vertical movement capacity of the stack joint when the gap between two units closes. The grey chicken head shows the nominal position as-designed. The blue chicken head shows the closed position if the rounded notch was used. The red chicken head shows the closed position if the semi-circular notch was used. It can be observed that the movement capacity of the semi-circular notch (sc) was smaller than that of the rounded notch (rnd), as the movement of the chicken head was limited by the contact

with the semi-circular notch (red contour in Figure 7). The position of the semi-circular notch would need to be higher to enable the same movement capacity as the rounded notch, but this is not possible, as, in that case, the semi-circular part of the notch would protrude over the horizontal transom and enter the area visible to the user (green hole in Figure 7), leaving it open for the passage of air and water into the building. However, the semi-circular notch was investigated as well for comparison. For test, specimens with a semi-circular notch at a total depth of 67.5 mm were used. Numerical modelling was performed for both semi-circular geometries, at 55 mm and 67.5 mm of the notch depth.
