Fatigue Behaviour of Aluminium Members with Different Notch Root Shapes

Source / Izvornik: **Buildings, 2022, 12**

Keywords: notch; aluminium profile; fatigue; wind action; stress concentration; unitised curtain wall

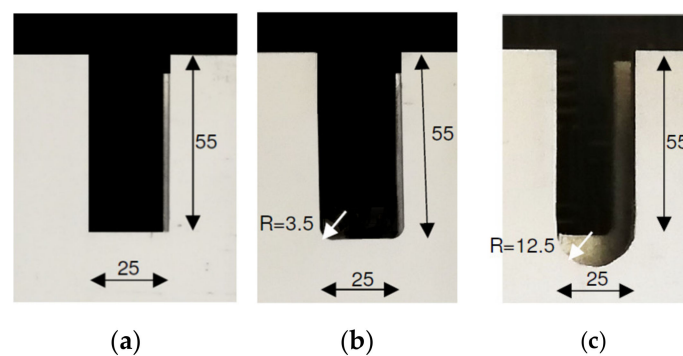
Figure 6. Geometry of the (a) sharp notch, N1, (b) rounded notch, N2, and (c) semi-circular notch (mm).

The geometry of the notches is shown in Figure 6. The width of the notch was 25 mm, which enabled a close fit of the chicken head. The depth of the notch was 55 mm. This enabled ± 20 mm of vertical movement in the stack joint.

It should be noted that the total depth of the semi-circular notch was 67.5 mm, which allowed for a straight length of 55 mm plus a radius of 12.5 mm for the semi-circle. In practice, the semi-circular notch was not used due to geometric constraints. The vertical section through the stack joint between two façade units is shown in Figure 7a. The enlarged detail in Figure 7b shows the vertical movement capacity of the stack joint when the gap between two units closes. The grey chicken head shows the nominal position as-designed. The blue chicken head shows the closed position if the rounded notch was used. The red chicken head shows the closed position if the semi-circular notch was used. It can be observed that the movement capacity of the semi-circular notch (sc) was smaller than that of the rounded notch (rnd), as the movement of the chicken head was limited by the contact
