Large gravitational collapse structure on a rocky coast (Kvarner, NE Adriatic Sea)

Source / Izvornik: **Geologia Croatica, 2023, 76, 105 - 112**

Čedomir Benac¹, Sanja Dugonjić Jovančević¹, Dražen Navratil², Andrea Tadić¹ and Lovro Maglić³

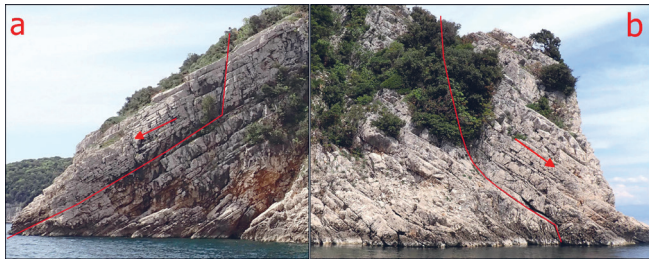
Figure 5. Structural interpretation of a possible slide in layered Upper Cretaceous limestones: a) south side, b) north side. Both red arrows are oriented to the east.

Rock mass surrounding the rock collapse consists of the Upper Cretaceous rudist limestones. The limestones show a distinct layering, with bedding planes uniformly inclined to the southeast with a dip angle of 28°. The layers are 10 to 100 cm thick. In addition to bedding planes, vertical or oblique fissures are also visible. This kind of structural fabric can favour the collapse of both sides of the described collapse structure (Figures 5a and 5b).

driven waves, discontinuities likely serve as initial patterns for the development of instability. Discontinuities that are diagonal to bedding planes, and discontinuity planes with dip vectors that form an oblique dihedral angle with the bedding planes dip vector, both contribute significantly to the development of instability. The aforementioned discontinuities are more persistent than others and run transverse to the bedding plane (Figure 5).

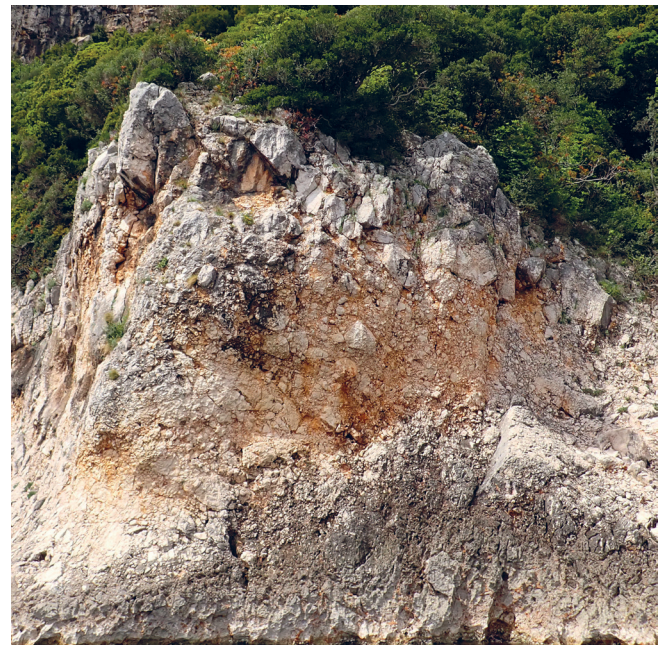
Figure 6. Cataclastic breccia in collapse structure (Photo: Č. Benac).

The rock mass in the collapse structure consists of cataclastic breccias. The size of the angular fragments ranges from a few centimetres to blocks over one metre in diameter. The matrix consists of calcitic reddish clay (Figure 6).
