Large gravitational collapse structure on a rocky coast (Kvarner, NE Adriatic Sea)

Source / Izvornik: **Geologia Croatica, 2023, 76, 105 - 112**

Journal article, Published version

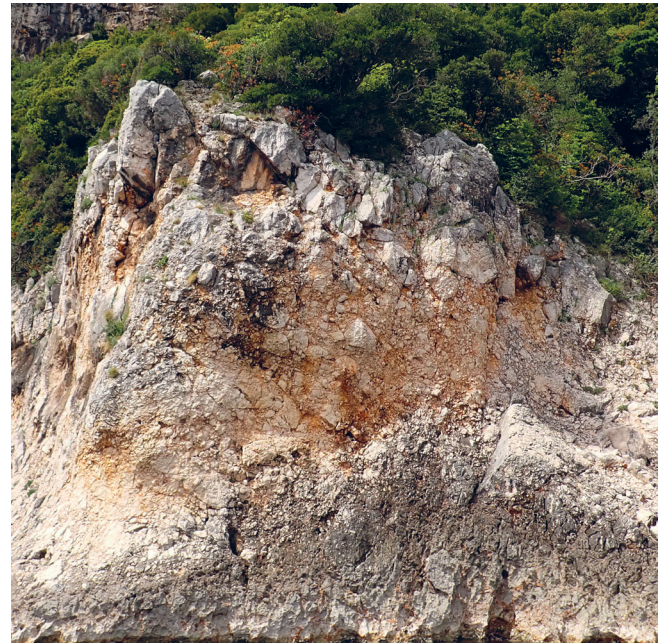
Figure 6. Cataclastic breccia in collapse structure (Photo: Č. Benac).

The rock mass in the collapse structure consists of cataclastic breccias. The size of the angular fragments ranges from a few centimetres to blocks over one metre in diameter. The matrix consists of calcitic reddish clay (Figure 6).
