Large gravitational collapse structure on a rocky coast (Kvarner, NE Adriatic Sea)

Source / Izvornik: **Geologia Croatica, 2023, 76, 105 - 112**

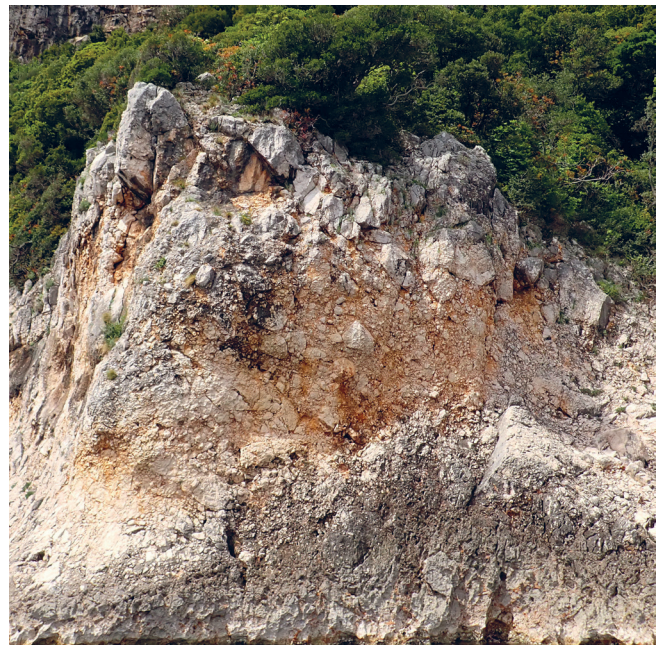
Figure 6. Cataclastic breccia in collapse structure (Photo: Č. Benac).

The rock mass in the collapse structure consists of cataclastic breccias. The size of the angular fragments ranges from a few centimetres to blocks over one metre in diameter. The matrix consists of calcitic reddish clay (Figure 6).
