Geotechnical Study of Raspadalica Cliff Rockfall, Croatia

Source / Izvornik: **Applied Sciences, 2022, 12**

Abstract: The Raspadalica Cliff is an almost vertical 100 m high limestone cliff with a railway line at its foot and is known for numerous rockfall occurrences in the past. This article presents the results of the geotechnical study of the cliff based on a traditional geological and geotechnical field survey and remote sensing analysis. Both the traditional geological and geotechnical field survey and remote sensing surveys and analyses enabled the establishment of the structural model of the Raspadalica Cliff and the determination of the discontinuity sets and discontinuity features, such as orientation, spacing, persistence, roughness, discontinuity wall strength, aperture, degree of weathering of discontinuity wall, seepage conditions, and the presence and hardness of discontinuity filling. Kinematic analyses were performed on five cliff zones with slightly different structural features, indicating a relatively low probability of typical failures in the cliff rock mass that precede the rockfall occurrences. Although rockfall phenomena from the cliff face are relatively f

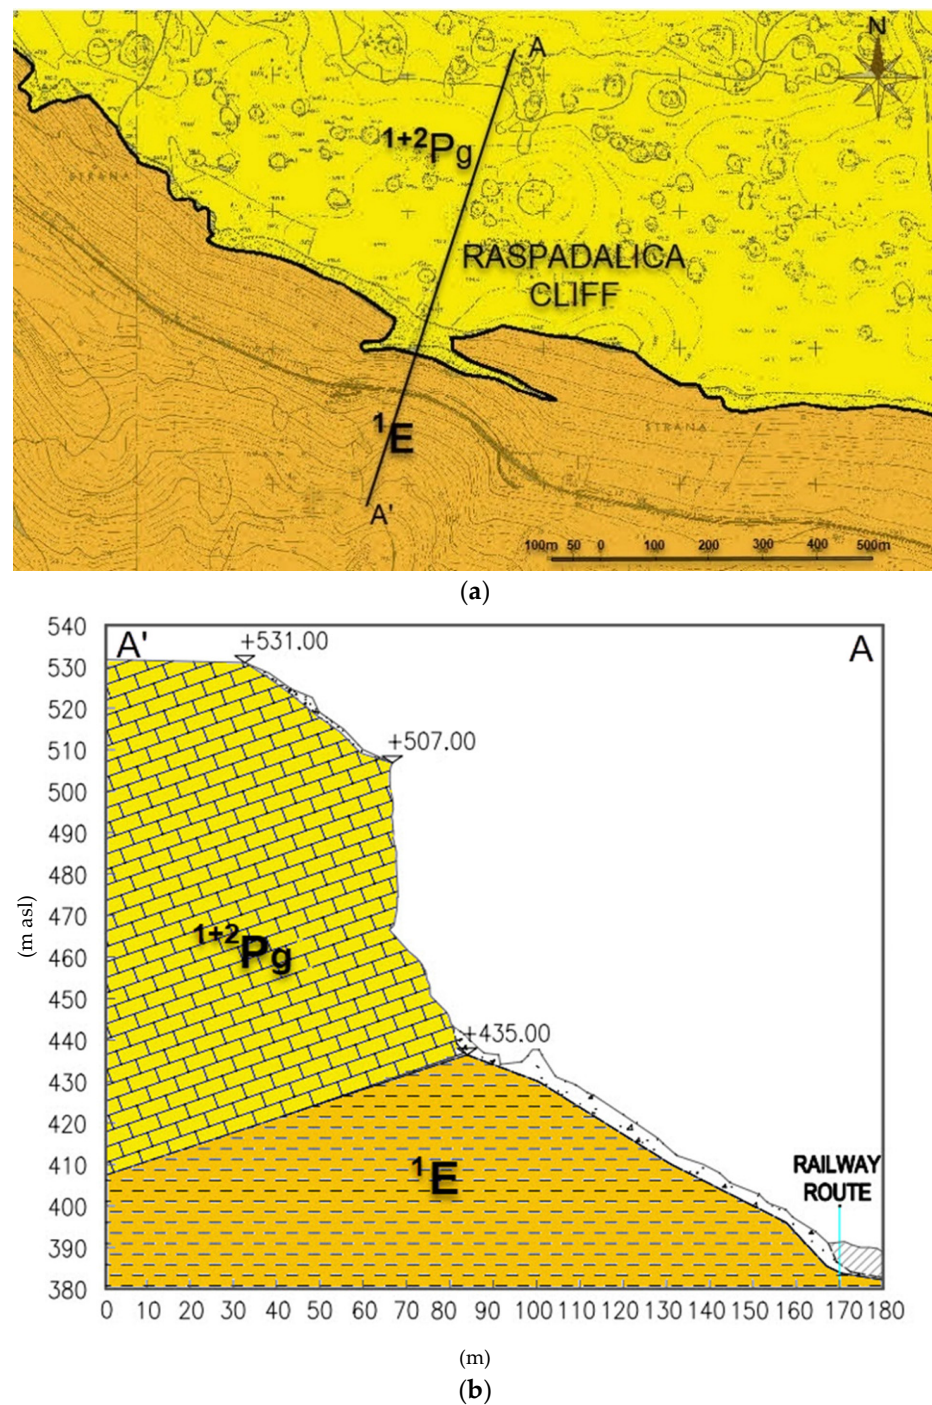
The Raspadalica Cliff is a part of the Ćićarija Mountain Range, built of Paleogene limestone, and the contact between the limestone rock mass of the cliff and the flysch rock complex in the lower part of the slope is a reverse fault dipping ~23 degrees towards the NE (Figures 3 and 4). The limestone mass is homogeneous, fine-grained, and well stratified. The thickness of beds ranges from 10 cm to 2 m with several interlayers of coal of several centimeters in thickness. The general dip of the bedding planes is relatively favorable for stability of the cliff and inclined toward the slope, with minor variations along the cliff. A detailed description of the geotechnical model of the cliff is described in the following sections.

Figure 4. Geological map of the Raspadalica Cliff (a) and marked schematic cross-section (A–A'): (b). Overthrust limestone Lower and Middle Paleogene rock mass (^{1+2}Pg) lies on Lower Eocene flysch deposits (1E). The flysch deposits are covered with talus material originating from a limestone cliff [12].

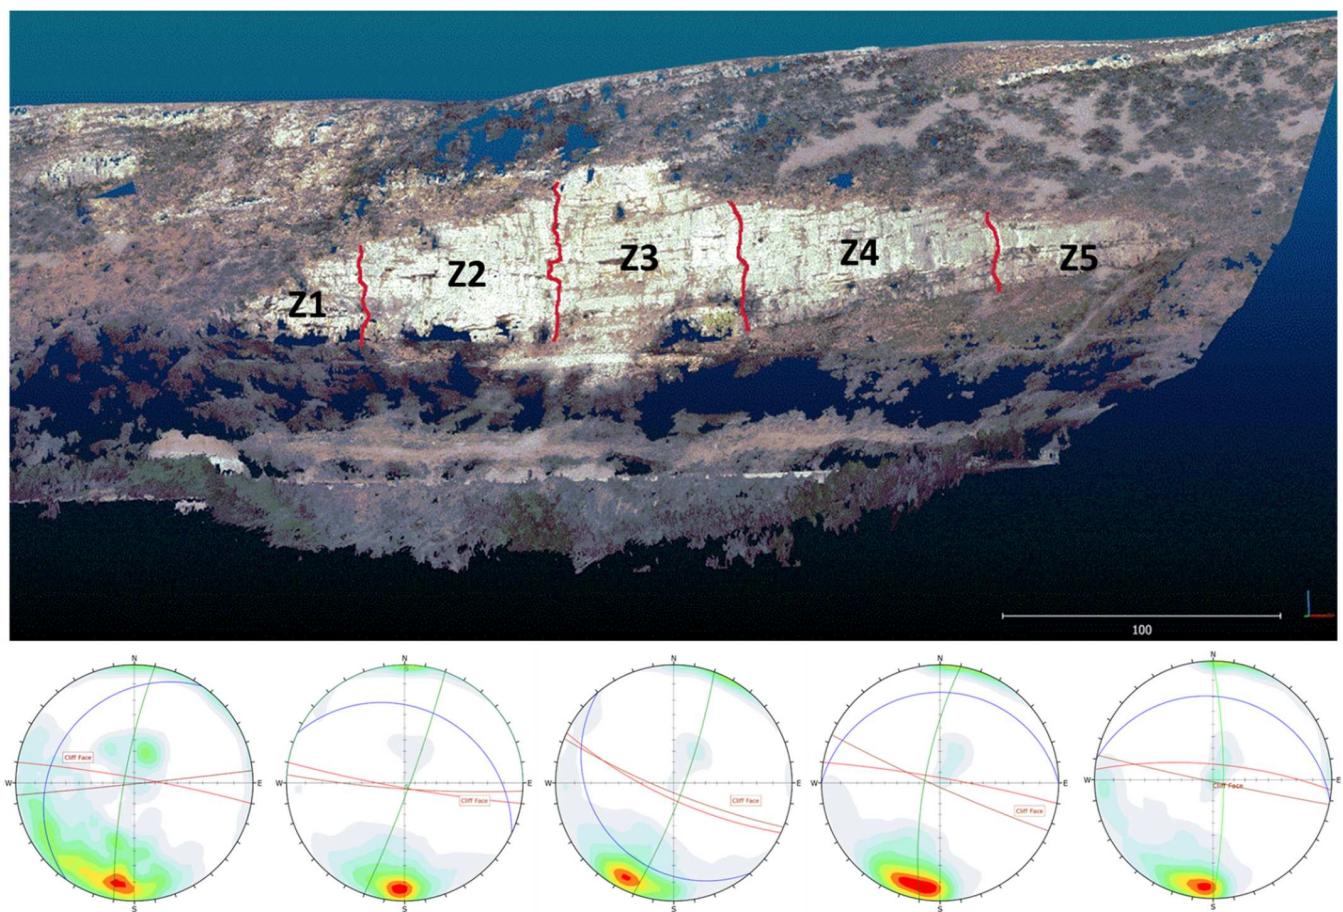
The *Cloud Compare* software [92] was employed to identify discontinuity sets and their dips and dip orientations. The cliff face was divided into five zones (Figure 7), and for each segmented zone extraction of joint planes and bedding using the *Cloud Compare Facet* plugin [45,63] (Fast Marching procedure) was completed to identify their orientations (dip directions and dips). An equal area projection was used in the presentations of the joint data. Since most of the discontinuity planes belong to the joint set that is quasi-parallel to the cliff face (Joint Set 1), and the other two are nearly perpendicular and rarely exposed the joint sets (Joint Set 2 and bedding) could not be clearly recognized using the *Facet* plugin, the *Cloud Compare Compass* plugin [92] was employed to measure the joint surface orientations of the main joint sets (Figure 9).

Figure 7. The 3D HR Point Cloud of the Raspadalica Cliff divided into five zones. For each zone the stereograph presentation of the main discontinuity sets (mean value) and orientation of the average cliff slope is presented. The concentration of plane poles quasi-parallel to cliff face is visible on each stereogram (from white (cold) with no or several poles to (hot) with high concentration of poles). Red is transversal of the average cliff face, other represent transversals of joint sets.

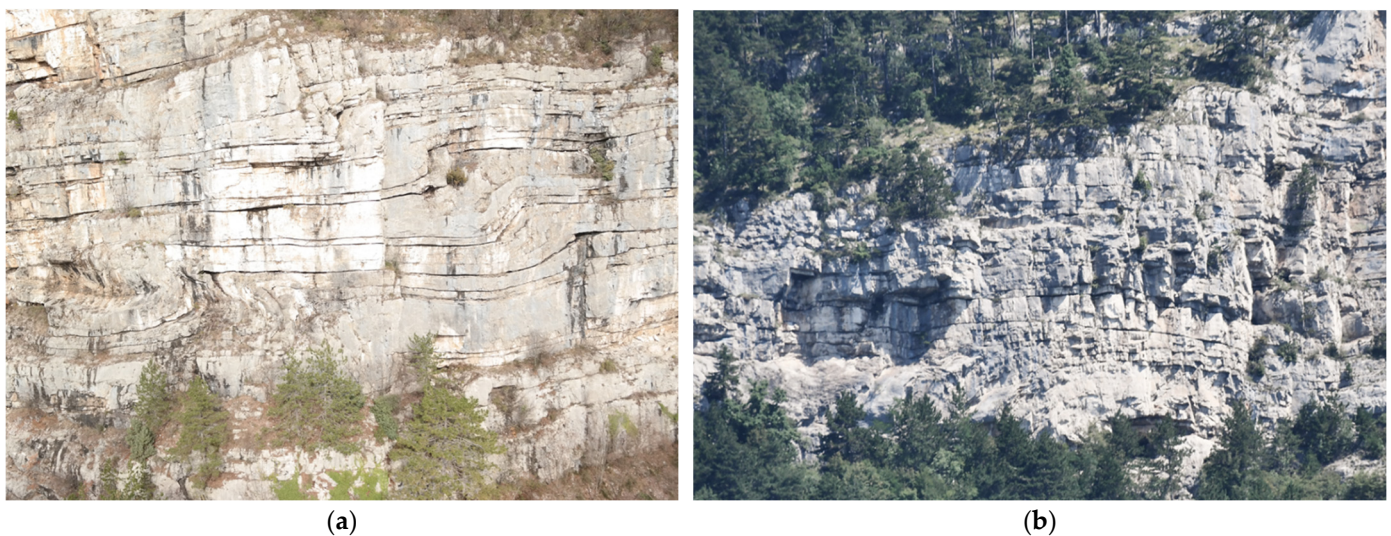
The folding in the rock mass structure is identified during the field investigation and two folds within the cliff were identified: one fold is visible along the face of the cliff, while the other is locally visible at the location of drop blocks in the west part of the cliff (Figure 8). The folds in the eastern part (in Zones Z3 and Z4) are monocline type of fold and beds lying at two different levels and quasi-horizontal (Figure 8a, left down). In the western part of the cliff, in area of zone Z2, the remains of the anticline fold are visible; a limb of lower beds are exposed while the upper rock material collapsed in historical toppling processes (Figure 8b). This anticline fold was formed by bending due to the deformations of the lower, relatively weaker Lower Eocene flysch deposits.

Figure 8. Folds identified at the Raspadalica Cliff face: (a) monocline type of fold (middle part) and horizontal inclined fold (left down) in the eastern part (in Zones Z3 and Z4); (b) the remains of the anticline fold western part of the cliff, in area of zone Z2 in the lower part of the figure.

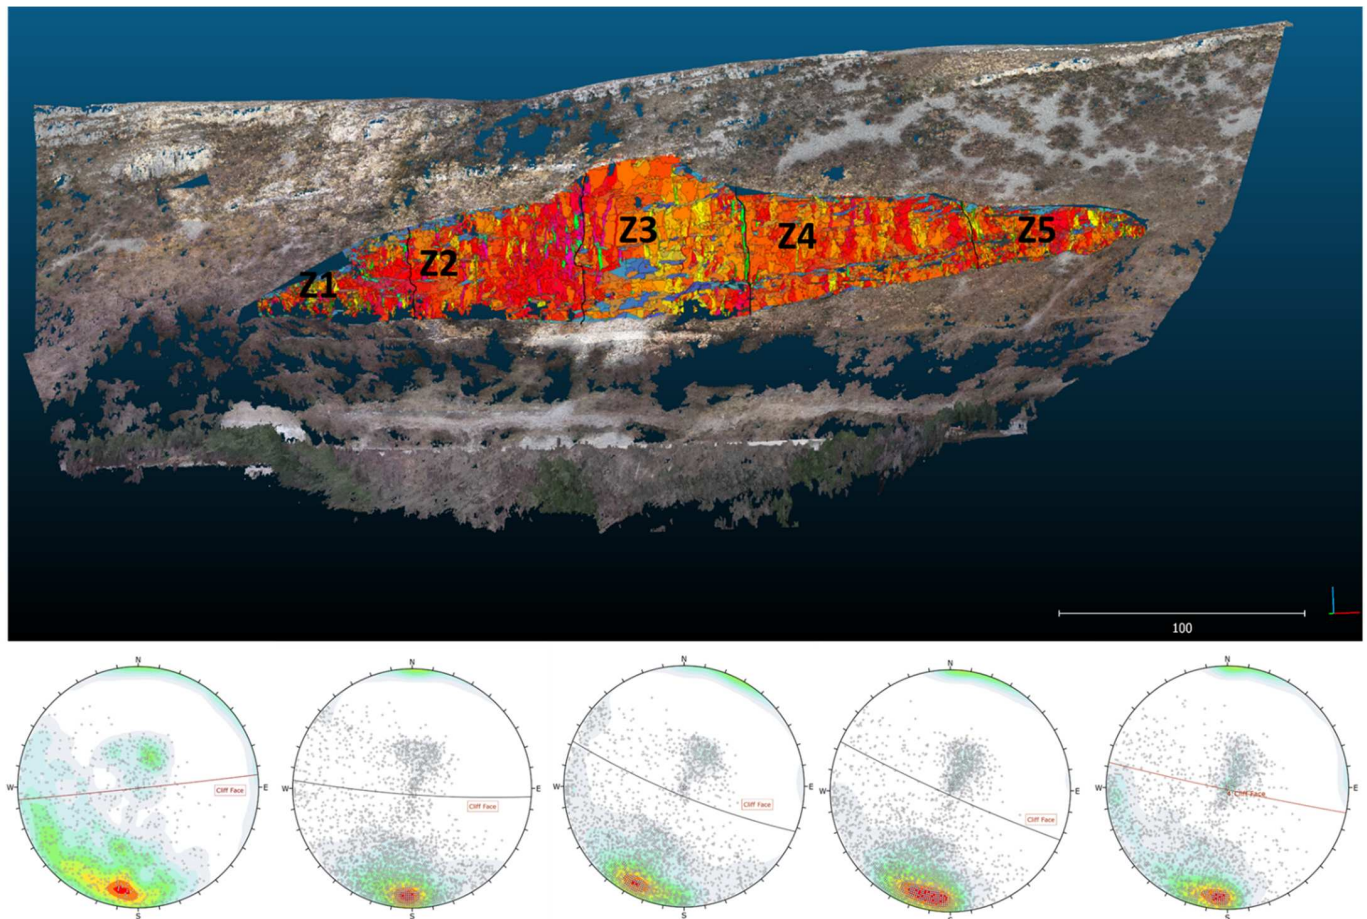
Figure 9. Three-dimensional HR Point Cloud of the Raspadalica Cliff with extracted facets using the *Cloud Compare Facet* plugin [43,61] (Fast Marching procedure). Orange and red to cyan facets represent Joint Set 1, parallel with the cliff face; green to yellow facets represent Joint Set 2, almost orthogonal to Joint Set 1; and blue facets represent Joint Set 3 (bedding).
