# Ties in unreinforced masonry structures: Case study in Krk

Conference presentation / Izlaganje na skupu

## TIES IN UNREINFORCED MASONRY STRUCTURES: CASE STUDY IN KRK

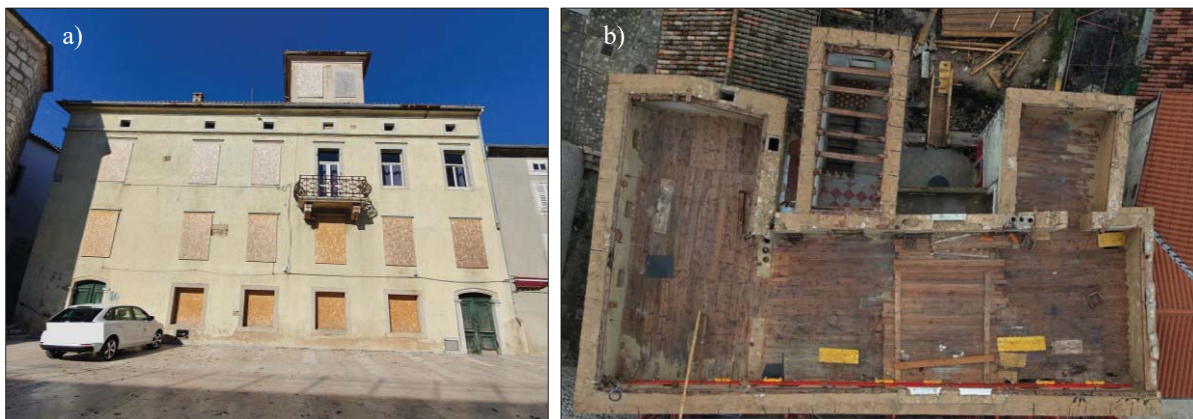
Figure 1. a) Front façade; b) Building plan at the roof level [6].

It consists of a ground floor, two storeys and an attic, with approximate floor plan dimensions 20 x 12,5 m. The height of the roof cornice is around 10 m. It has an almost symmetrical arrangement of the openings on the front façade (Fig. 1a); the windows are rather large and extend over almost the entire floor (except on the attic).

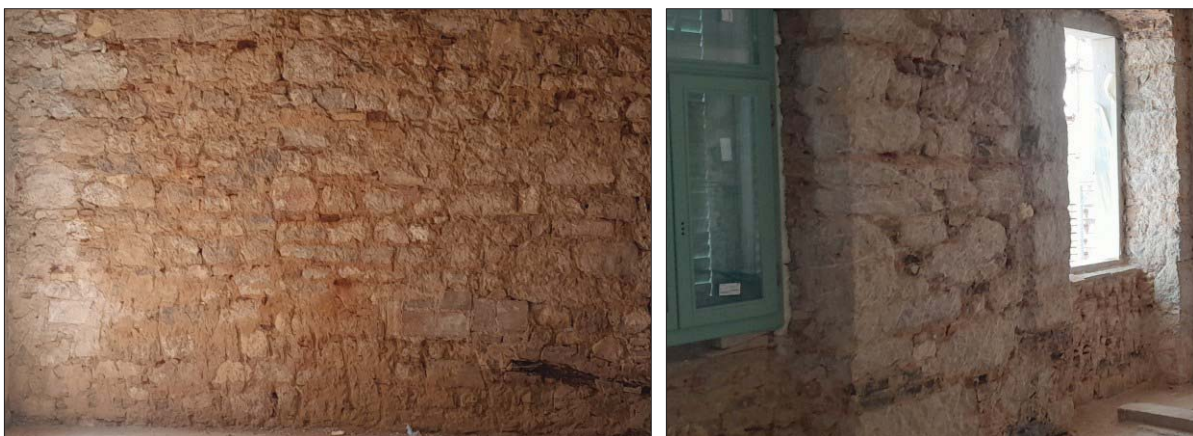
Figure 2. Masonry typology.

The floor structures are made of timber beams and boards, as common in this region, while the roof structure is a king-post, covered with tiles. The walls may be categorized into rubble stone masonry (wall thickness 65 cm), though some later added walls are built of brick. The stone blocks are mostly of the same size, with considerably larger dimensions at the corners or at the openings (Fig. 2)

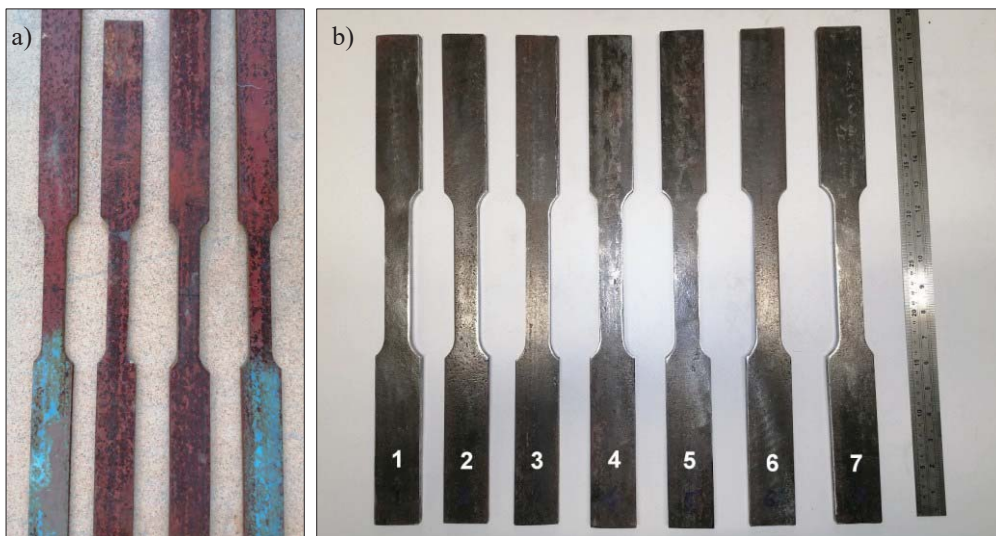
Figure 10. Preparation of specimens: a) after waterjet cutting; b) after sanding.

Testing specimens were prepared by waterjet cutting, using a high-pressure jet of a mixture of water and an abrasive substance (Fig. 10). This cutting method was selected because it does not heat the metal,

which is preferable since exposure to high temperatures can change its characteristics. According to [15] it is possible to test specimens as-manufactured (without the cross-section reduction), but there is a possibility that the fracture may then occur outside the extensometer length. The surface of the specimens was additionally sanded with an 80 grit flap disc to remove the rust and old paint.

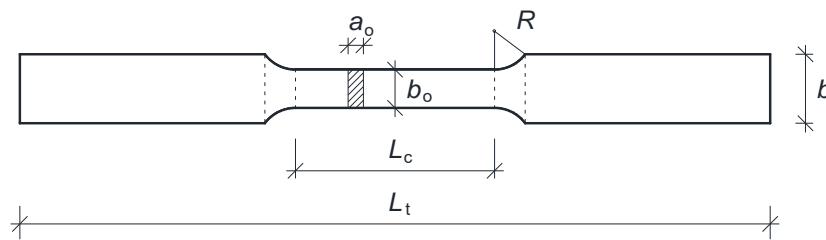
Figure 11. Specimen details.

The dimensions of the specimens have been selected to match the so-called proportional specimens [15], in which the gauge length  $L_o$  is in direct relationship with the cross-sectional area by the equation  $L_o = 5,65 \cdot (a_o \cdot b_o)^{1/2}$ . However, since the thickness of the specimens after sanding  $a_o$  varied from 8,1 to 12,1 mm (i.e. the gauge length would be different for each specimen), due to the ease of testing it was decided to adopt the extensometer gauge length  $L_c$  equal to 100 mm (corresponding to the specimen with the largest thickness) for all specimens. A transition radius  $R$  of 25 mm was selected between the gripped ends and the parallel (reduced) length (Fig. 11). The following symbols are used:  $L_t$  – specimen length ( $L_t = 500$  mm),  $L_c$  – length of the parallel reduced section ( $L_c = 130$  mm),  $b$  – specimen width,  $b_o$  and  $a_o$  – width and thickness of the parallel length (reduced section) respectively.

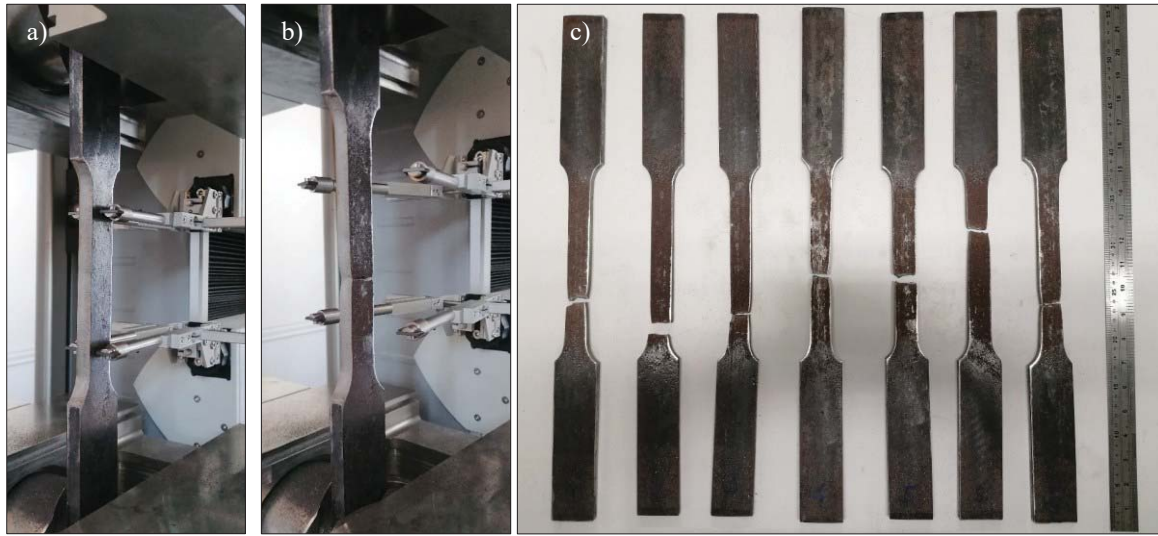
Figure 12. a) Testing setup; b) Specimen 7 just after fracture; c) Specimens after testing.

Specimens were tested on Zwick Röhl Z600E (Fig. 12) according to method A1 [15] with strain rate control, based on the feedback obtained from the extensometer in the range up to yielding (recommended strain rate  $0,00025 \text{ s}^{-1}$  was applied). In the yielding range, the strain rate control over the parallel length ( $L_c = 130$  mm) achieved by controlling the crosshead separation rate was used (strain rate equal to  $0,00025 \text{ s}^{-1}$  was applied), while after the yielding phase the strain rate was increased to  $0,0067 \text{ s}^{-1}$  (crosshead separation rate). Grip to grip length was 334 mm.

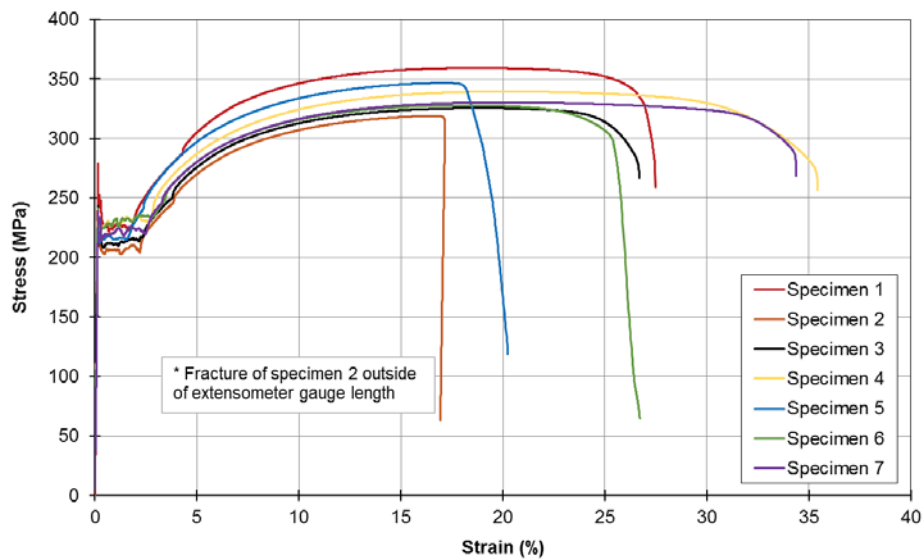
Figure 13. Stress-strain diagram of iron ties.

The results of the tensile tests are presented in Table 2, while the stress-strain relationships are given in Fig. 13. The following symbols are used:  $R_{eH}$  – upper yield strength,  $R_m$  – tensile strength (stress corresponding to maximum load),  $A_{gt}$  – deformation at maximum load,  $A_t$  – deformation at

The following values were obtained: mean yield strength 244 MPa, mean tensile strength 335 MPa and mean elongation at fracture 26,8 %. When compared with the results of tensile test of ties from Czech Republic [16] or Italy [17], differences may be noticed, what can be attributed to the different composition of wrought iron and different periods of production, so special care should be taken when assuming mechanical properties from different periods and different countries.
