Geotechnical Study of Raspadalica Cliff Rockfall, Croatia

Dalibor Udovič¹, Branko Kordić² and Željko Arbanas^{3,*}

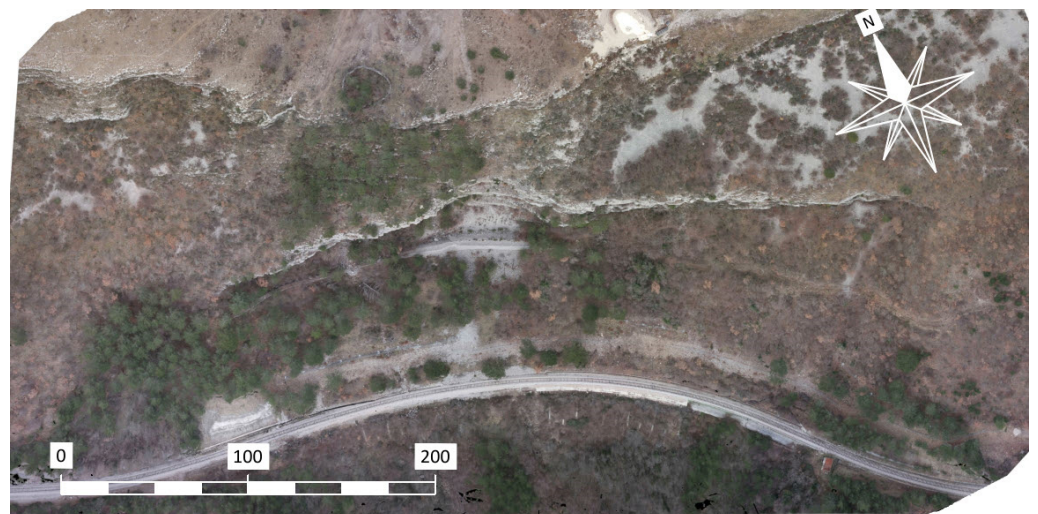
The field survey with UAV was conducted during two flight missions. The first flight mission covered wider research area while the second flight mission was focused on a detailed survey of the cliff. During the field surveys, an area of 20 ha was covered with 273 oblique images with 80% longitudinal and lateral image overlapping. Post-processing of the 3D trajectory was performed with an image position accuracy of 3 cm planar and 5 cm in the vertical direction. The initial data processing in the office consisted of assigning the coordinates of the image center and setting up coordinate systems. The first step in the *SfM* workflow consisted of automatic identification and feature matching in multiple overlapping images using the object recognition system scale invariant feature transform (SIFT). Then, the matched feature points, along with the exact or approximate image position and orientation, were used for a bundle block adjustment procedure. The adjustment was based on 654,328 tie points. The average camera location error was 0.04 m in planar and 0.05 m in vertical direction. The mean reprojection error was 0.128 pixels. Based on the 3D object reconstruction, a dense 3D high resolution point cloud (3D HRPC) with about 32 million points was generated as well as a high resolution digital surface model and orthophoto (Figure 6) with an average ground sampling distance (GSD) of 2 cm.

Figure 6. Orthophoto of Raspadalica Cliff derived from the *SfM* photogrammetry.
