Ties in unreinforced masonry structures: Case study in Krk

Conference presentation / Izlaganje na skupu

TIES IN UNREINFORCED MASONRY STRUCTURES: CASE STUDY IN KRK

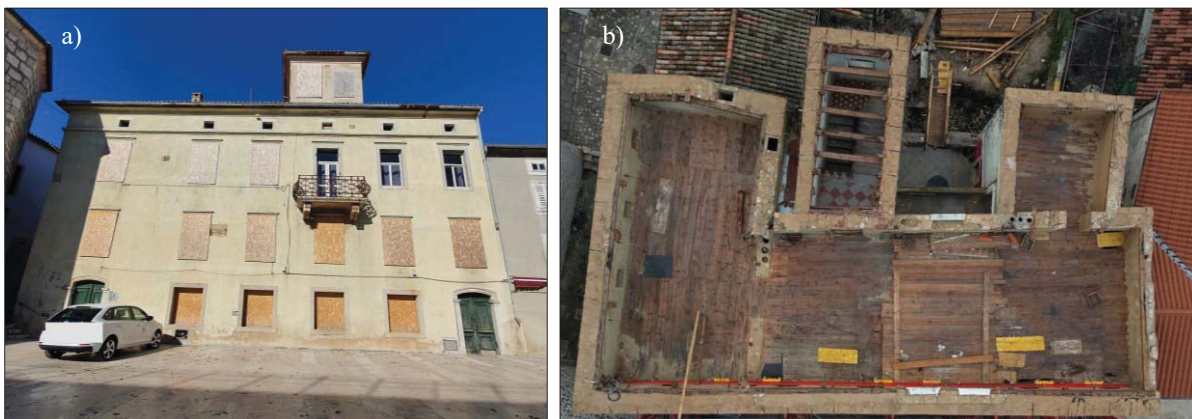
It consists of a ground floor, two storeys and an attic, with approximate floor plan dimensions 20 x 12,5 m. The height of the roof cornice is around 10 m. It has an almost symmetrical arrangement of the openings on the front façade (Fig. 1a); the windows are rather large and extend over almost the entire floor (except on the attic).

Figure 1. a) Front façade; b) Building plan at the roof level [6].

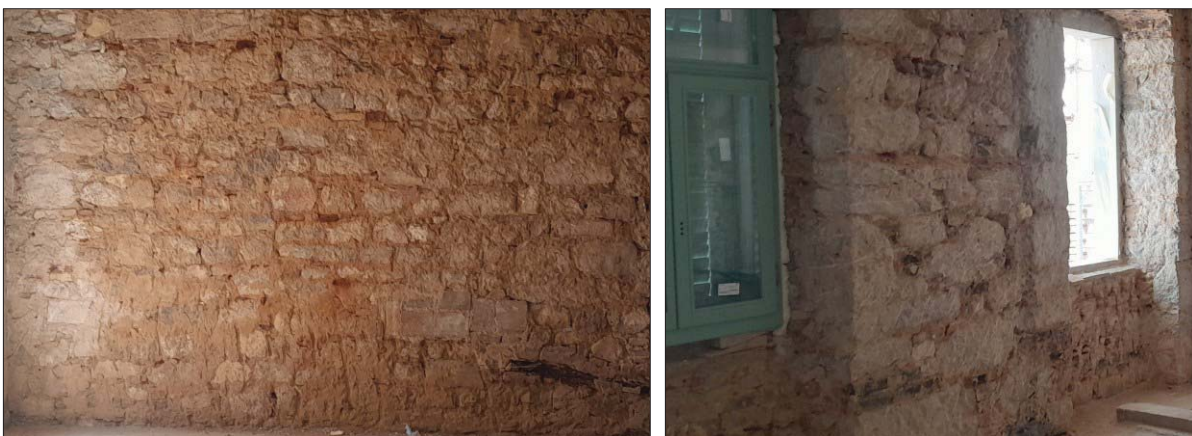
Figure 2. Masonry typology.

The floor structures are made of timber beams and boards, as common in this region, while the roof structure is a king-post, covered with tiles. The walls may be categorized into rubble stone masonry (wall thickness 65 cm), though some later added walls are built of brick. The stone blocks are mostly of the same size, with considerably larger dimensions at the corners or at the openings (Fig. 2)

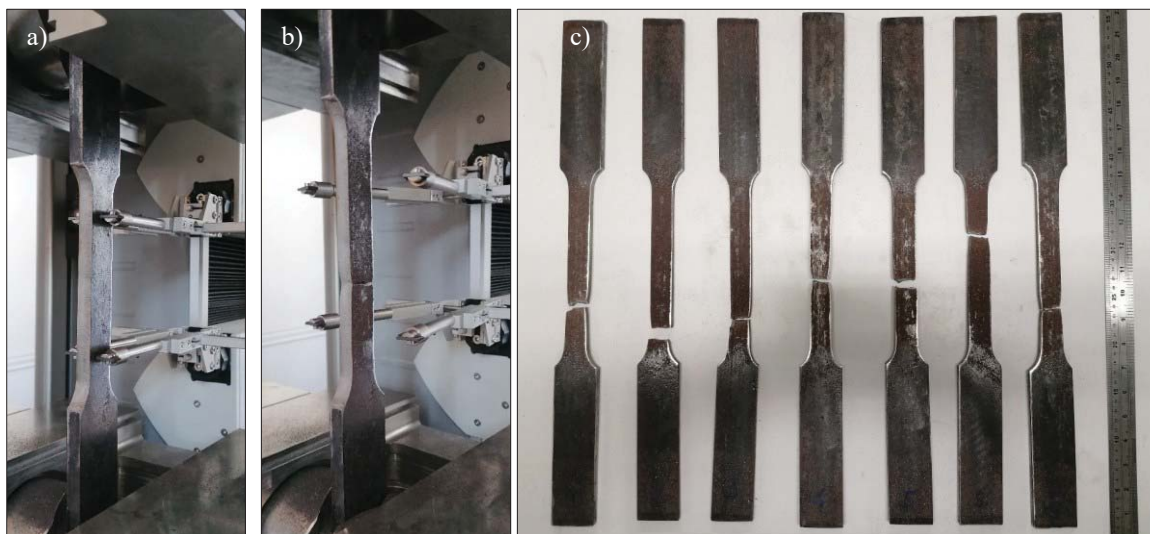
Figure 12. a) Testing setup; b) Specimen 7 just after fracture; c) Specimens after testing.

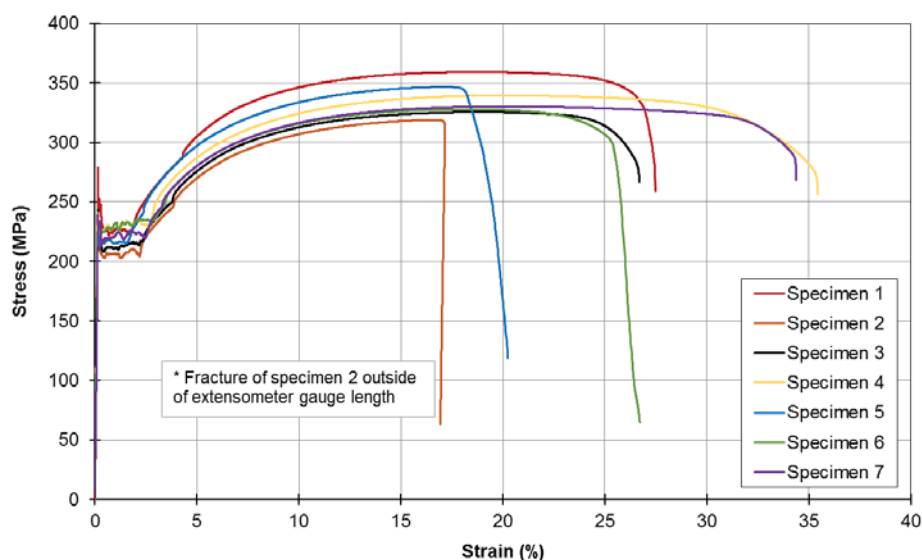
Figure 13. Stress-strain diagram of iron ties.

The following values were obtained: mean yield strength 244 MPa, mean tensile strength 335 MPa and mean elongation at fracture 26,8 %. When compared with the results of tensile test of ties from Czech Republic [16] or Italy [17], differences may be noticed, what can be attributed to the different composition of wrought iron and different periods of production, so special care should be taken when assuming mechanical properties from different periods and different countries.
