Geotechnical Study of Raspadalica Cliff Rockfall, Croatia

Abstract: The Raspadalica Cliff is an almost vertical 100 m high limestone cliff with a railway line at its foot and is known for numerous rockfall occurrences in the past. This article presents the results of the geotechnical study of the cliff based on a traditional geological and geotechnical field survey and remote sensing analysis. Both the traditional geological and geotechnical field survey and remote sensing surveys and analyses enabled the establishment of the structural model of the Raspadalica Cliff and the determination of the discontinuity sets and discontinuity features, such as orientation, spacing, persistence, roughness, discontinuity wall strength, aperture, degree of weathering of discontinuity wall, seepage conditions, and the presence and hardness of discontinuity filling. Kinematic analyses were performed on five cliff zones with slightly different structural features, indicating a relatively low probability of typical failures in the cliff rock mass that precede the rockfall occurrences. Although rockfall phenomena from the cliff face are relatively frequent, the kinematic analyses did not indicate a

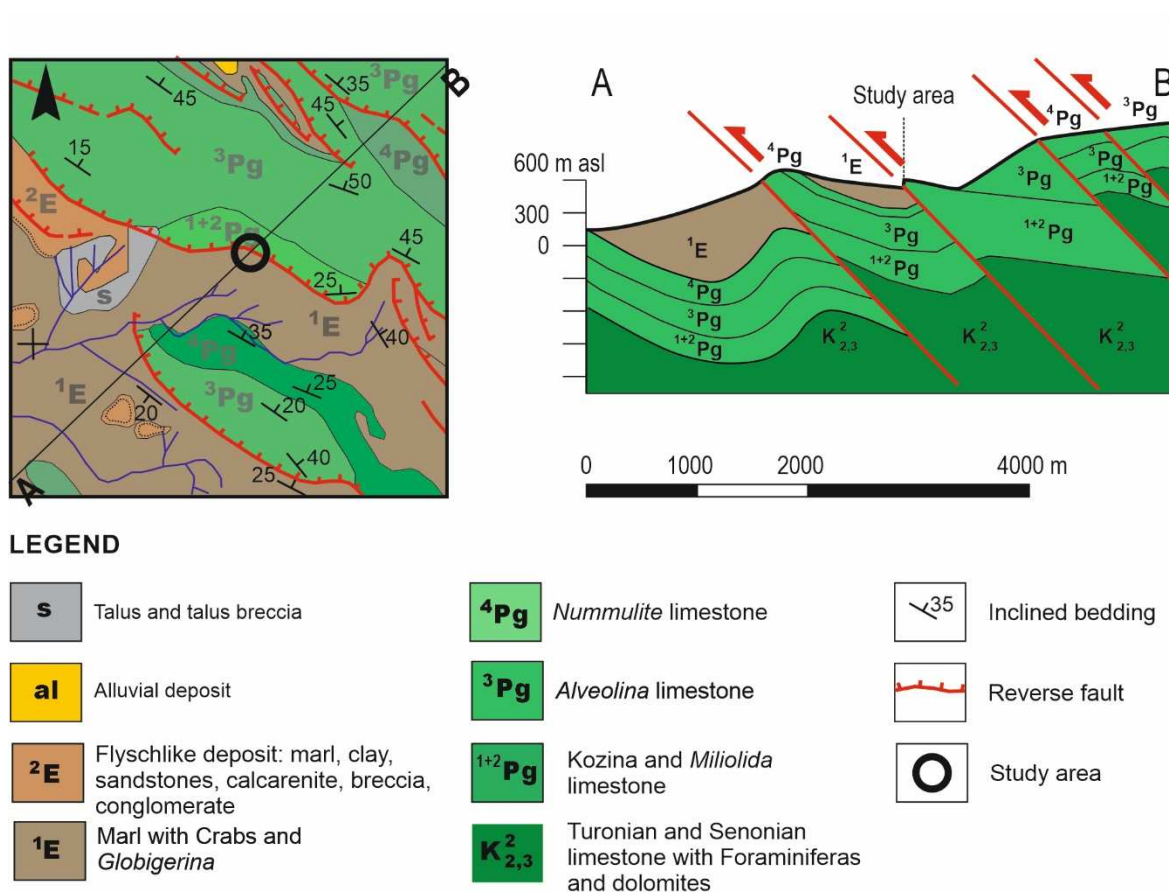
Figure 3. Geological map of the wider area of the Raspadalica Cliff: Geological map (left) and geological cross-section (right). Black circle indicates the Raspadalica Cliff location [8,9].

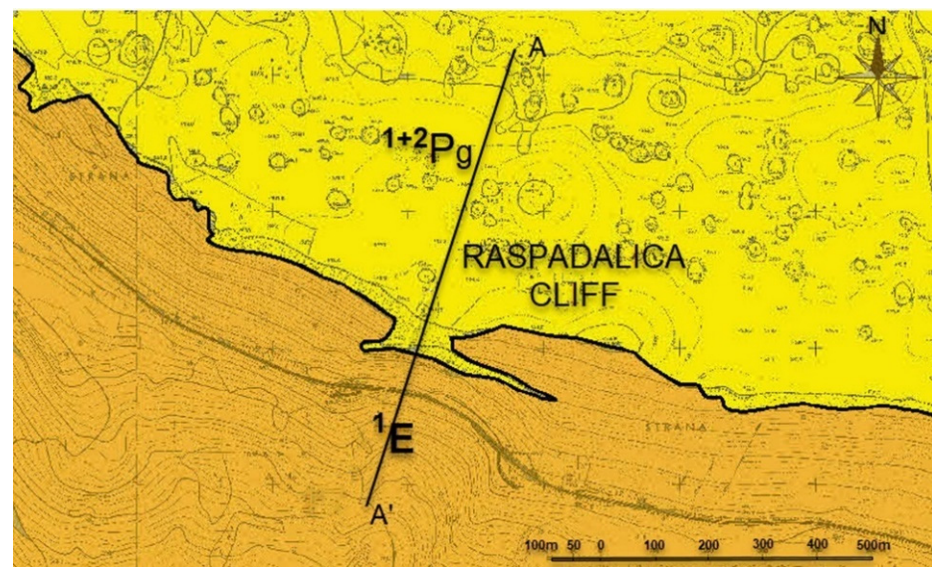
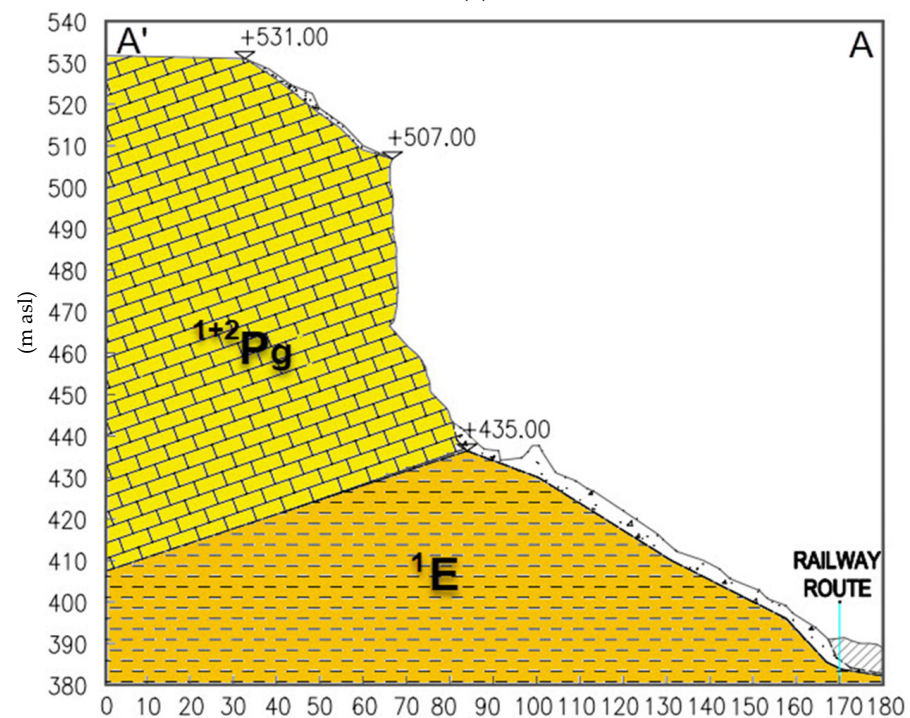
The Raspadalica Cliff is a part of the Ćićarija Mountain Range, built of Paleogene limestone, and the contact between the limestone rock mass of the cliff and the flysch rock complex in the lower part of the slope is a reverse fault dipping ~23 degrees towards the NE (Figures 3 and 4). The limestone mass is homogeneous, fine-grained, and well stratified. The thickness of beds ranges from 10 cm to 2 m with several interlayers of coal of several centimeters in thickness. The general dip of the bedding planes is relatively favorable for stability of the cliff and inclined toward the slope, with minor variations along the cliff. A detailed description of the geotechnical model of the cliff is described in the following sections.

Figure 4. Geological map of the Raspadalica Cliff (a) and marked schematic cross-section (A–A'): (b). Overthrust limestone Lower and Middle Paleogene rock mass (^{1+2}Pg) lies on Lower Eocene flysch deposits (1E). The flysch deposits are covered with talus material originating from a limestone cliff [12].

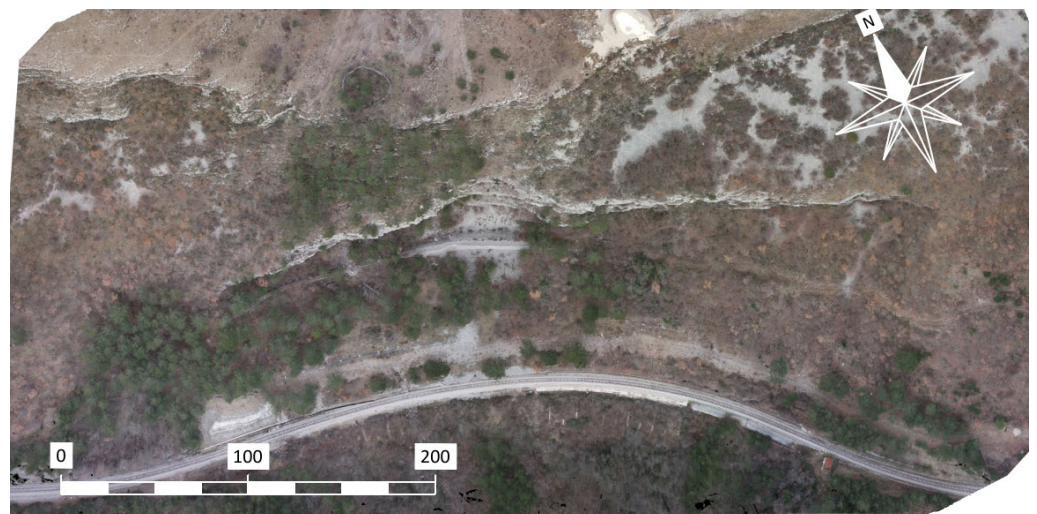
The field survey with UAV was conducted during two flight missions. The first flight mission covered wider research area while the second flight mission was focused on a detailed survey of the cliff. During the field surveys, an area of 20 ha was covered with 273 oblique images with 80% longitudinal and lateral image overlapping. Post-processing of the 3D trajectory was performed with an image position accuracy of 3 cm planar and 5 cm in the vertical direction. The initial data processing in the office consisted of assigning the coordinates of the image center and setting up coordinate systems. The first step in the *SfM* workflow consisted of automatic identification and feature matching in multiple overlapping images using the object recognition system scale invariant feature transform (SIFT). Then, the matched feature points, along with the exact or approximate image position and orientation, were used for a bundle block adjustment procedure. The adjustment was based on 654,328 tie points. The average camera location error was 0.04 m in planar and 0.05 m in vertical direction. The mean reprojection error was 0.128 pixels. Based on the 3D object reconstruction, a dense 3D high resolution point cloud (3D HRPC) with about 32 million points was generated as well as a high resolution digital surface model and orthophoto (Figure 6) with an average ground sampling distance (GSD) of 2 cm.

Figure 6. Orthophoto of Raspadalica Cliff derived from the *SfM* photogrammetry.

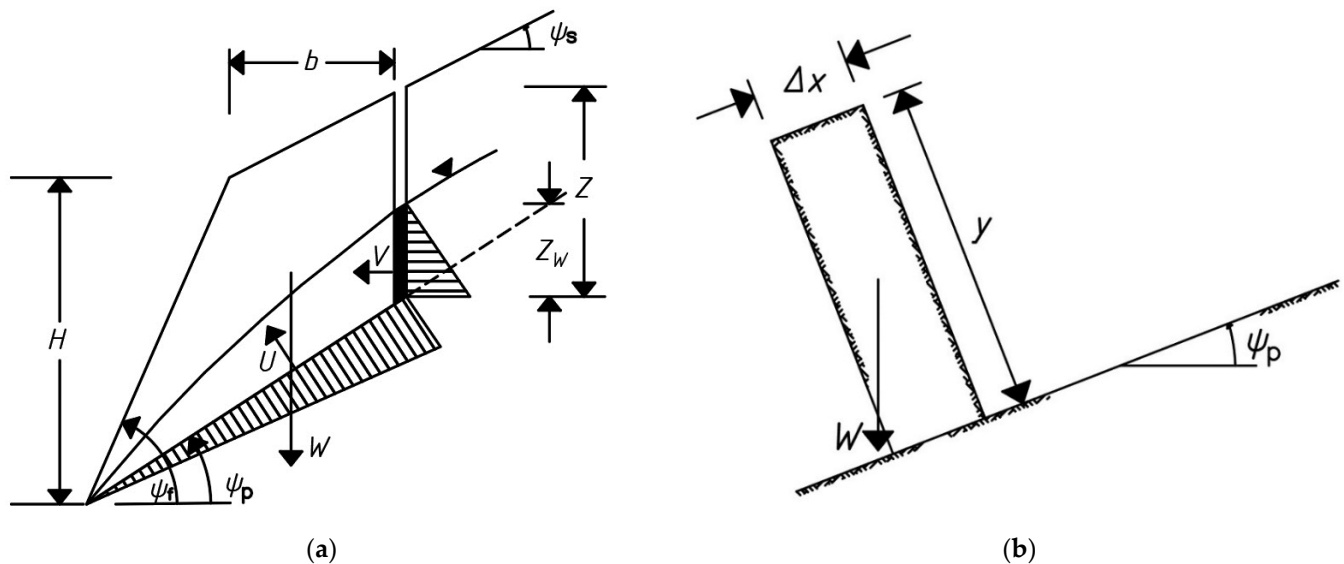
Analyzing planar sliding and direct toppling stability of the block in the Raspadalica Cliff, the geometrics and acting forces of these two mechanisms included in the analyses are schematically presented in Figure 11 (according to [90]).

Figure 11. Geometrics and forces of (a) planar sliding failure; (b) direct toppling failure (Reprinted with permission [90] 2004, Spoon Press).

General geometric conditions in order for planar failure to occur in the identified blocks at the Raspadalica Cliff face are satisfied [90], except that the dip of sliding plane (in this case bedding plane) must be greater than the angle of friction of this plane:

where c is cohesion; A the area of sliding plane; and W , U , and V forces are presented in Figure 11a. Neglecting cohesion at the sliding plane, and in conditions with no impact from ground water (dry conditions), Equation (3) can be written as

In these conditions, it is possible to identify the stability of a single block (neglecting the impact of friction at the side walls of a block), as is illustrated in Figure 11b. The Figure 11b shows the conditions that indicate on stable, sliding, or toppling blocks with height of y and width of Δx on a plane dipping at an angle Ψ_p . Toppling occurs if when the center of gravity of the block lies outside of the base:
