Ties in unreinforced masonry structures: Case study in Krk

Conference presentation / Izlaganje na skupu

TIES IN UNREINFORCED MASONRY STRUCTURES: CASE STUDY IN KRK

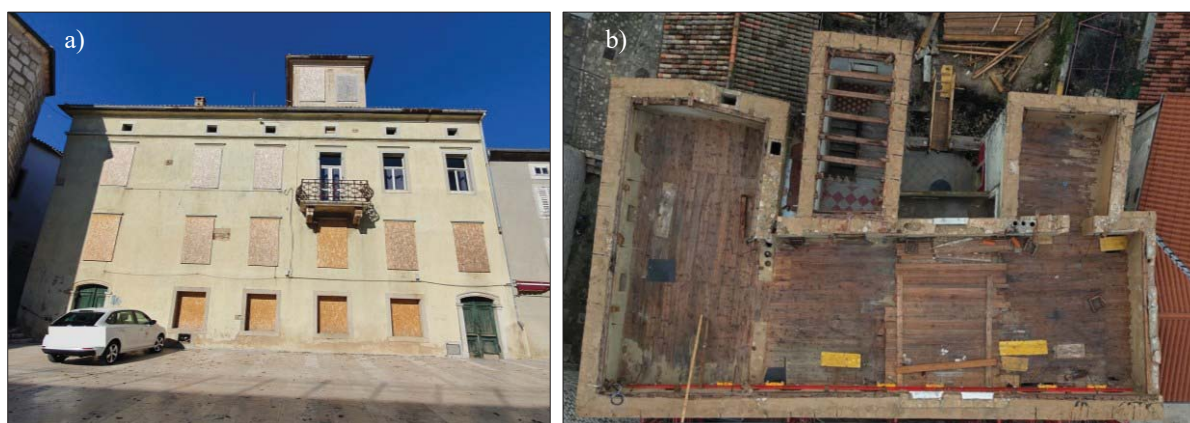
It consists of a ground floor, two storeys and an attic, with approximate floor plan dimensions 20 x 12,5 m. The height of the roof cornice is around 10 m. It has an almost symmetrical arrangement of the openings on the front façade (Fig. 1a); the windows are rather large and extend over almost the entire floor (except on the attic).

Figure 1. a) Front façade; b) Building plan at the roof level [6].

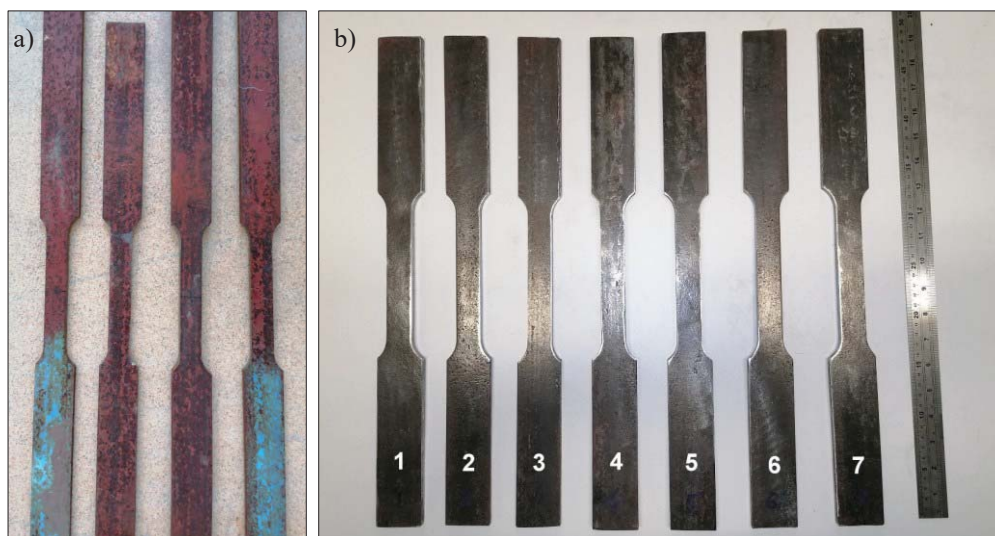
Testing specimens were prepared by waterjet cutting, using a high-pressure jet of a mixture of water and an abrasive substance (Fig. 10). This cutting method was selected because it does not heat the metal,

Figure 10. Preparation of specimens: a) after waterjet cutting; b) after sanding.

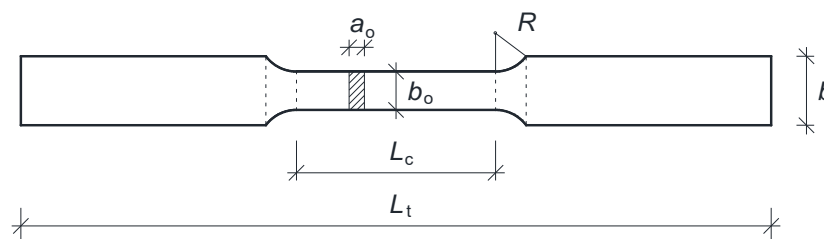
The dimensions of the specimens have been selected to match the so-called proportional specimens [15], in which the gauge length L_o is in direct relationship with the cross-sectional area by the equation $L_o = 5,65 \cdot (a_o \cdot b_o)^{1/2}$. However, since the thickness of the specimens after sanding a_o varied from 8,1 to 12,1 mm (i.e. the gauge length would be different for each specimen), due to the ease of testing it was decided to adopt the extensometer gauge length L_c equal to 100 mm (corresponding to the specimen with the largest thickness) for all specimens. A transition radius R of 25 mm was selected between the gripped ends and the parallel (reduced) length (Fig. 11). The following symbols are used: L_t – specimen length ($L_t = 500$ mm), L_c – length of the parallel reduced section ($L_c = 130$ mm), b – specimen width, b_o and a_o – width and thickness of the parallel length (reduced section) respectively.

Figure 11. Specimen details.

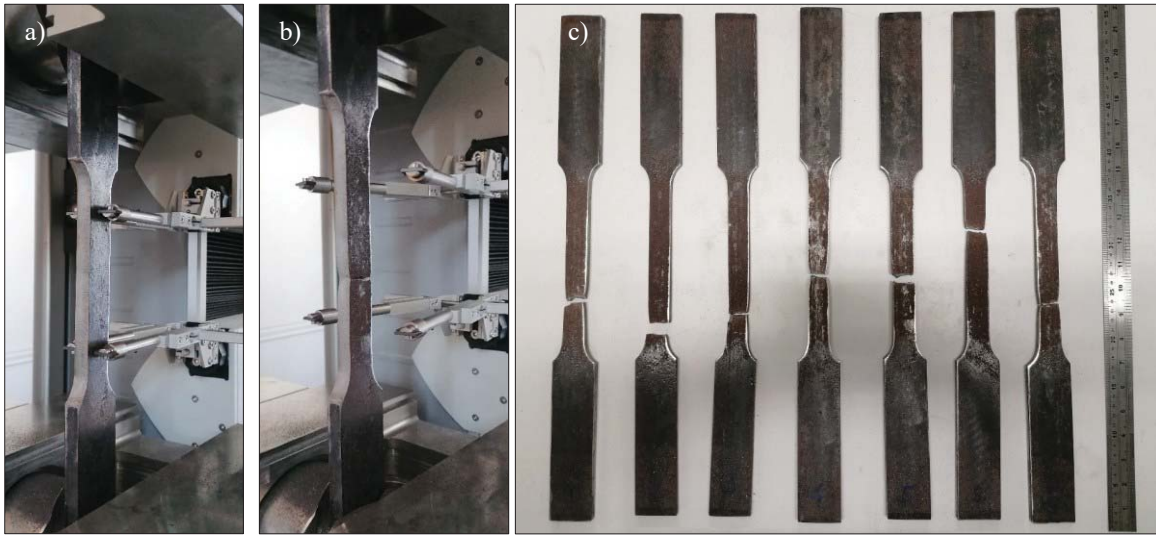
Specimens were tested on Zwick Röhl Z600E (Fig. 12) according to method A1 [15] with strain rate control, based on the feedback obtained from the extensometer in the range up to yielding (recommended strain rate $0,00025 \text{ s}^{-1}$ was applied). In the yielding range, the strain rate control over the parallel length ($L_c = 130$ mm) achieved by controlling the crosshead separation rate was used (strain rate equal to $0,00025 \text{ s}^{-1}$ was applied), while after the yielding phase the strain rate was increased to $0,0067 \text{ s}^{-1}$ (crosshead separation rate). Grip to grip length was 334 mm.

Figure 12. a) Testing setup; b) Specimen 7 just after fracture; c) Specimens after testing.

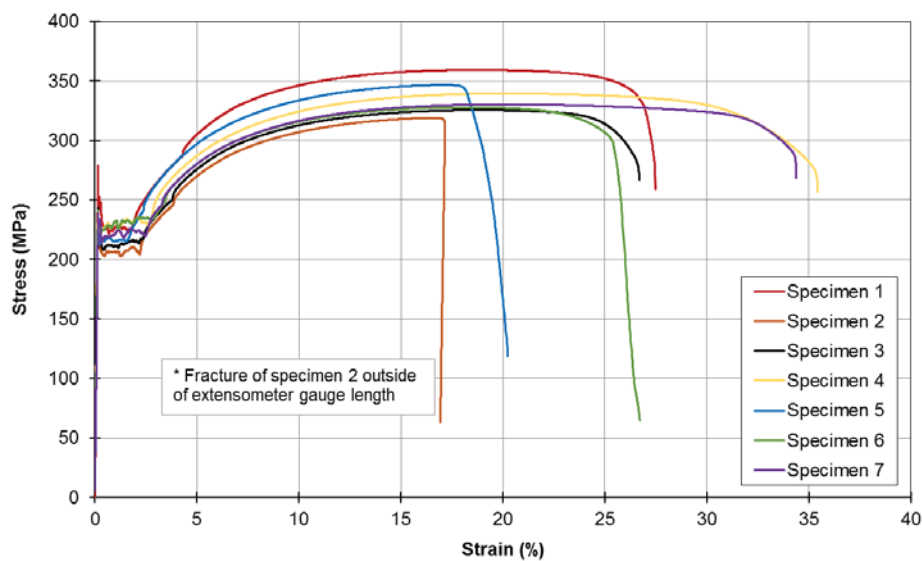
Figure 13. Stress-strain diagram of iron ties.

The following values were obtained: mean yield strength 244 MPa, mean tensile strength 335 MPa and mean elongation at fracture 26,8 %. When compared with the results of tensile test of ties from Czech Republic [16] or Italy [17], differences may be noticed, what can be attributed to the different composition of wrought iron and different periods of production, so special care should be taken when assuming mechanical properties from different periods and different countries.
