Structures of the I. Industrial age in Rijeka (Croatia) - from timber to iron

Structures of the First Industrial Age in Rijeka, Croatia — from Timber to Iron

Adriana Bjelanović, Nana Palinić & Marko Franković

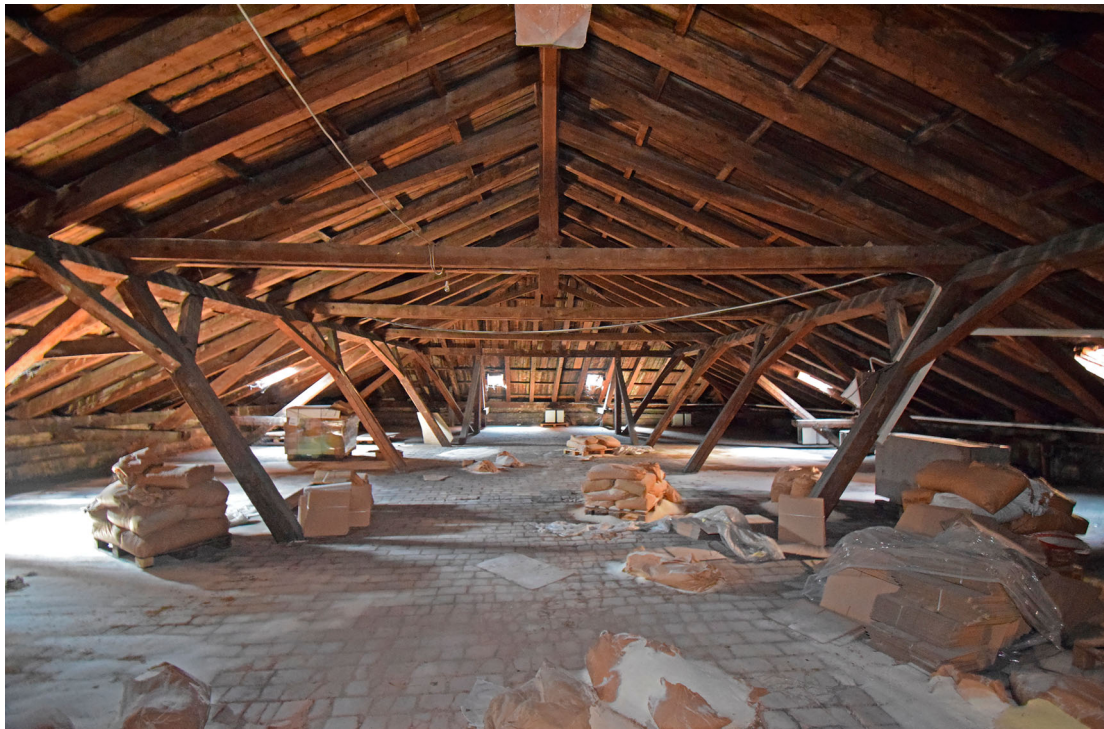
Figure 14. Tobacco Factory H-building, roof structure (Marko Franković, 2018).

regular, with longitudinal spacings of about 3.0m to 4.25m, and about 5.0m and 5.40m in the middle part. The hipped roof of the H-building has a particularly interesting timber structure which has been mostly well preserved and successfully serves its current use.³⁵ The roofs of both parts of the H-building (Figure 13) have the same purlin structures of an almost identical geometry. Their axial spans slightly exceed 19.0m, since the spacings of the attic walls are 18.7m (in eastern part) and 18.6m (in the western part). The massive attic walls are about 1.1m tall, having protruded head stones as parts of the decorative eaves. The height of each attic exceeds 5.60m, while the free height below the collar-tie is about 3.10m, measuring from the flooring level. This complex timber structure is a combination of a purlin-tie roof with double 'raking chairs' on the lower level and a king post truss on the upper level (Figures 14 and 15).³⁶ The used term 'raking chairs' refers to compression structural members within the principal truss of purlin-tie roof structures. As is otherwise typical for this typology, they are inclined at an angle to the rafters and support the middle purlins, and are constructed as braced struts (Figures 13 and 14).³⁷
