Source / Izvornik: **Industrial Archaeology Review, 2022, 44, 19 - 35**

Structures of the First Industrial Age in Rijeka, Croatia — from Timber to Iron

Adriana Bjelanović, Nana Palinić & Marko Franković

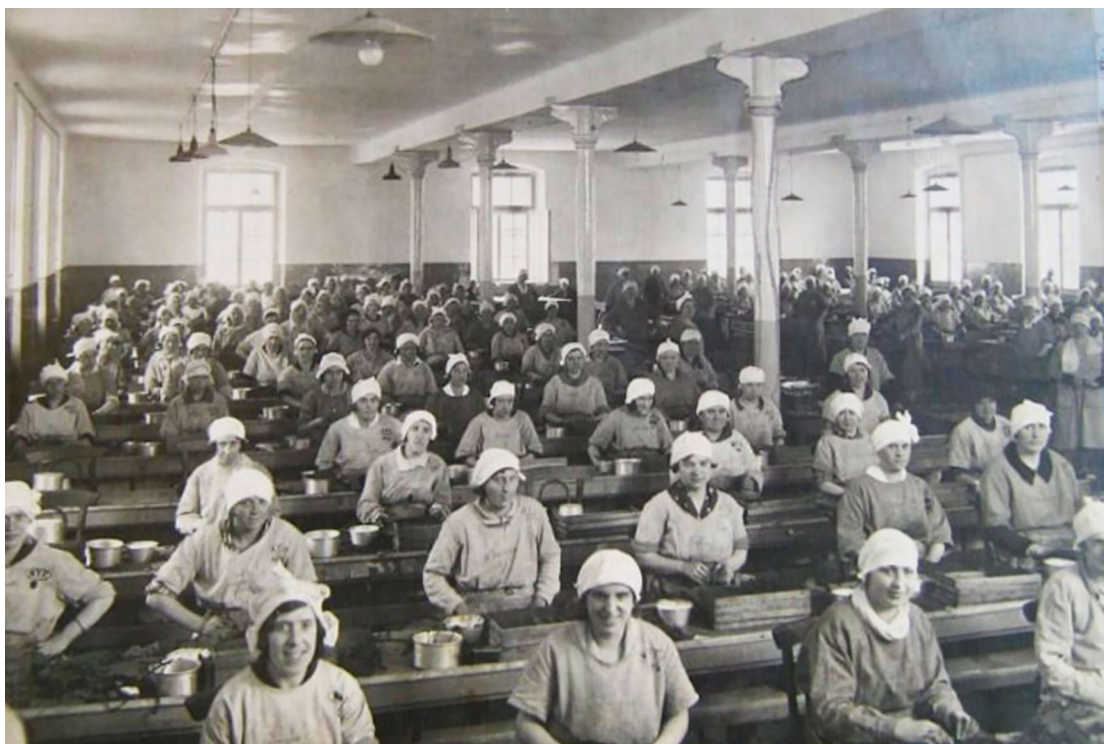
Figure 5. Tobacco Factory T-building, production hall of the first floor. State Archives in Rijeka (HR-DARI), reproduced with permission.

Just like the structure of the Žakalj Mill, the load-bearing structure of the T-building was also hybrid. Its foundations were set on a terrain of dredged loam mixed with stone. The massive peripheral walls were constructed of roughly chiselled and broken stone. The inner structure in the basement was constructed with massive stone pillars and cross-vaulted brick bays, and in each of the upper storeys a skeletal system of cast-iron columns and longitudinal wooden main beams was constructed (Figure 5).¹⁷

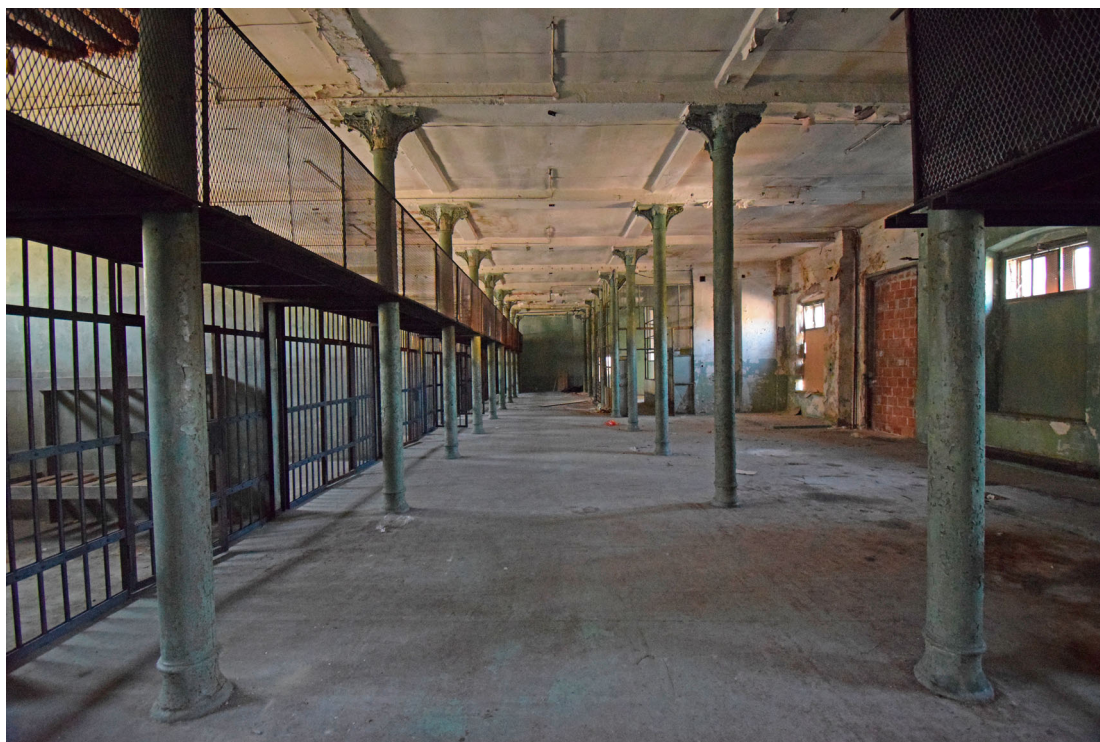
Figure 6. Tobacco Factory T-building, first-floor skeletal structure (Marko Franković, 2018).

Two rows of columns divided the interior space of the raised ground floor, first and second floors into three aisles (Figure 4 and Figure 6).¹⁸ Originally, the columns were probably made as single castings but three different parts can be identified — a base, a cylindrical body (*ie* conical pipe) which was slightly narrowed upwards, and a capital with enlargements on both sides around the tubular part on which the base for fitting the body of the column of the upper storey was assembled (Figure 7).

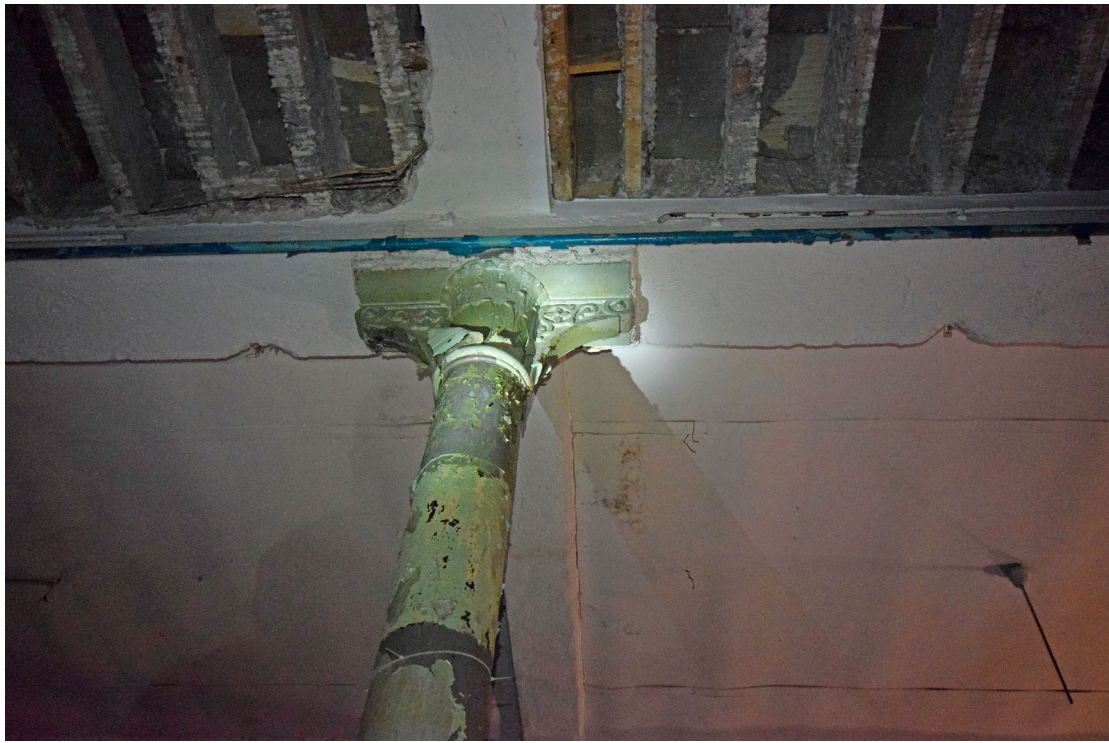
Figure 7. Tobacco Factory T-building, first-floor skeletal structure — detail of capital and pillar (Marko Franković, 2018).

The tubular parts of the iron columns of the ground floor had a diameter of 240mm and 3mm thick walls, while the smaller load-bearing columns of upper storeys were more slender, with an outer diameter of 220mm and 2.5mm thick walls.¹⁹ The decorated capitals also, besides their aesthetic value, had a very important structural function of positioning the head plates, the iron bearing plate which the longitudinal main girders were mounted on. In the storeys of the raised ground floor and the first floor, head plates (820l × 300w × 50d mm) were supports to the pair of longitudinal main beams, whose parts of double square cross-section (2 × 300 × 300mm) were spaced for the outer diameter of tubular extrusion in the middle of the head plate. Low protrusions on the edges of the head plates of the capitals emphasised the impression of the planned bearing of the main girders. These longitudinal beams supported the transverse, secondary members of the ceiling structures on all storeys: in the attic, there were beams with a rectangular cross-section of about 160w × 220d mm, while on the lower storeys, edgewise settled planks were used instead of beams and arranged on double denser spacings. The length of the secondary members was probably about two-thirds and one-third of the transverse span of the building, so they could be put in a staggered arrangement, supported by main girders at one end, and at the other one they leaned on the massive walls over the wall plates. It is presumed that the joints were made in a carpentry manner. The floor was executed as simple plank flooring with structural function as well. It can be concluded that the system represented a stable structure, and was built completely according to its primary purpose, within the spirit of the time and the achievements in engineering of the period, at which the manner of construction and the assemblage of columns were thought of, and the alternate staggered arrangement of continuations of the ceiling beams of both directions ensured an additional robustness to the lightweight load-bearing structure of the interior.

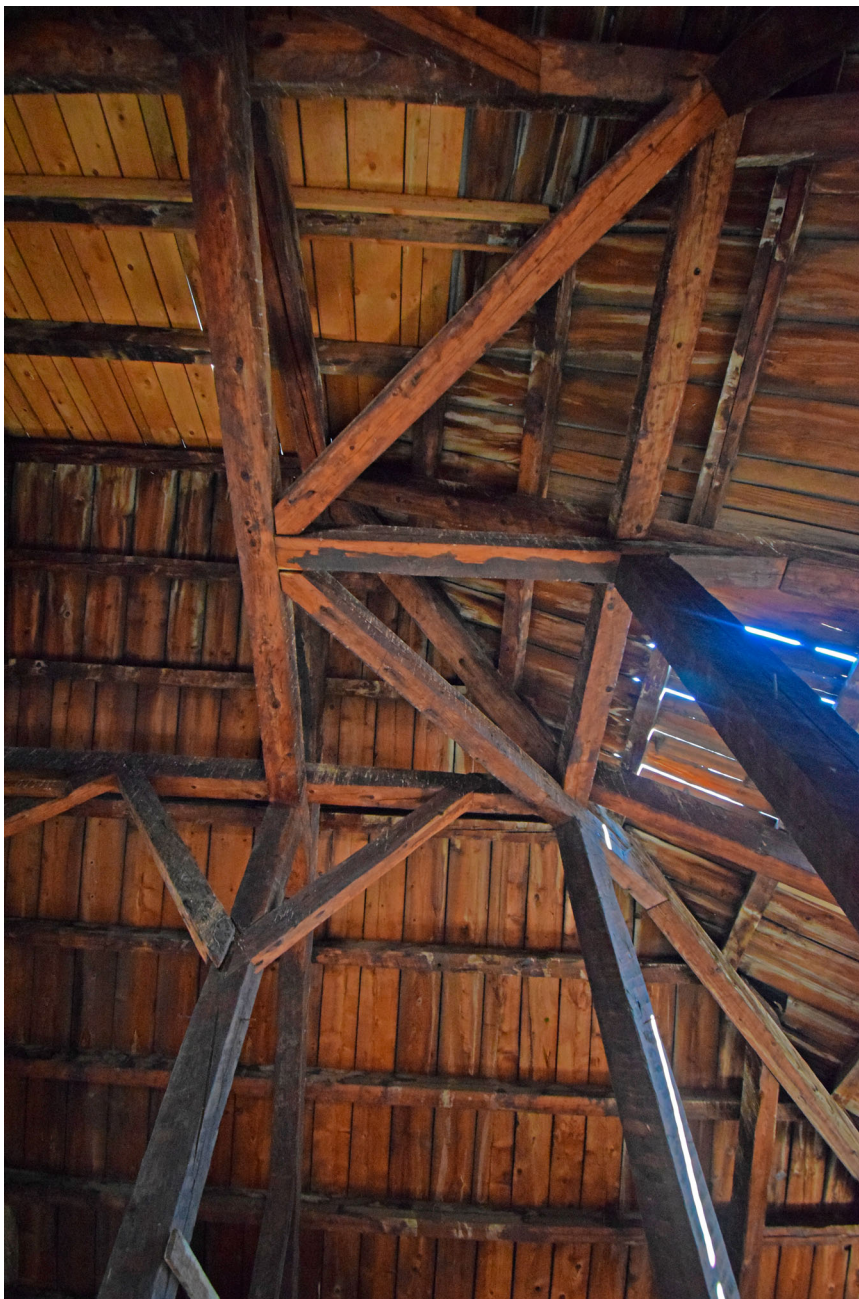
Figure 9. Tobacco Factory T-building, roof structure detail (Marko Franković, 2018).
