Source / Izvornik: **Industrial Archaeology Review, 2022, 44, 19 - 35**

Structures of the First Industrial Age in Rijeka, Croatia — from Timber to Iron

Adriana Bjelanović, Nana Palinić & Marko Franković

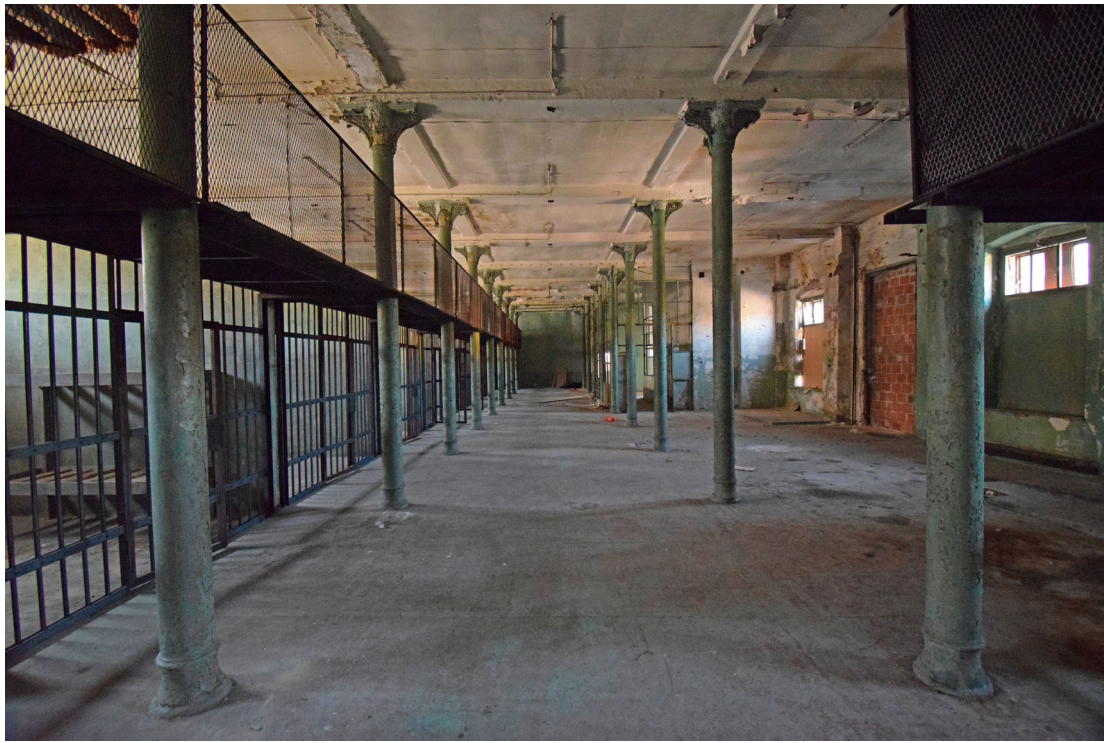
Figure 6. Tobacco Factory T-building, first-floor skeletal structure (Marko Franković, 2018).

Two rows of columns divided the interior space of the raised ground floor, first and second floors into three aisles (Figure 4 and Figure 6).¹⁸ Originally, the columns were probably made as single castings but three different parts can be identified — a base, a cylindrical body (*ie* conical pipe) which was slightly narrowed upwards, and a capital with enlargements on both sides around the tubular part on which the base for fitting the body of the column of the upper storey was assembled (Figure 7).

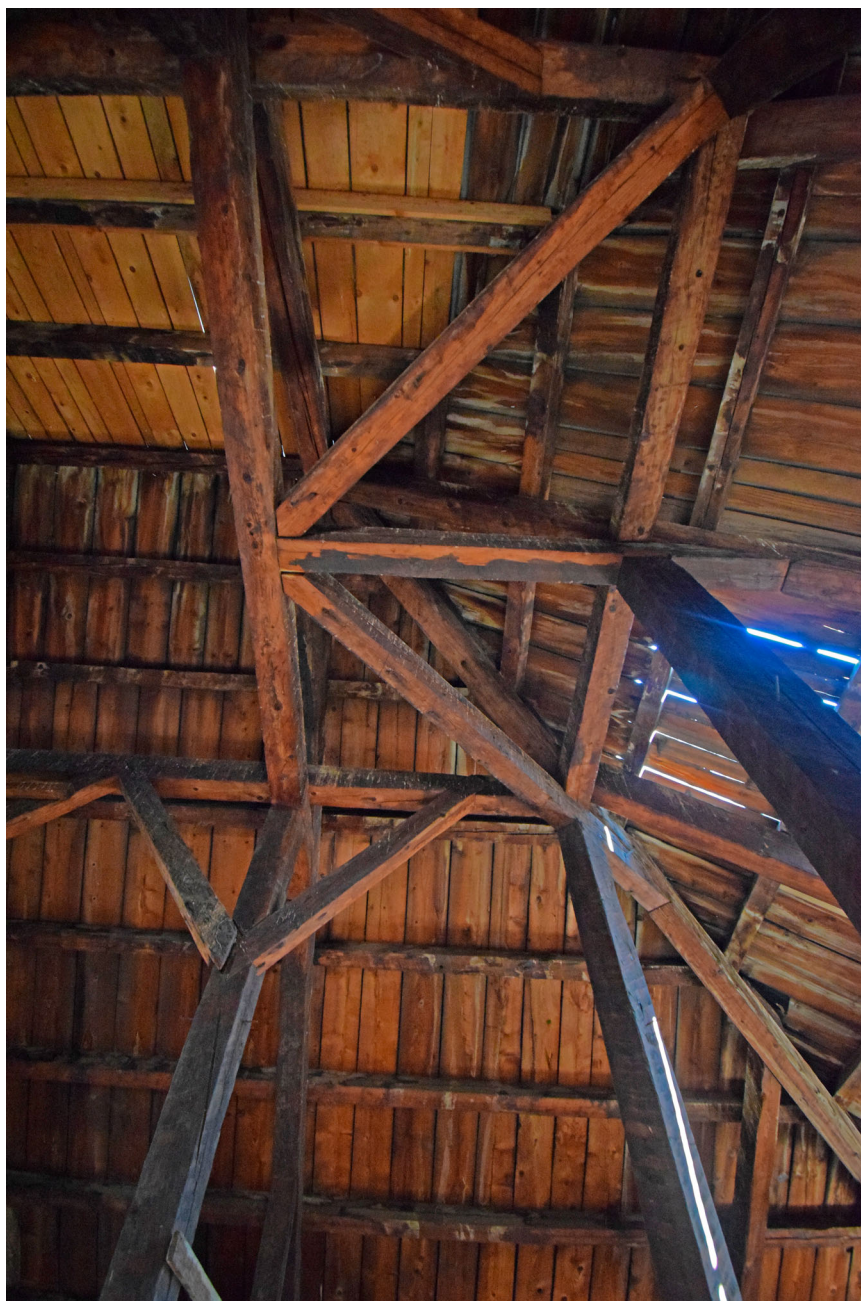
Figure 9. Tobacco Factory T-building, roof structure detail (Marko Franković, 2018).

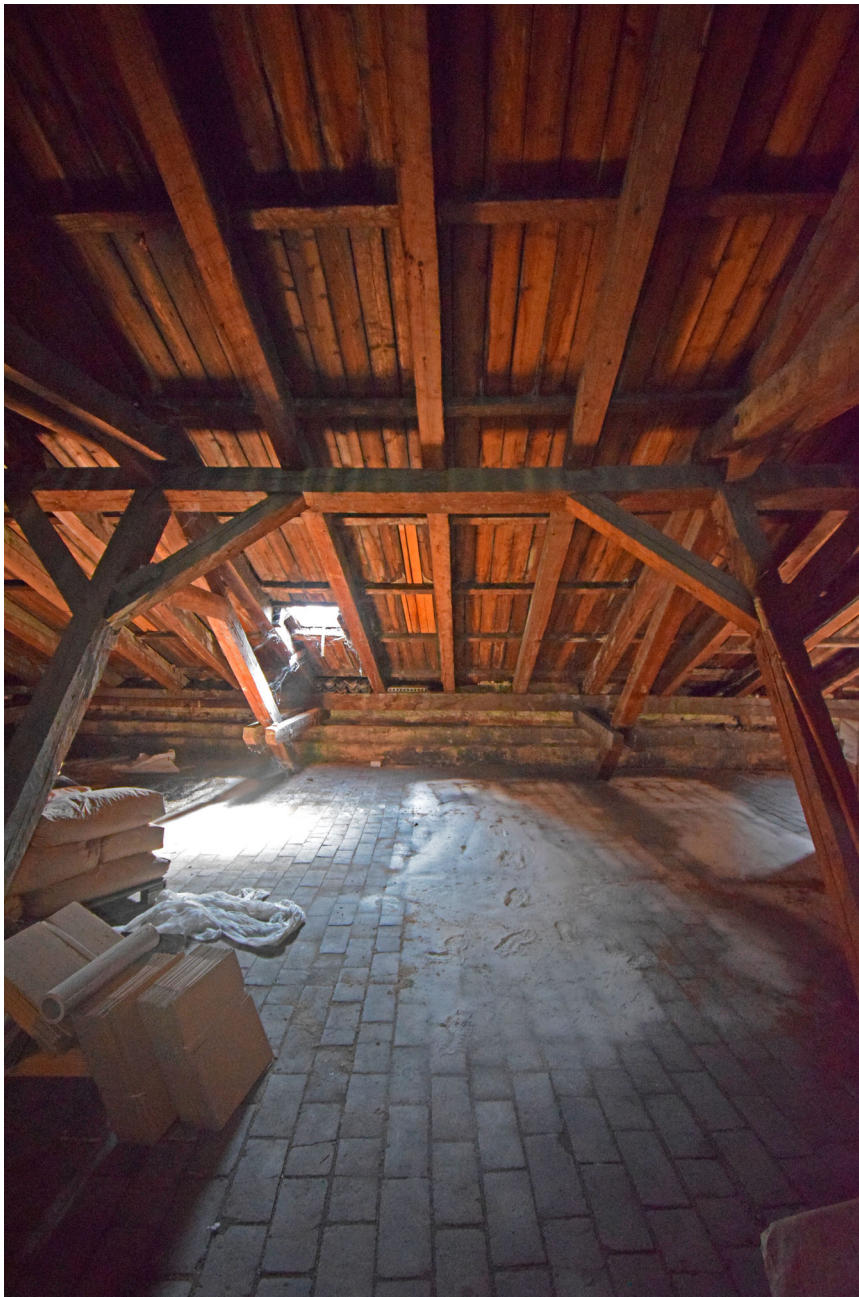
Figure 15. Tobacco Factory H-building, roof details (Marko Franković, 2018).

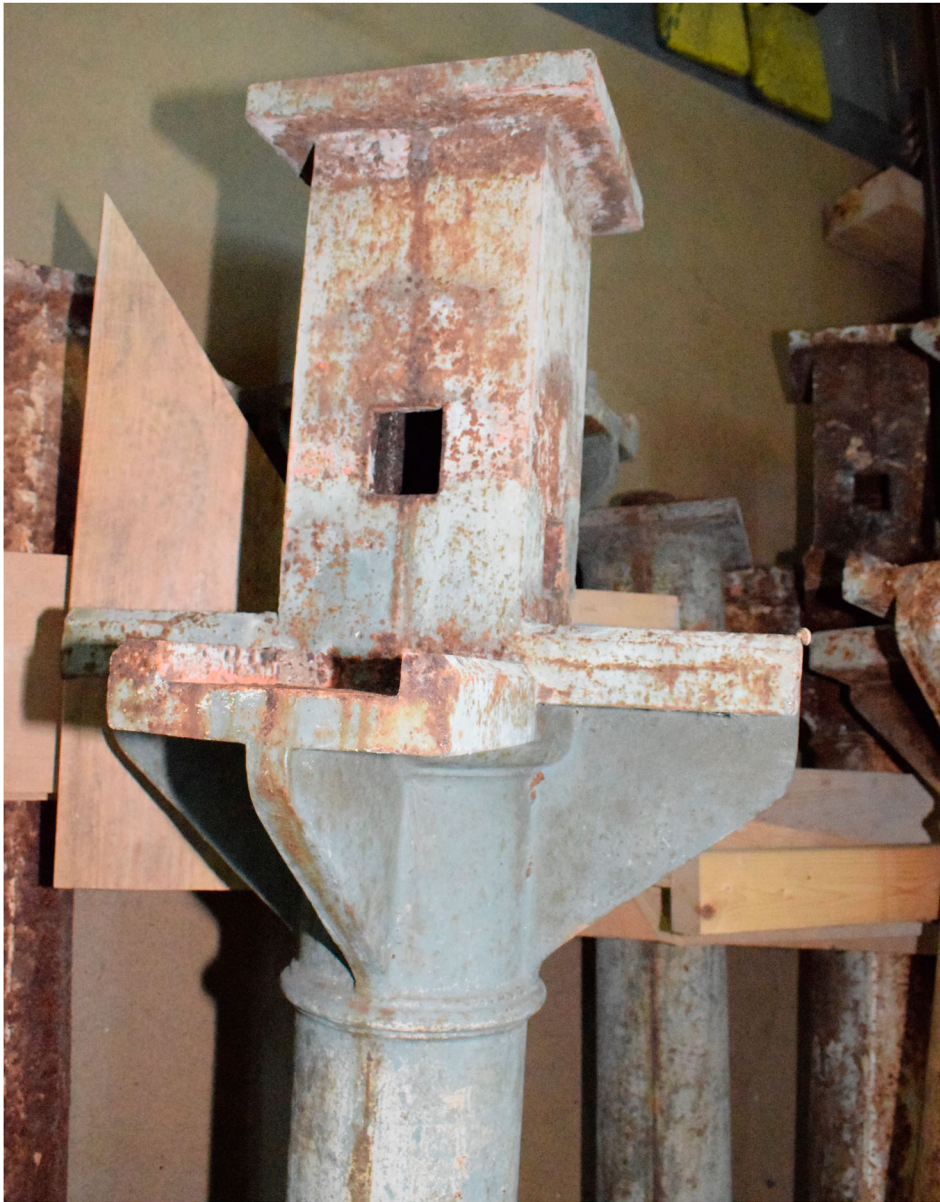
Figure 18. Tobacco drying facility, detail of column (Marko Franković, 2019).

The iron columns were of a circular hollow section, with capitals devoid of any ornaments.⁴⁵ At the same time, the four protruding plates were constitutive parts of the extensions above the capitals, enabling the installation of metal I-girders of the cross layout (Figures 17 and 18). In the old part of the building, the longitudinal I-girders had a depth of 220mm, while the transverse I-girders of the skeletons were 80mm deeper. Between these latter, the longitudinal ceiling I-girders were placed (one in each field), serving as supports of the transverse wooden ceiling beams which were uniformly arranged at spacings of 0.8m, carrying the plank flooring.
