Source / Izvornik: Industrial Archaeology Review, 2022, 44, 19 - 35

## Structures of the First Industrial Age in Rijeka, Croatia — from Timber to Iron

Adriana Bjelanović, Nana Palinić & Marko Franković

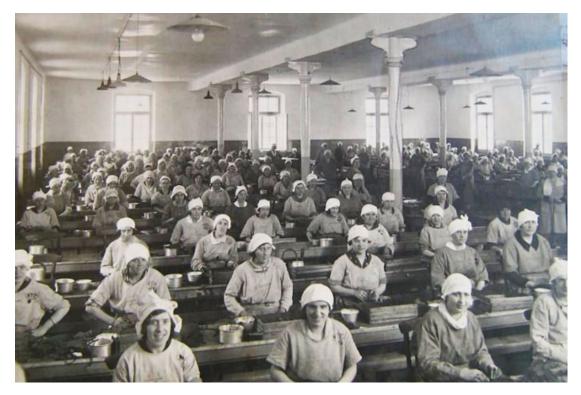
Figure 5. Tobacco Factory T-building, production hall of the first floor. State Archives in Rijeka (HR-DARI), reproduced with permission.

Just like the structure of the Žakalj Mill, the load-bearing structure of the T-building was also hybrid. Its foundations were set on a terrain of dredged loam mixed with stone. The massive peripheral walls were constructed of roughly chiselled and broken stone. The inner structure in the basement was constructed with massive stone pillars and cross-vaulted brick bays, and in each of the upper storeys a skeletal system of cast-iron columns and longitudinal wooden main beams was constructed (Figure 5).<sup>17</sup>

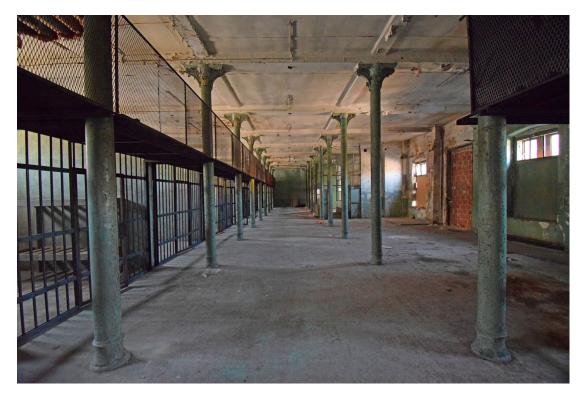
Figure 6. Tobacco Factory T-building, first-floor skeletal structure (Marko Franković, 2018).

Two rows of columns divided the interior space of the raised ground floor, first and second floors into three aisles (Figure 4 and Figure 6).<sup>18</sup> Originally, the columns were probably made as single castings but three different parts can be identified — a base, a cylindrical body (*ie* conical pipe) which was slightly narrowed upwards, and a capital with enlargements on both sides around the tubular part on which the base for fitting the body of the column of the upper storey was assembled (Figure 7).

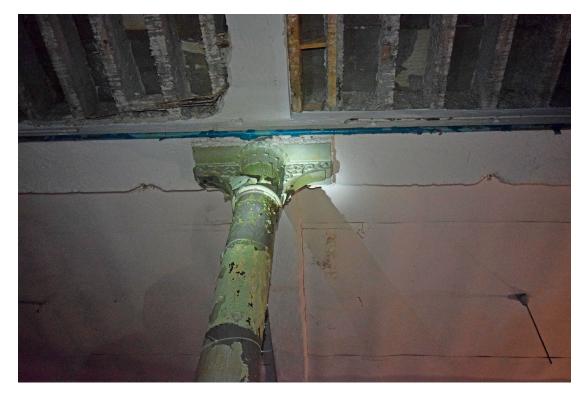
Figure 7. Tobacco Factory T-building, first-floor skeletal structure — detail of capital and pillar (Marko Franković, 2018).

The tubular parts of the iron columns of the ground floor had a diameter of 240mm and 3mm thick walls, while the smaller load-bearing columns of upper storeys were more slender, with an outer diameter of 220mm and 2.5mm thick walls.<sup>19</sup> The decorated capitals also, besides their aesthetic value, had a very important structural function of positioning the head plates, the iron bearing plate which the longitudinal main girders were mounted on. In the storeys of the raised ground floor and the first floor, head plates (820l  $\times$  300w  $\times$  50d mm) were supports to the pair of longitudinal main beams, whose parts of double square cross-section  $(2 \times 300 \times 300 \text{ mm})$  were spaced for the outer diameter of tubular extrusion in the middle of the head plate. Low protrusions on the edges of the head plates of the capitals emphasised the impression of the planned bearing of the main girders. These longitudinal beams supported the transverse, secondary members of the ceiling structures on all storeys: in the attic, there were beams with a rectangular cross-section of about  $160w \times 220d$  mm, while on the lower storeys, edgewise settled planks were used instead of beams and arranged on double denser spacings. The length of the secondary members was probably about two-thirds and one-third of the transverse span of the building, so they could be put in a staggered arrangement, supported by main girders at one end, and at the other one they leaned on the massive walls over the wall plates. It is presumed that the joints were made in a carpentry manner. The floor was executed as simple plank flooring with structural function as well. It can be concluded that the system represented a stable structure, and was built completely according to its primary purpose, within the spirit of the time and the achievements in engineering of the period, at which the manner of construction and the assemblage of columns were thought of, and the alternate staggered arrangement of continuations of the ceiling beams of both directions ensured an additional robustness to the lightweight loadbearing structure of the interior.

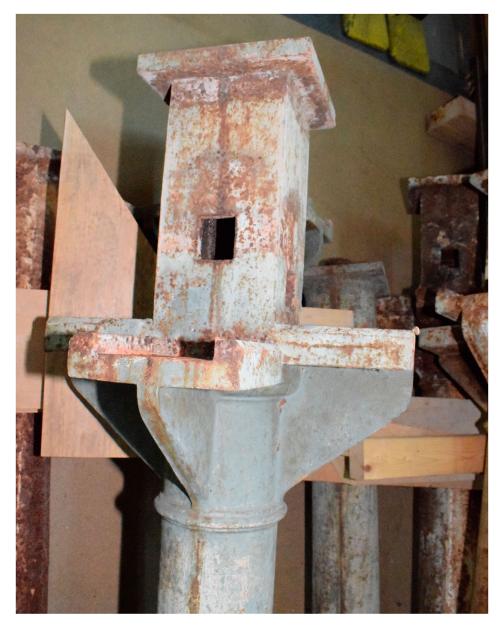
Figure 18. Tobacco drying facility, detail of column (Marko Franković, 2019).

The iron columns were of a circular hollow section, with capitals devoid of any ornaments.<sup>45</sup> At the same time, the four protruding plates were constitutive parts of the extensions above the capitals, enabling the installation of metal I-girders of the cross layout (Figures 17 and 18). In the old part of the building, the longitudinal I-girders had a depth of 220mm, while the transverse I-girders of the skeletons were 80mm deeper. Between these latter, the longitudinal ceiling I-girders were placed (one in each field), serving as supports of the transverse wooden ceiling beams which were uniformly arranged at spacings of 0.8m, carrying the plank flooring.
