Source / Izvornik: **Industrial Archaeology Review, 2022, 44, 19 - 35**

Structures of the First Industrial Age in Rijeka, Croatia — from Timber to Iron

Adriana Bjelanović, Nana Palinić & Marko Franković

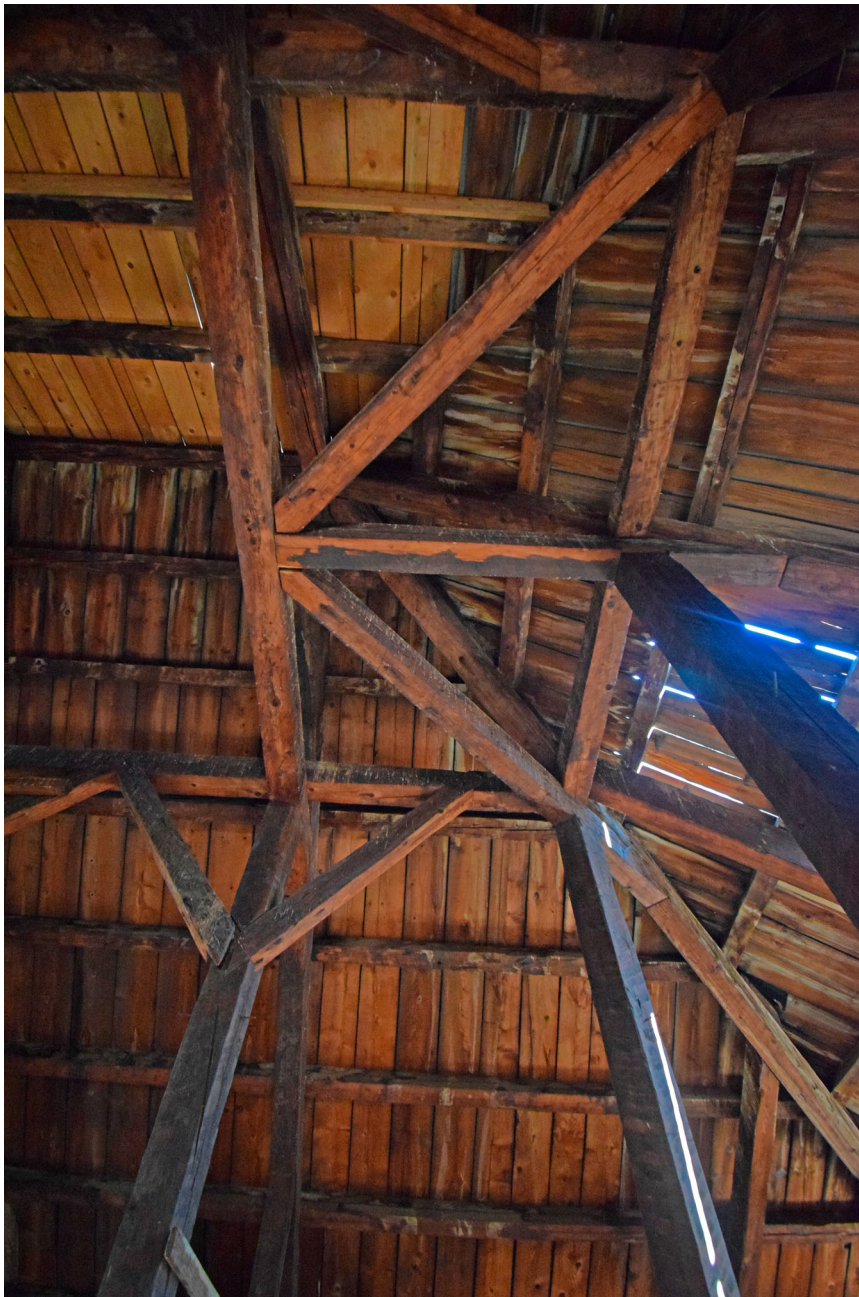
Figure 9. Tobacco Factory T-building, roof structure detail (Marko Franković, 2018).
