Source / Izvornik: **Industrial Archaeology Review, 2022, 44, 19 - 35**

Structures of the First Industrial Age in Rijeka, Croatia — from Timber to Iron

Adriana Bjelanović, Nana Palinić & Marko Franković

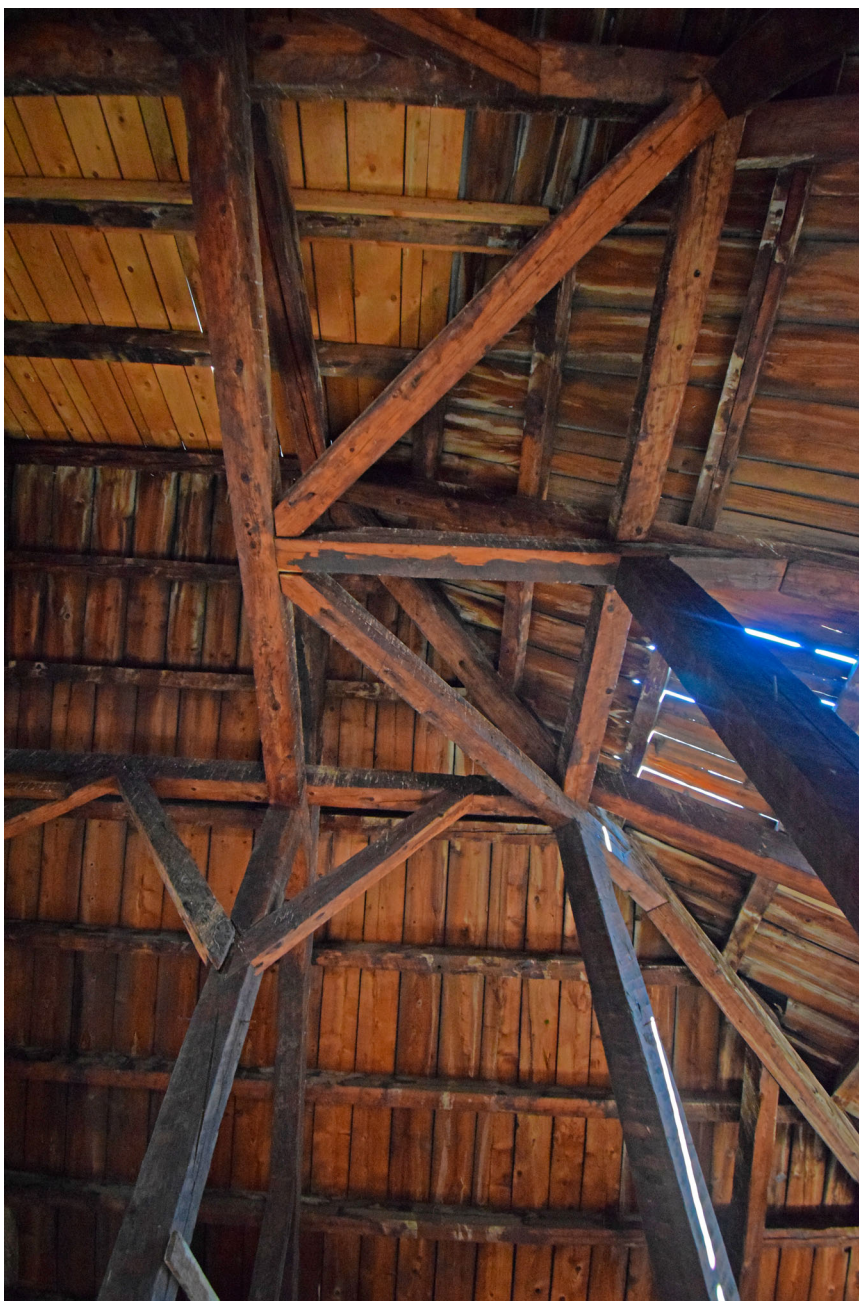
Figure 9. Tobacco Factory T-building, roof structure detail (Marko Franković, 2018).

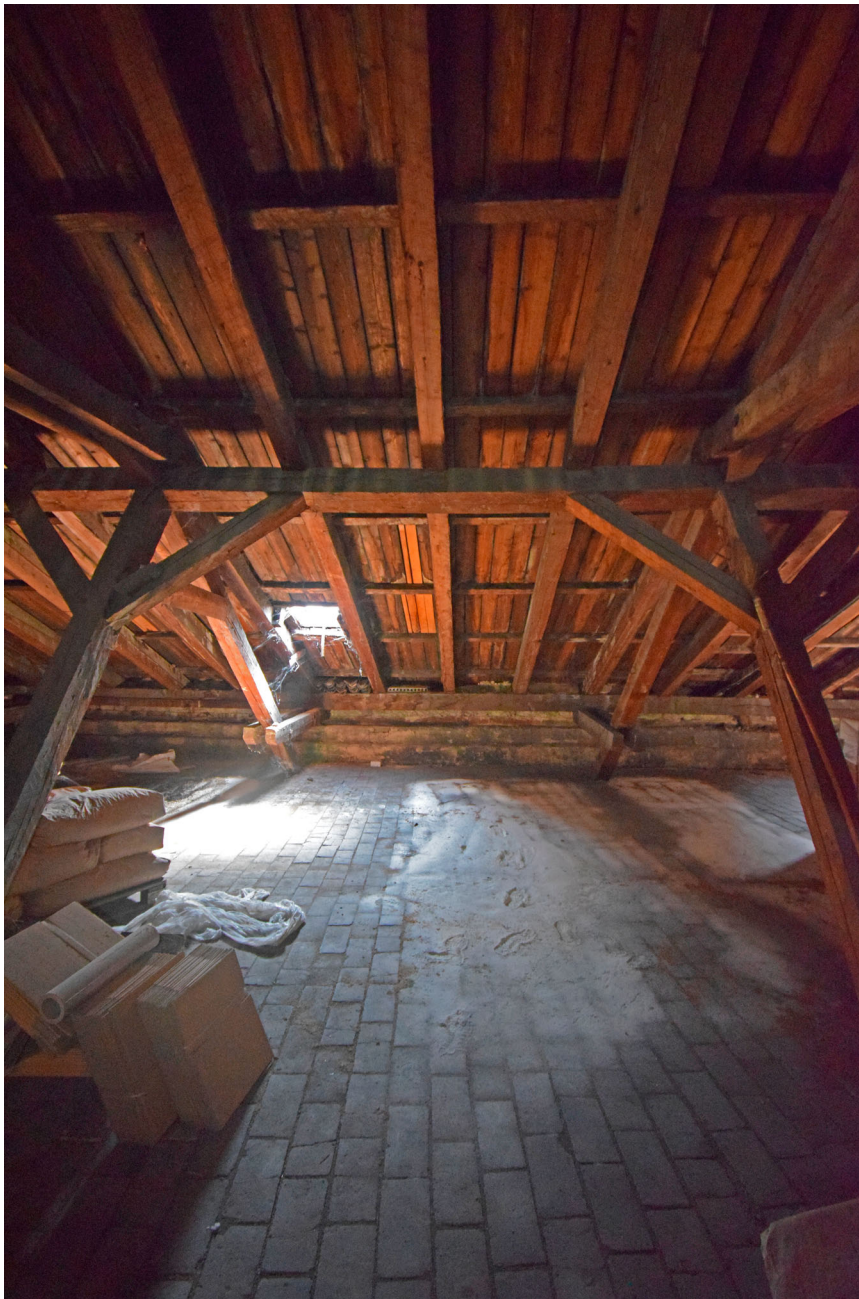
Figure 15. Tobacco Factory H-building, roof details (Marko Franković, 2018).
