*Source / Izvornik:* **Industrial Archaeology Review, 2022, 44, 19 - 35**

## Structures of the First Industrial Age in Rijeka, Croatia — from Timber to Iron

Adriana Bjelanović, Nana Palinić & Marko Franković

Rijeka; industrial architecture; construction; timber; iron; warehouses; tobacco factory; corn mill

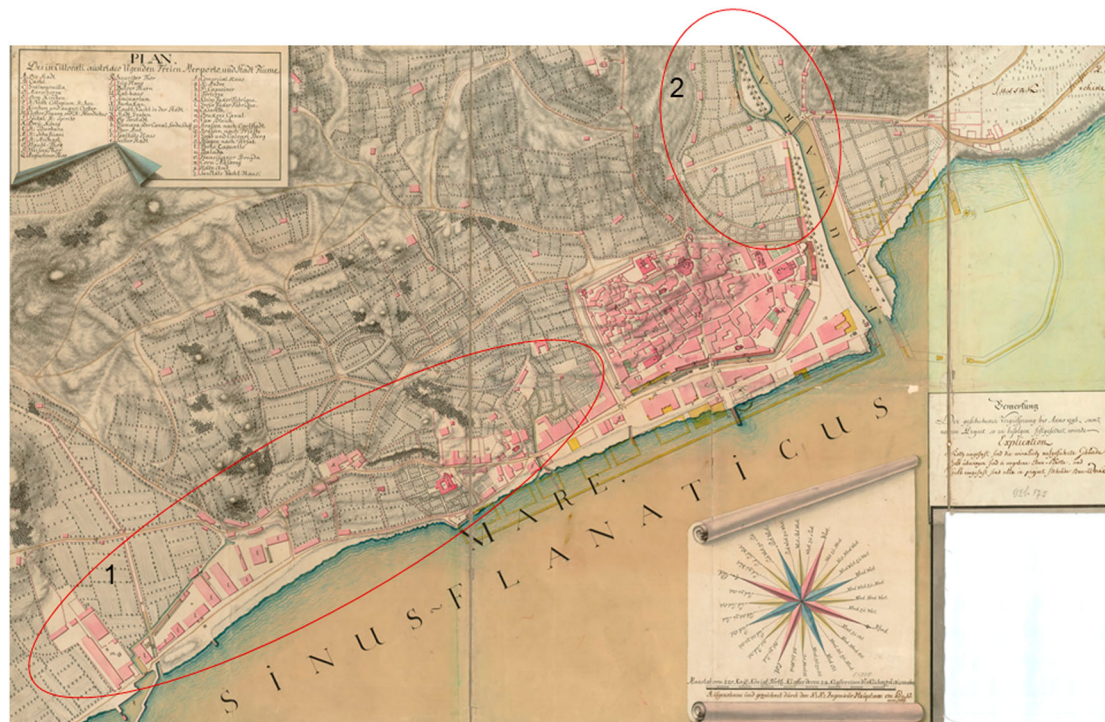
**Figure 1.** Rijeka, the main production zones of the first industrial age on the plan of the city from the end of 18th century made by Mayor von Benko: 1. central zone; 2. zone along the river Rječina (HR-DARI), original in Österreichisches Staatsarchiv, Kriegsarchiv, sign. Glh 175 Fiume). State Archives in Rijeka (HR-DARI), reproduced with permission.
