# Experimental Investigation of the CFS-PU Composite Wall Panel under Axial Compression

**Abstract:** This study presents an innovative design for a cold-formed steel polyurethane (CFS-PU) composite wall panel, combining a cold-formed steel frame, a polyurethane foam infill, and a gypsum fibreboard sheathing. The foam filling process, in which the foam is injected under pressure, ensures uniform distribution, bonding, and interaction of all panel components. The aim of the study is to evaluate the behaviour of the CFS-PU composite panels and the influence of the PU foam and sheathing on the performance of the CFS frame structure. For this purpose, a comprehensive test programme was conducted with nine full-scale specimens, including four CFS-F specimens without infill and sheathing and five CFS-PU specimens with infill and sheathing on both sides. The study examined various aspects of the specimens, including failure modes, stability, stiffness, load-bearing capacity, and ductility index. By analysing these parameters, valuable insights were gained into the performance characteristics of the composite wall panels. The load-bearing capacity of the CFS-PU test specimens was improved

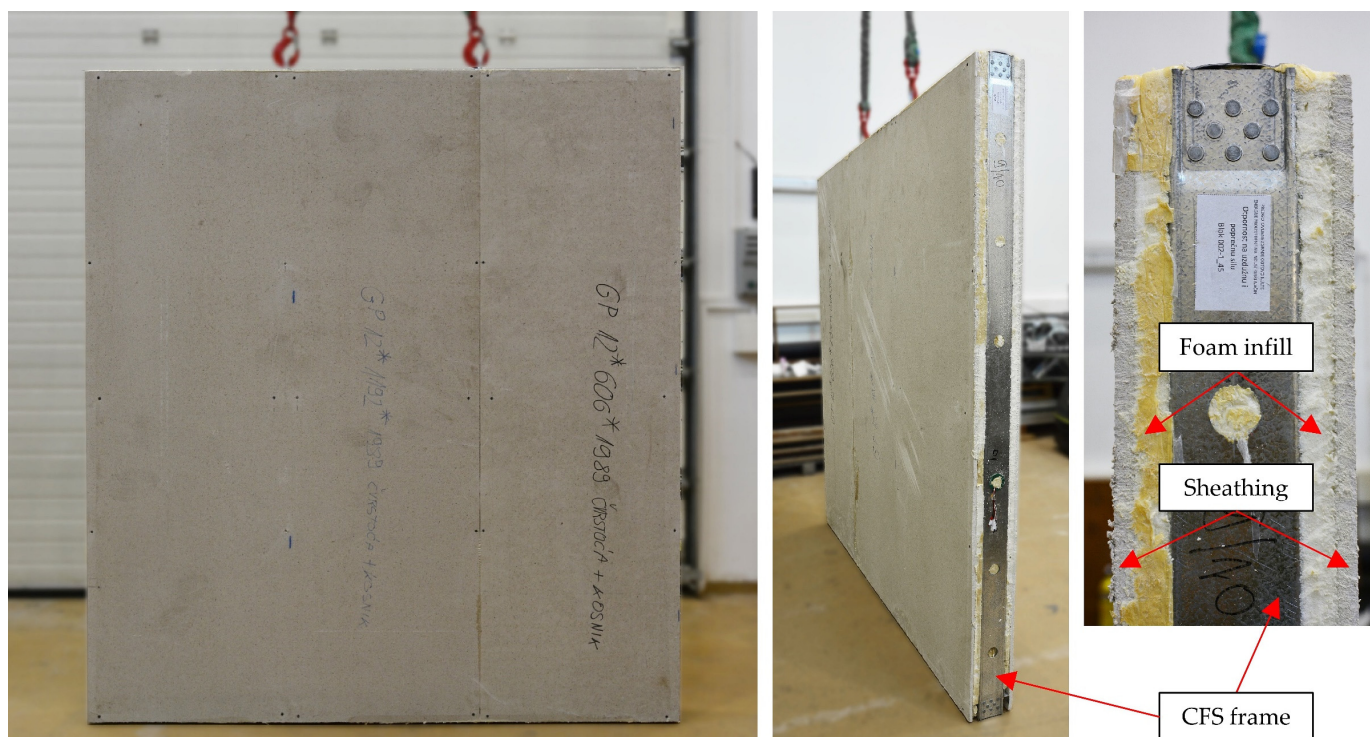
To ensure a solid surface of the wall panels, sheathing is used on both sides of the frame, consisting of gypsum fibreboards with a thickness of 12.5 mm. Each sheathing consists of two boards placed next to each other with the dimensions  $1195 \times 1990$  and  $595 \times 1990$  mm. The sheathings are intentionally made smaller than the CFS frame so that there is a 5 mm free margin on each side to prevent vertical load transfer to the sheaths and to ensure load transfer to the CFS frame only. The sheathings are fastened to the CFS frame with  $3.5 \times 50$  mm self-tapping countersunk drywall screws at the edges of the boards and at the position of the studs and noggings. The screws are placed at a mutual vertical distance of 485 mm so that the screws cannot collide with the spacers. Each board is individually fastened to the CFS frame.

A CFS-PU composite wall panel is filled with closed-cell PU foam with a nominal density of  $45 \text{ kg/m}^3$ , which is injected under pressure between the sheathings and the CFS frame. The PU foam fills the space between the CFS elements of the frame and in the process of expansion achieves an adhesive bond with the CFS structure and sheathings. The results of the adhesive bond test can be found in [28,29]. Figure 4 shows the CFS-PU composite wall panel with sheathing and PU foam filling.

**Figure 4.** CFS-PU composite wall panel specimen with sheathings and PU foam filling.

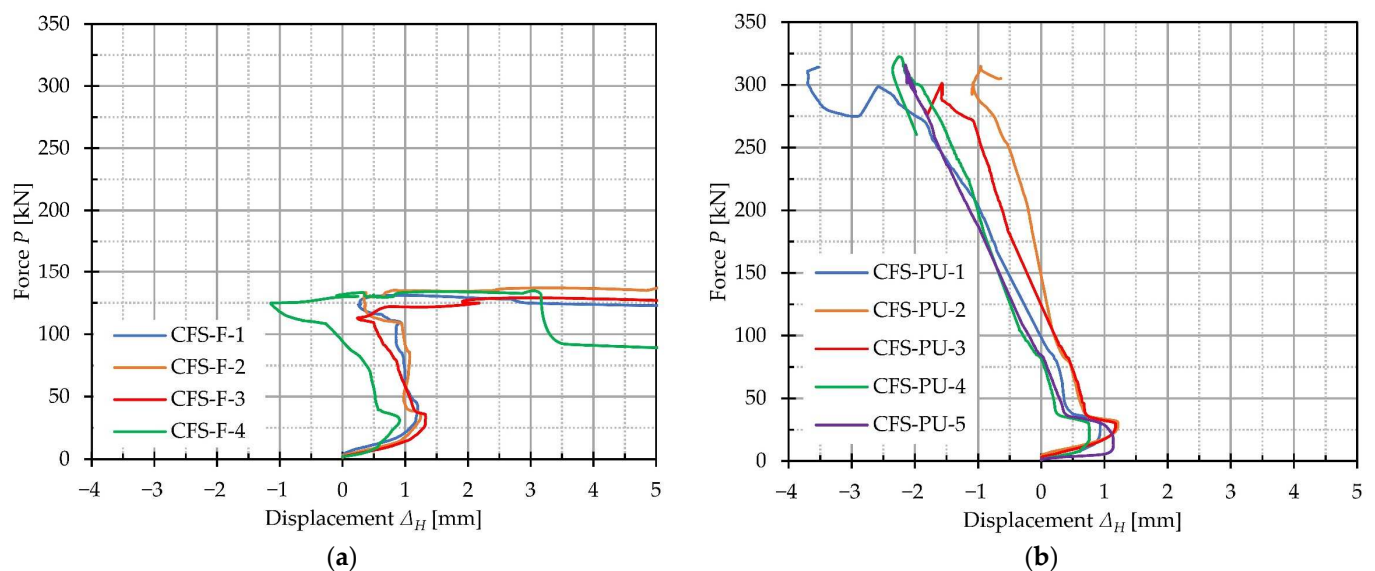
Figure 15 shows the relationship between the force  $P$  and horizontal displacements  $\Delta_H$  at the middle heights of the specimens. The displacements given are the mean values of LVDT-2, LVDT-3, and LVDT-4.

**Figure 15.** Force–displacement ( $P - \Delta_H$ ) curves of (a) CFS-F and (b) CFS-PU specimens.

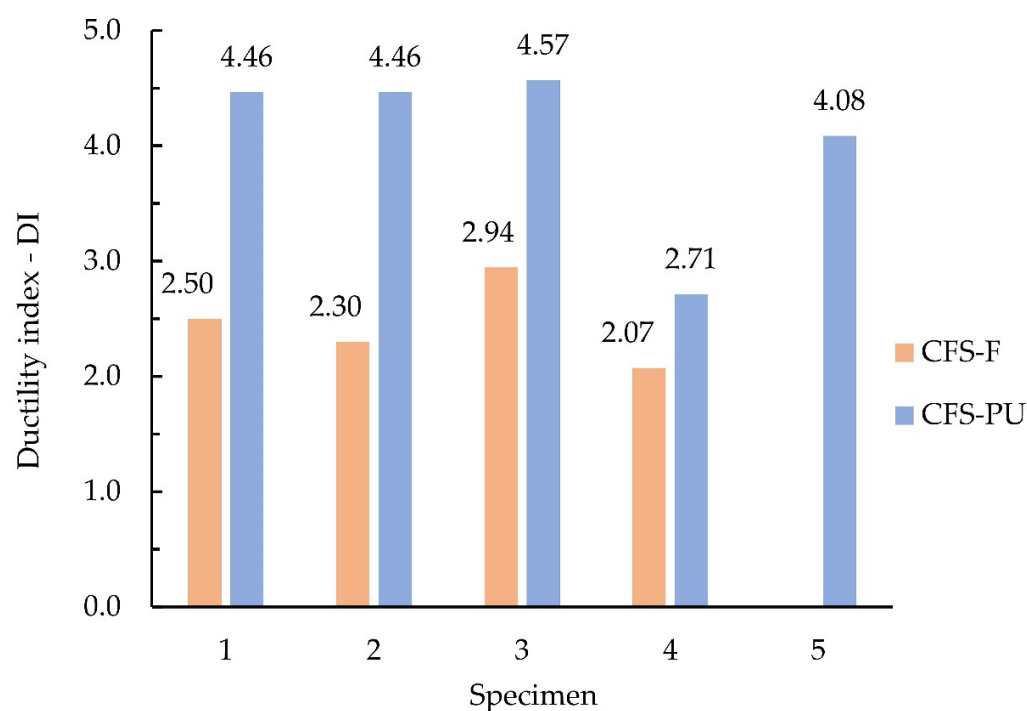
Figure 16 shows a summary of the  $DI$  values obtained for the CFS-F and CFS-PU specimens. The average  $DI$  value for CFS-F specimens is equal to 2.45, while for CFS-PU specimens the average  $DI$  value is 4.06. It is evident that the  $DI$  for CFS-PU specimens is 1.65 higher than for CFS-F specimens.

Figure 16. Ductility index for CFS-F and CFS-PU specimens.

- (d) CFS-PU specimens showed satisfactory resistance and ductility even after failure. The ductility index was 1.65 times higher for the CFS-PU specimens compared to the CFS-F specimens, indicating their ability to withstand loading and absorb energy.
