Rekonstrukcija hotela President u Dubrovniku 2013. godine

Source / Izvornik: **E-Zbornik, elektronički zbornik radova Građevinskog fakulteta, 2022, 12, 55 - 65**

Reconstruction of Hotel President in Dubrovnik in 2013

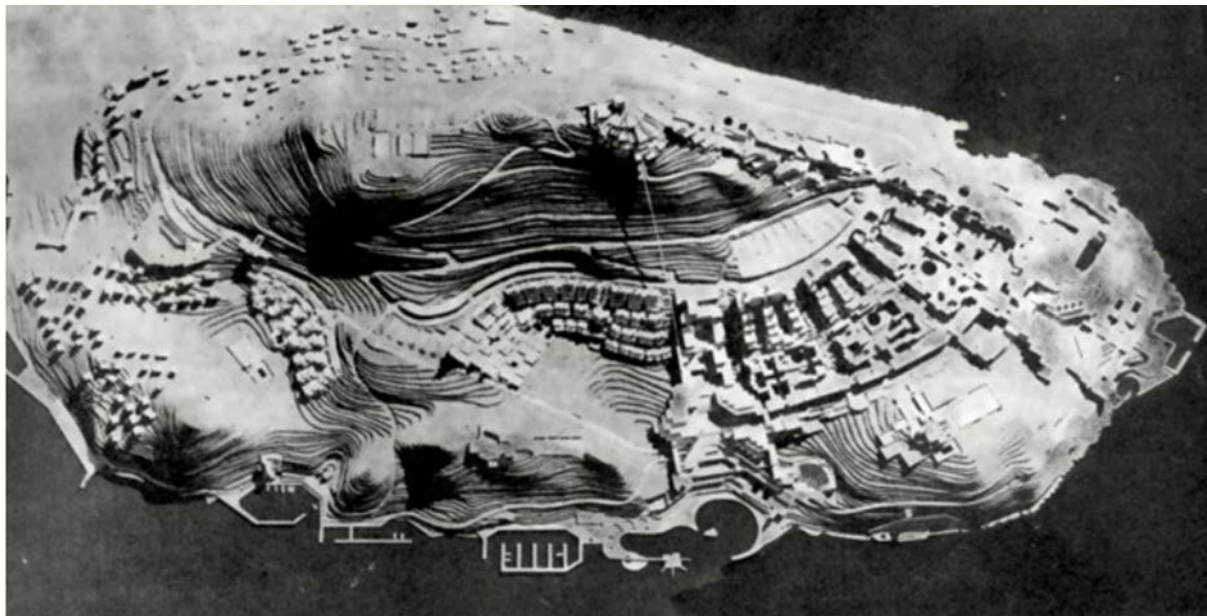
Figure 1. Model of the Babin Kuk tourist complex from 1969 according to the South Adriatic project, cooperation SWECO, Urban Institute, Zagreb, SR Croatia. Urbanistički projekt Babinog Kuka kod Dubrovnika, Arhitektura, 1969, 104, pp. 25-30.

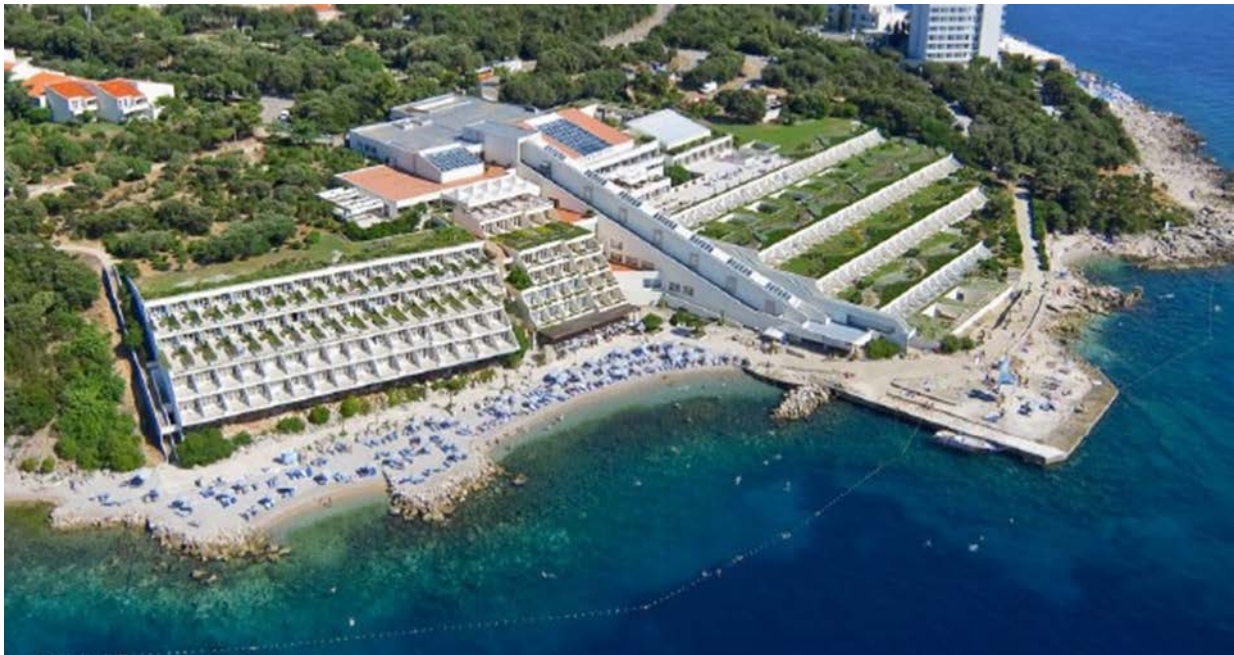
Figure 2. View of the Babin Kuk complex, the existing state before the reconstruction in 2013. Studio 92 d.o.o., Labin

The public areas of the hotel are located mainly on the upper floors, while the accommodation tract is on the lower floors. The hotel has direct exit to the terrain from the highest and lowest floors, although the accommodation tract follows the configuration of the terrain. The inclined exterior and interior elevators were a special feature of the existing hotel President. The external inclined elevators were a recognizable detail in the design of the hotel's volume and also one of the most challenging parts of the reconstruction (Fig. 2).

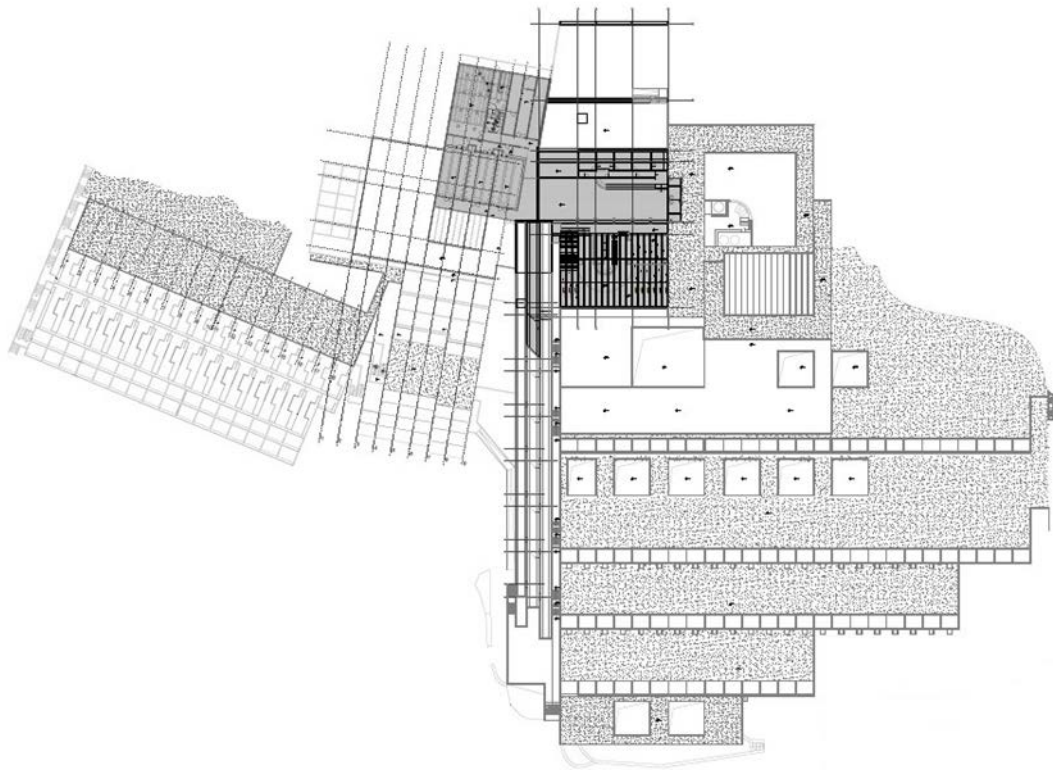
Figure 3. Plan view of the 7th (entrance) floor before reconstruction. Studio 92 d.o.o., Labin

The specificity of the hotel for reconstruction is its cascading structure that adapts to the hillside on which it is located. The main vehicular and pedestrian access to the hotel's main entrance and reception and parking area in front of the hotel is from Iva Dulčića Street at level 7 (Figs. 3, 4). Access to the hotel and other buildings at the site is provided by a number of pedestrian and vehicular-pedestrian areas around the hotel. The hotel has an indented plan form with 8 floors spaced apart in plan view to follow the natural slope of the terrain. Green roofs, visible from the upper floors, are formed on the roof slabs of the lower floors, with emphasized landscaping of the fifth façade (Fig. 2). The hotel is accessed from the highest floor (floor 7) where there are public facilities of the reception, lobby bar, meeting room. All the lower floors are accessed by an internal staircase and inclined elevators. On the floor below the reception (floor 6) there is another lobby bar, a multifunctional hall, an a la carte restaurant and a kitchen and hotel restaurant with terraces. On the 5th floor there is an indoor pool, wellness, fitness and a small bar with outdoor terrace and the first part of the accommodation units. On the lower floors (from 4 to 1) there are other accommodation units and other service facilities. On the floor 0, which corresponds to the floor of the beach, there is a restaurant serving the beach (Fig. 3).

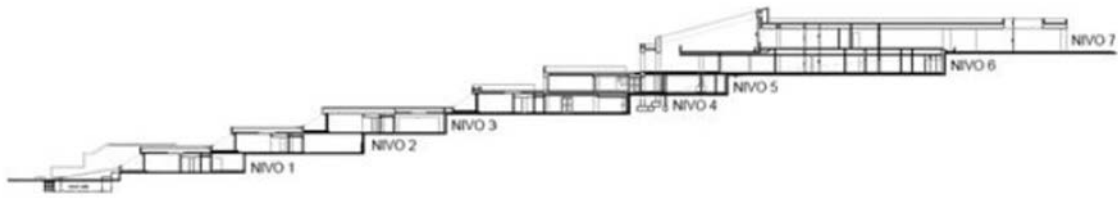
Figure 4. Section through the central part of the existing condition of the hotel in 2013.
Studio 92 d.o.o., Labin

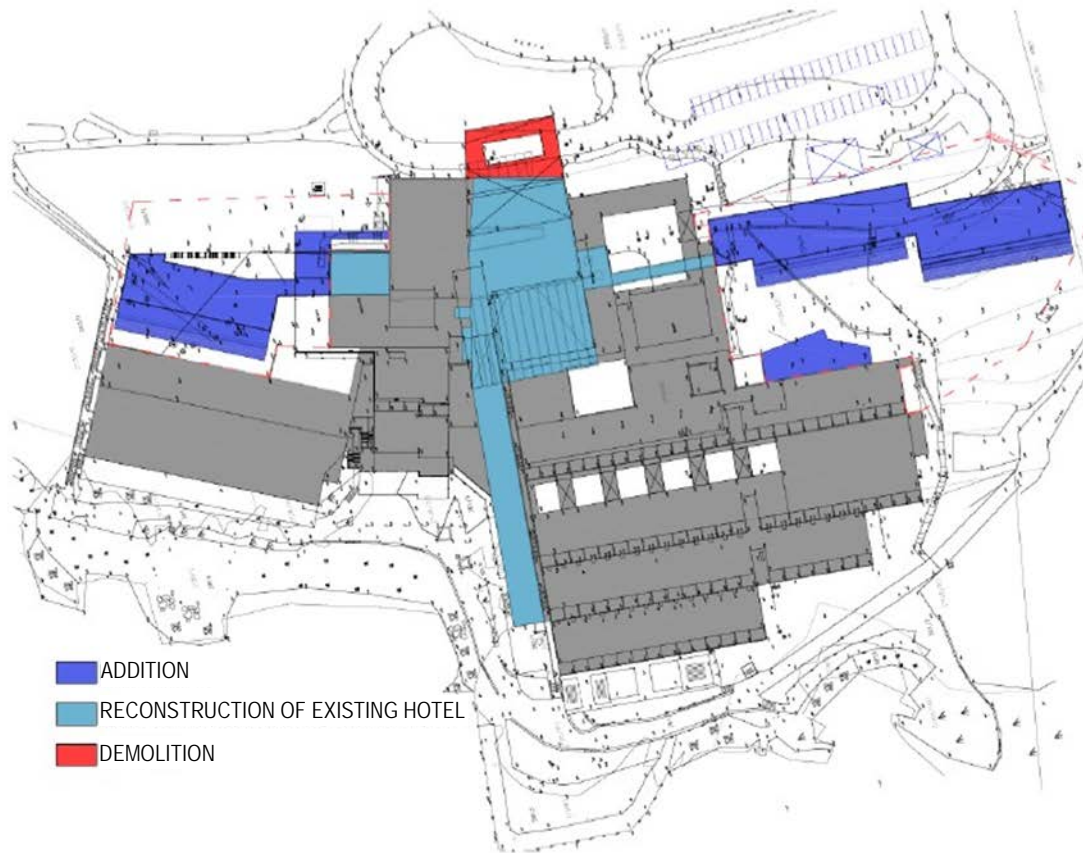
Figure 5. Marked hotel reconstruction zones from 2013. D. Sošić: Reconstruction of Hotel President in Dubrovnik in 2013, Master's thesis, University of Rijeka, Faculty of Civil Engineering, Rijeka, 2020.

The need for reconstruction of hotel facilities is inevitable due to the flexible nature of this industry, keeping pace with market trends and competitiveness (hotel rating, worn-out interior, outdated technology of inclined elevators that have become too slow and expensive to maintain, etc. (Fig. 5). The disadvantages of terraced hotels are long horizontal communications between individual facilities, as well as vertical communications, expensive construction and maintenance. Construction of such a hotel follows the natural slope of the terrain, which increases the cost of construction due to the large required insulation area of the embedded part of the building, displaced load-bearing structures in all floors, large façade surfaces and large surfaces of flat roofs. All of the above increases the quantity of materials and the construction cost.

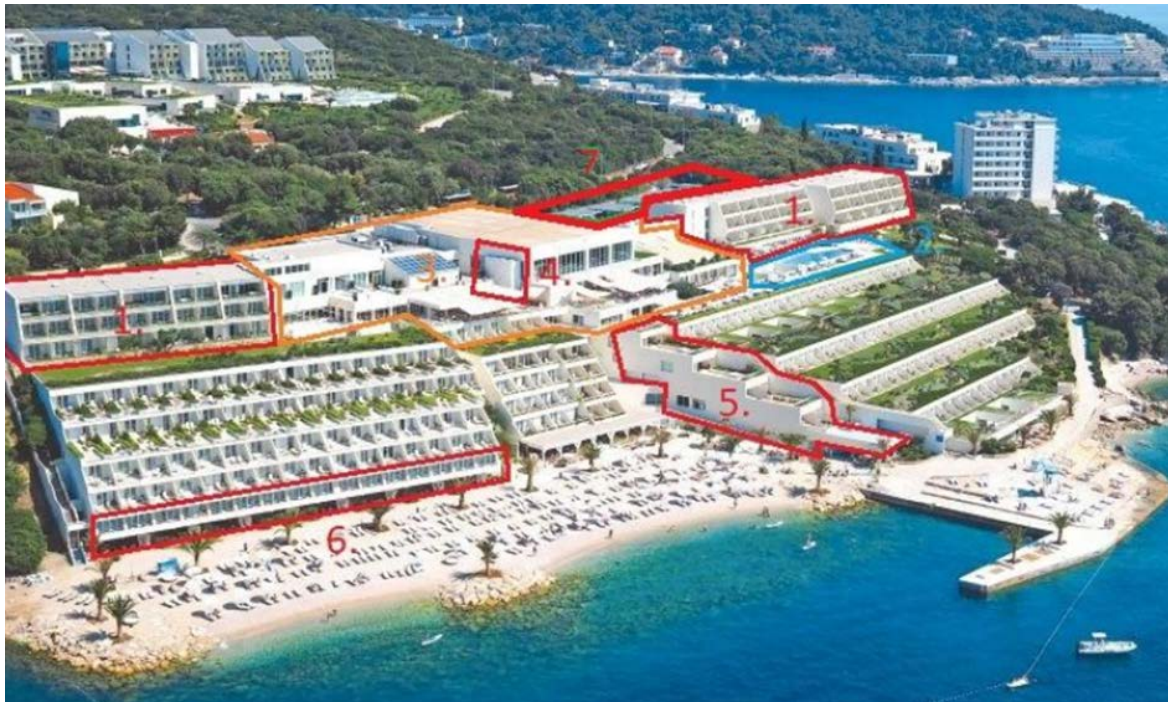
Figure 6. Plan of interventions performed during the 2013 reconstruction. D. Sošić: Reconstruction of Hotel President in Dubrovnik in 2013, Master's thesis, University of Rijeka, Faculty of Civil Engineering, Rijeka, 2020.

The 2013 intervention by the architects of Studio 92 d.o.o. from Labin brings the hotel back to its 5-star rating and includes the following (Fig. 6): addition of the north and south accommodation wings (1); construction of an outdoor pool (2); reconstruction of public parts of the hotel (3); replacement of two inclined internal service elevators and two external guest elevators with vertical elevators (4), addition of new rooms in the position of inclined external elevators (5); construction of rooms on floor 1 (6), construction of outdoor covered parking area (7), landscaping.

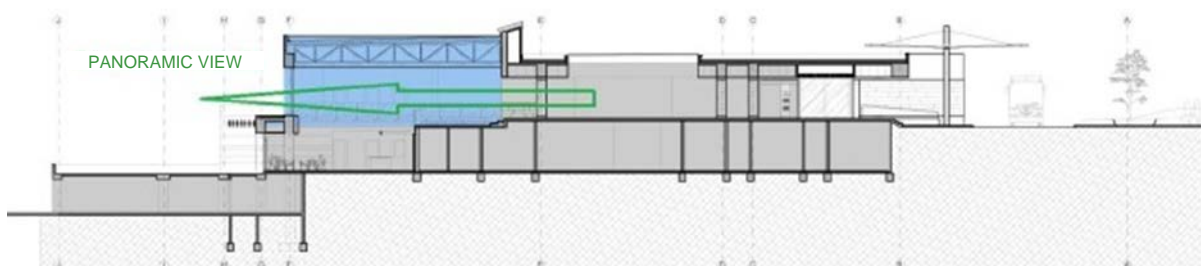
Figure 7. Section through the hotel lobby. D. Sošić: Reconstruction of Hotel President in Dubrovnik in 2013, Master's thesis, University of Rijeka, Faculty of Civil Engineering, Rijeka, 2020.

According to the original solution of the entrance part of the hotel, the sea was not visible in all its splendor but at the entrance, probably due to the architect's desire to gradually reveal the beauty of the site. In order to open the sea view in the lobby, Investor Valamar Riviera d.d. had the entire roof structure replaced (Figs. 7, 8).

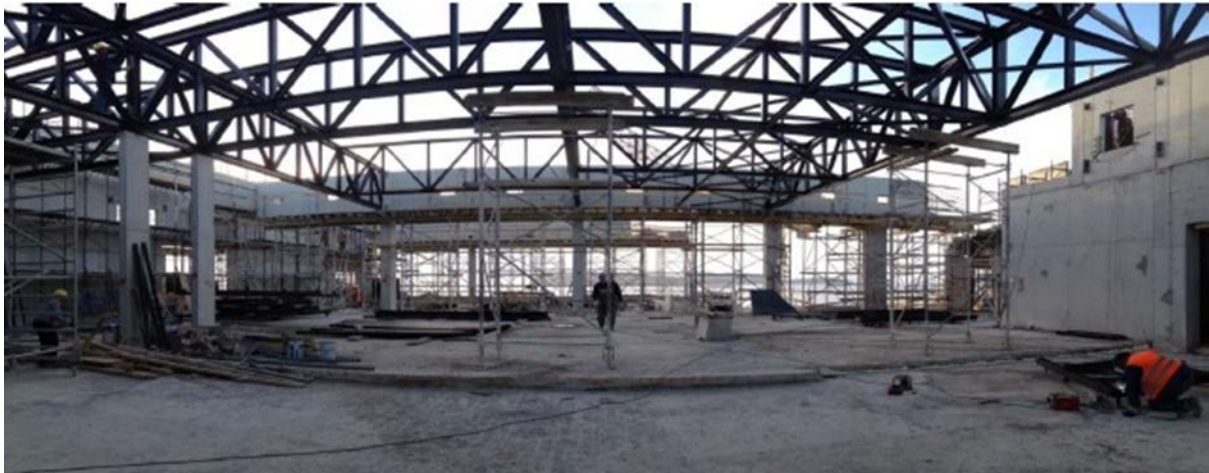
Figure 8. Photo of the lattice roof structure of the hotel reception during the reconstruction in 2013. Studio 92 d.o.o., Labin

The technological solutions used in the reconstruction of the hotel are as follows: steel lattice structure of the lobby roof, which provides a representative entrance area and sea view with its span. Deep beams enabled the construction of the entire floor of cantilever rooms on level 1 above the existing beach (Figs. 6, 9); the solution of vertical elevators required a markedly complex static solution because the vertical shaft of the new elevators (8 levels) penetrated through the load-bearing foundation structure of the hotel and the existing internal inclined elevators. In plan view, the newly planned vertical elevators are located near the very edge of the reception interior space in order to minimize the depth of the corridor on the lowest floors. The system of main vertical elevators consists of three guest elevators and one service elevator (Figs. 9, 10). During the excavation, the existing structure had to be gradually stabilized by supports. The total elevator height is 28 m. The existing structure of the hotel is made of reinforced concrete: foundations, walls and floor slabs.

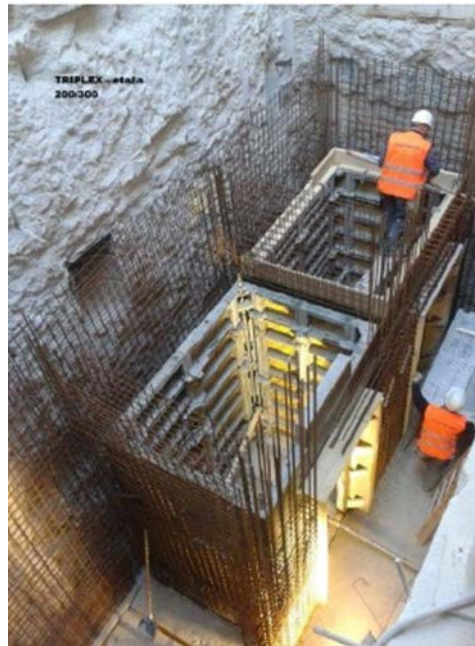
Figure 10. Photo of elevator shaft concreting. D. Sošić: Reconstruction of Hotel President in Dubrovnik in 2013, Master's thesis, University of Rijeka, Faculty of Civil Engineering, Rijeka, 2020.

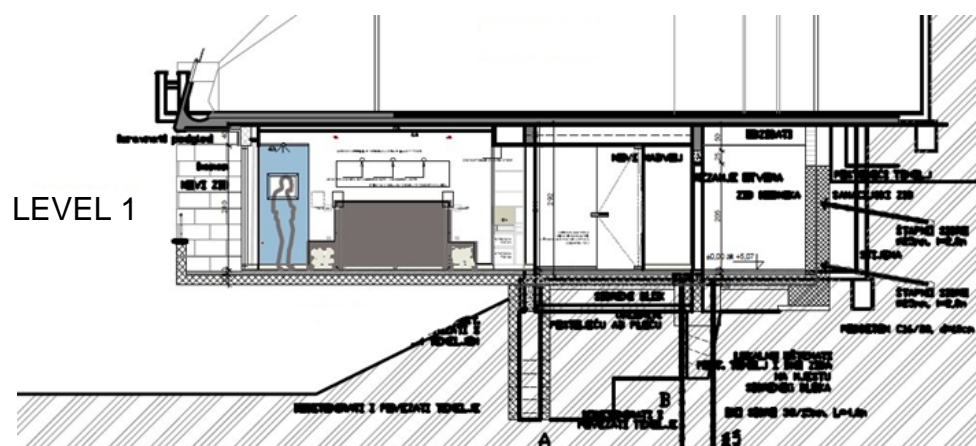
Figure 11. Cross section of a so-called cantilever room on level 1. Studio 92 d.o.o., Labin

The so-called cantilever rooms on floor 1 were the structurally demanding part of the construction. The length of the cantilever is about 6 m. Rooms are constructed on a deep beam fixed to the foundations and retaining wall along the slope of the terrain. Floor slabs are supported horizontally on deep beams. The foundations are reinforced with anchor blocks and rock bolts in the rock. It was also necessary to excavate part of the new corridors through the solid rock under the existing foundations of the rooms. The excavation was challenging also because of the restricted space (Fig. 11).

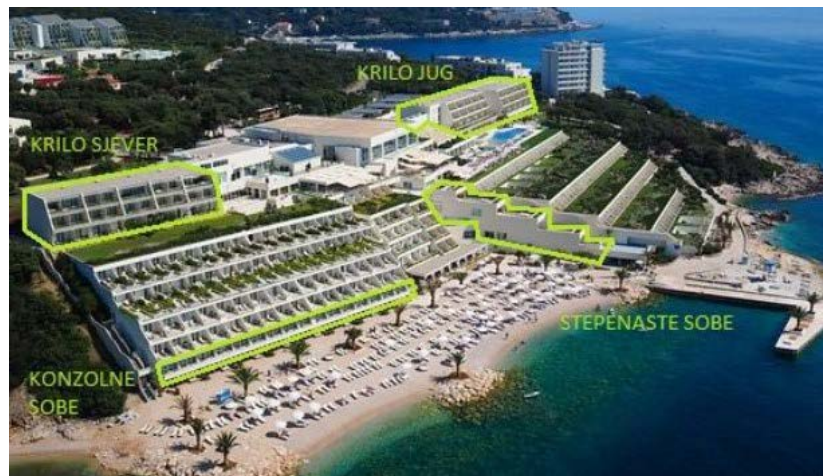
Figure 12. Plan of added parts of the hotel accommodation tract. D. Sošić: Reconstruction of Hotel President in Dubrovnik in 2013, Master's thesis, University of Rijeka, Faculty of Civil Engineering, Rijeka, 2020.
